Technical Service Bulletin

Subject: LIFTGATE SWITCH DOES NOT WORK	Bulletin No.: 09-004/22
	Last Issued : 01/27/2022

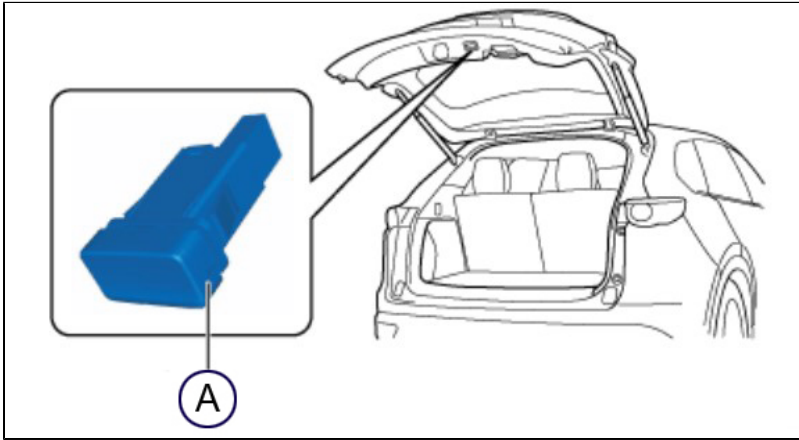
NOTE: CX-5 shown below

Some CX-5 and CX-30 customers may find that the liftgate does not close when pressing the power liftgate (PLG) rear switch (A) located on the interior liftgate trim. This may be caused by PLG switch corrosion. Water from a high pressure car washer and/or condensation may drip onto the switch connector and cause corrosion.

Some Mazda3, CX-30 and MX-30 customers may complain that the vehicle door locking system does not work when the door lock switch on the liftgate interior trim is pressed. DTC B11C4:23 (BCM - liftgate lock switch circuit malfunction) may be stored. This may be caused during a high pressure car wash and/or condensation. Water may enter through the rear center brand emblem base component and drip onto the switch connector causing corrosion. The rusted connector may also cause a battery drain.

To eliminate this concern, the PLG rear switch has been modified with a waterproof connector.

To eliminate this concern, the rear center brand emblem base has been modified to prevent water entry (Mazda3) and the rear harness has been modified to prevent water infiltration (Mazda3, CX-30 and MX-30).
