# Technical Service Bulletin

## 40 Noises from the front suspension's buffer stops

40 22 32 2059474/3 January 4, 2022. Supersedes Technical Service Bulletin Group 40 number 20-13 dated July 20, 2020 for reasons listed below.

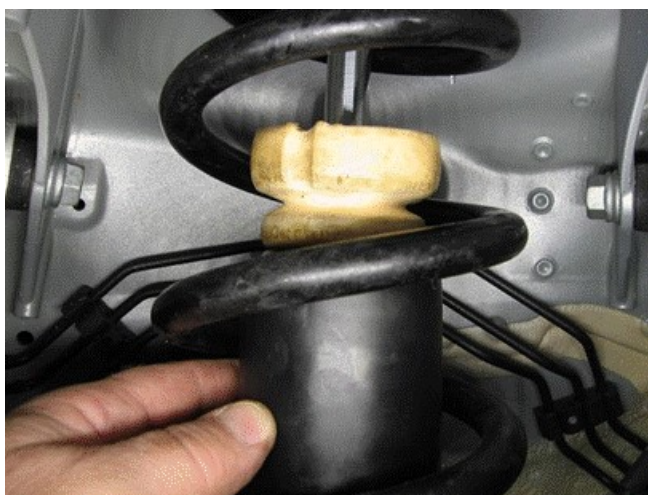
- The buffer stops of the shock absorbers are identified as the source of the noise because they do not sit correctly in the shock absorber mounting (Figure 1).

*Figure 1. The shock absorbers are sitting incorrectly.*

New improvements were made in the suspension design and the material in the buffer stop was changed to increase the hardness. As a result, it has become harder to press them into the mountings.

1. Secure the buffer stops correctly. A tire assembly paste can be used as an aid. The buffer stops must be completely pressed in.
2. If the buffer stops were deformed during the vehicle transport, try to shape them correctly by warming them up slightly. If this is not possible, replace the affected components.
