Technical Service Bulletin

60 Sunroof frame modification
60 22 58 2065731/1 January 8, 2022.

Model(s)	Year	VIN Range	Vehicle-Specific Equipment
Q3, Q8, and Audi e-tron quattro	2019 – 2022	All	Not Applicable
Audi e-tron Sportback quattro	2020 – 2022	All	Not Applicable

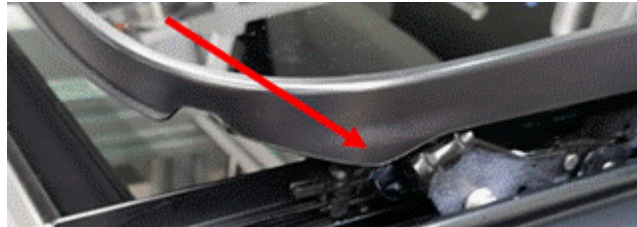
1. If the sunroof frame and/or front sunroof glass panel require replacement the water guidance washer on the sunroof mechanism pivot protrudes to the extent that the rubber "skirt" on the front glass panel also protrudes creating interference between the glass panel and the sunroof opening. This interference can prevent the front glass panel closing sequence from completing.
2. Figure 2 shows the location of the "skirt" protrusion from the water guidance washer.

Figure 1. Front sunroof glass panel side skirt deformed due to a protruding water guidance washer.

4. Remove the front sunroof glass panel. Using a small pair of diagonal cutters (side cutters) trim away the water guidance washer. The washer must be cut back such that it protrudes no greater than the pivot pin. Perform this operation to both sides.

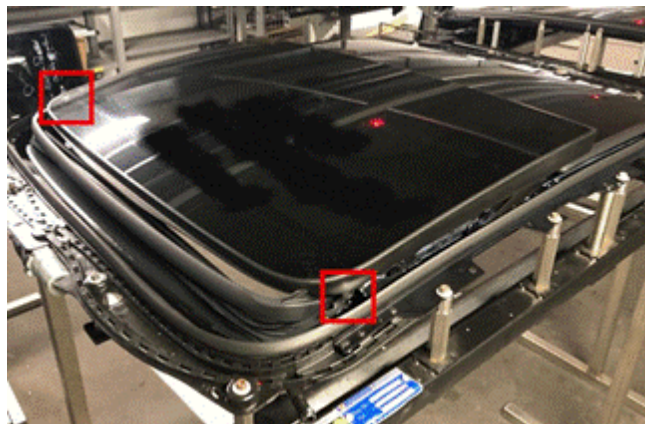
Figure 2. Front sunroof glass panel side skirt protrusion from an unmodified water guidance washer.

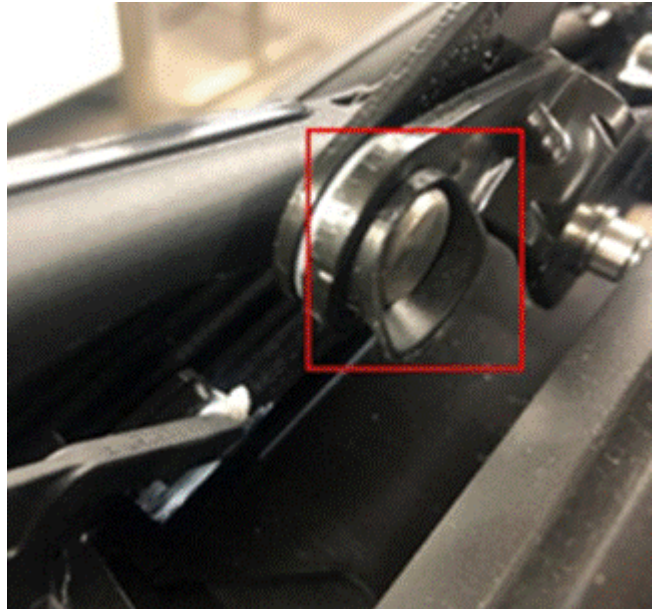
3. Figure 3 shows the water guidance washer with the front sunroof glass panel removed.

Figure 3. Water guidance washer on the front frame mechanism pivot.

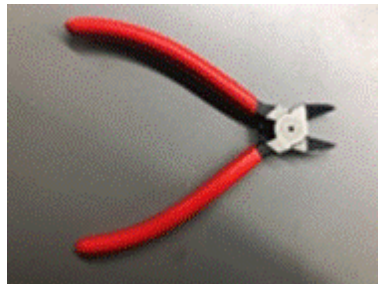
Figure 4. Diagonal cutters (side cutters).

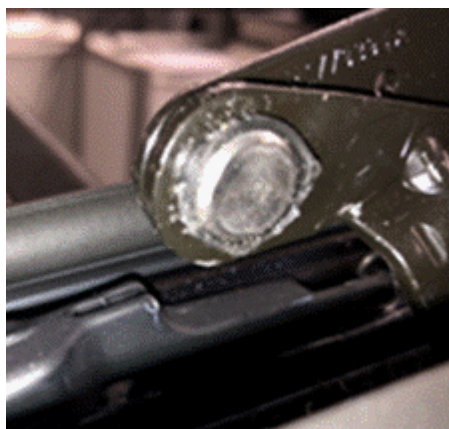
5. Figure 5 shows the removed water guidance washer trimmed below the pivot pin. Since this pivot pin is concealed by the front sunroof glass panel "skirt" it is not necessary to smooth the edges of the cut surfaces.

Figure 5. Water guidance washer on the front frame mechanism pivot.
