Technical Service Bulletin

66 Door cover trim is loose

66 22 83 2065001/2 January 7, 2022. Supersedes Technical Service Bulletin Group 66 number 21-78 dated November 13, 2021 for reasons listed below.

Model(s)	Year	VIN Range	Vehicle-Specific Equipment
Q8, SQ8, and RS Q8	2020 – 2021	All	Not applicable

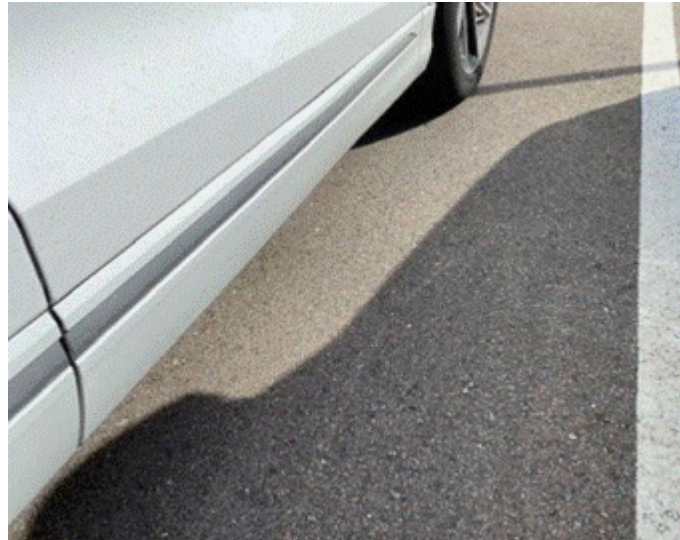
When the front door trim cover was installed in production one or more door trim clips may have been incorrectly engaged and subsequently damaged during the installation process. This issue may be present on either the left or right front doors.

Figure 1. A visible gap is present between the front door trim cover and the outer door panel.

Replace the front door trim according to the repair specifications in the Elsa Repair Manual. Since this issue may be present on front doors for this condition and repair as necessary.

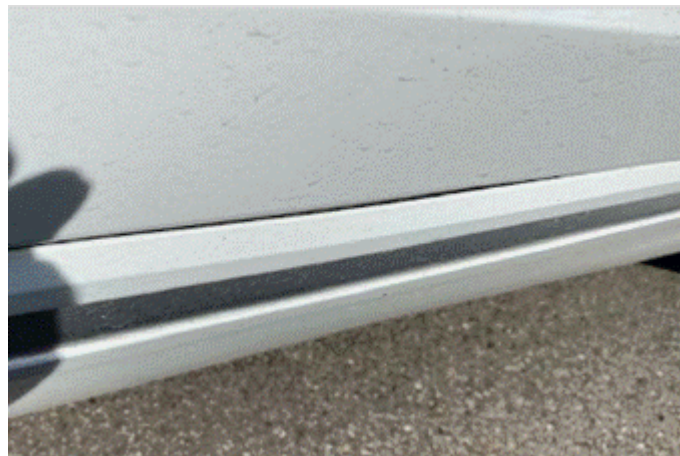
Figure 2. A closer view of the gap, which is present between the front door trim cover and the outer door panel.
