Clock Repair Procedure

AFFECTED VEHICLES

Applies to / All vehicles with Navigation

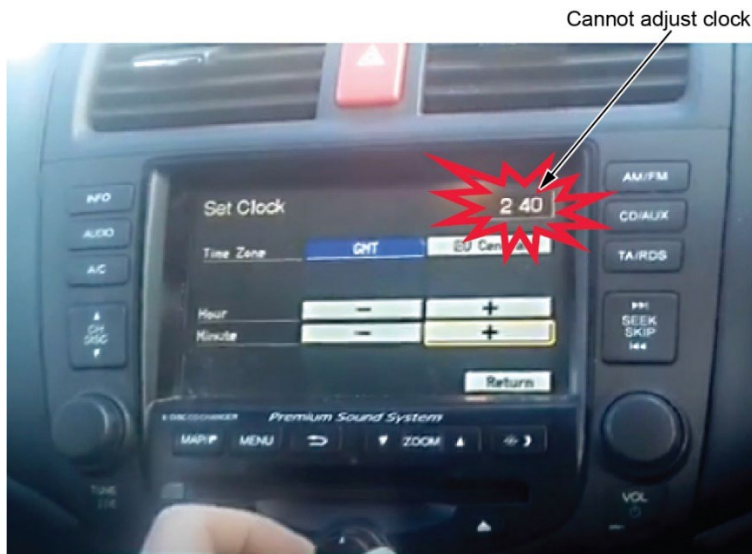
The clock shows the incorrect time. This issue is due to a limited GPS receiver capacity resulting in “rollover” of the internal chip memory; the “rollover” will occur on January 1, 2022, at **12:00AM** local time. As a result, once specific triggers are met, the navigation date and time will be incorrect.
