## Mack Chassis - Granite Models (GU, GR) - Revised Fan Ring Design; Engine Cooling Fan Ring Cracked At Welds - Model Years 2016 To 2020

Affected date ranges: 2 June 2014 (W1423) - 24 June 2019 (W1921)

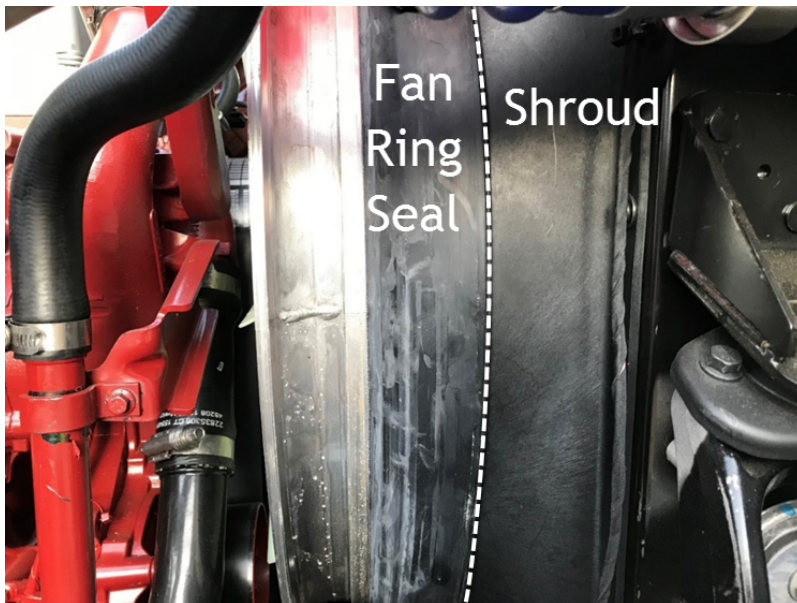
### Correct Setting of the Fan Ring Seal

The seal should be outside of the shroud

A new fan ring design has been released to address the vibration. The revised fan rings have been designed with a larger rubber seal that contacts the fan shroud and is able to effectively dampen vibration of the ring.

Please refer to the illustrations below to verify the fan ring seal has been installed correctly.

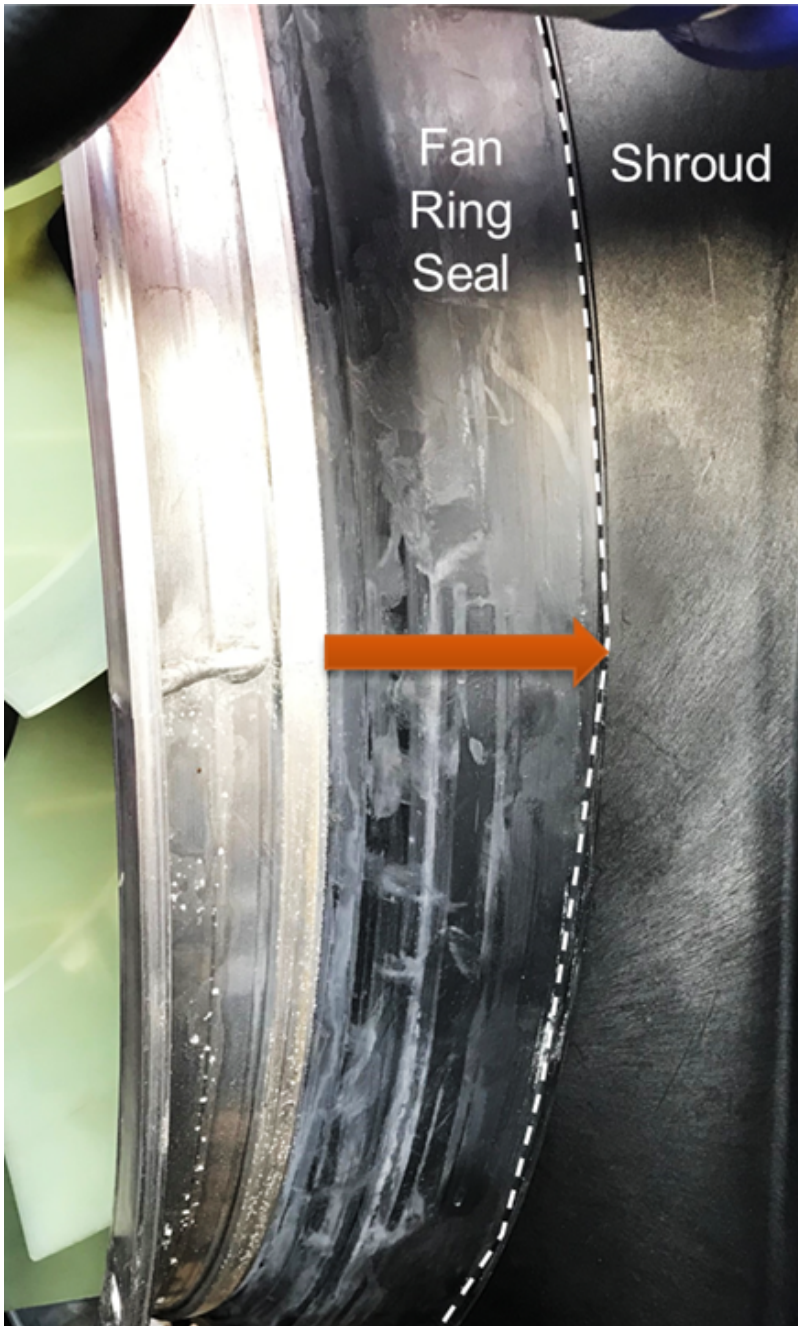
**Correct** - Fan Ring Seal sits on the outside of the shroud

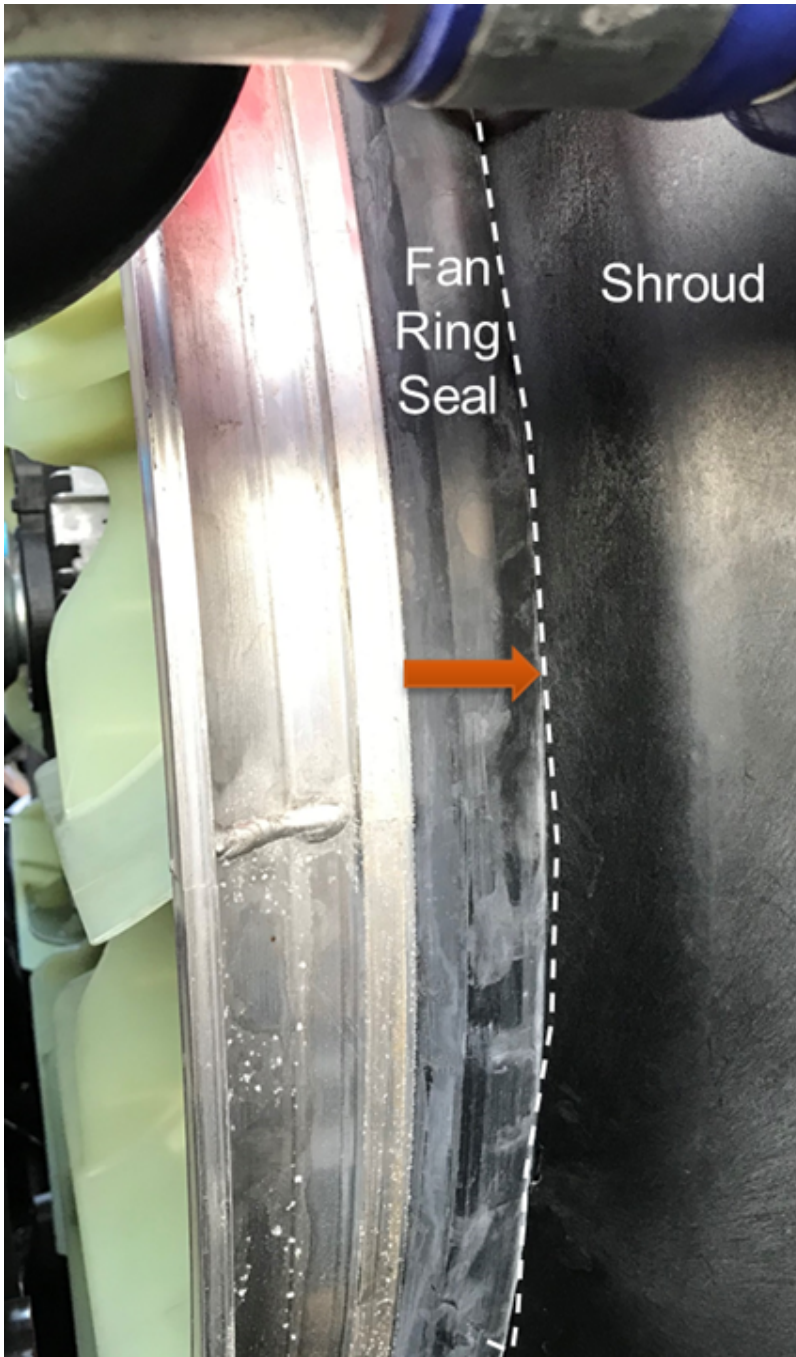
**Incorrect** - Fan Ring Seal is tucked INSIDE of the shroud causing it to look short in length. Be sure to check all the way around the shroud for mis-set seal
