Technical Service Bulletin

72 Noises from front center armrest
72 22 38 2064920/1 January 8, 2022.

Model(s)	Year	VIN Range	Vehicle-Specific Equipment
Q8	2019	All	Not Applicable
Q8, SQ8, RS Q8	2020 – 2022	All	Not Applicable

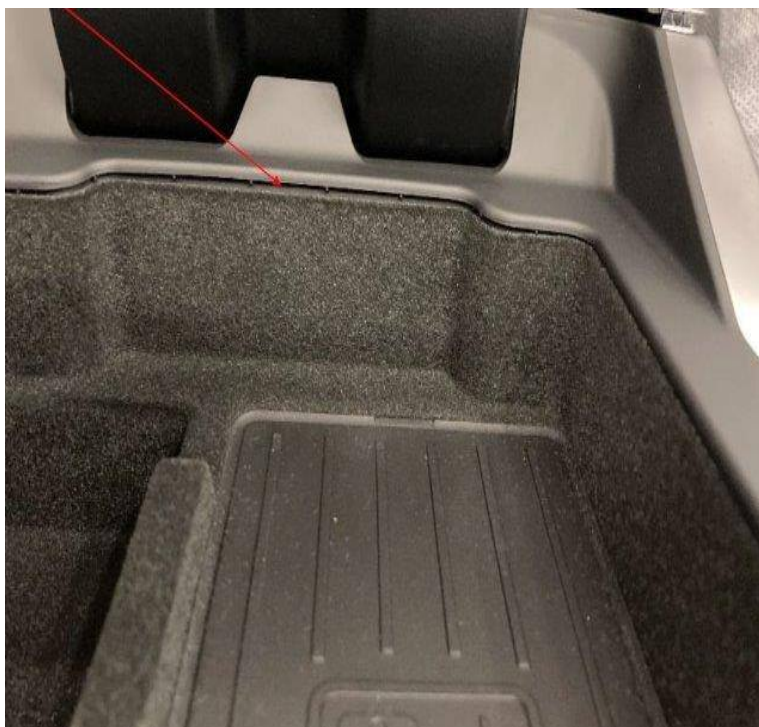
Figure 1. Check the gap between the center console upper section and the storage bin.

1. Check the gap between the center console upper section and the storage compartment (Figure 1). The gap should not exceed 0.5 mm.

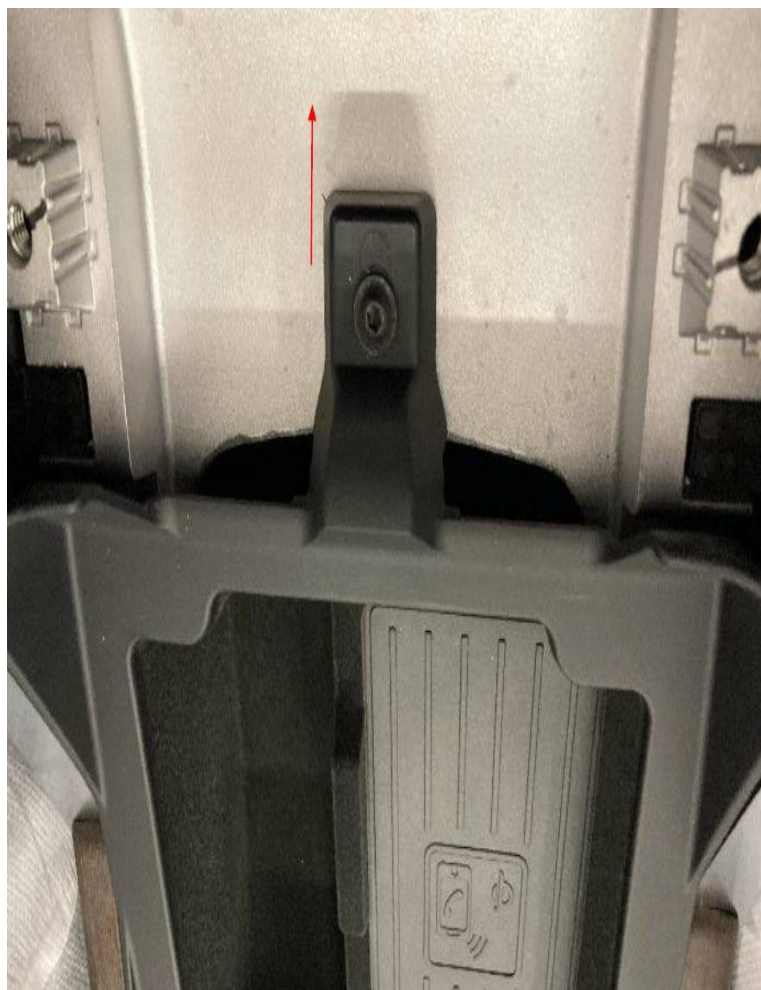
Figure 2. Moving the center console upper section towards the rear of the vehicle

2. Remove the armrest trim and the rear center console trim.
3. Remove the center armrest following the Elsa Repair Manual.
4. Loosen the center console upper section screw (Figure 2).

5. Pull the center console upper section towards the rear of the vehicle and tighten the screw (Figure 2).

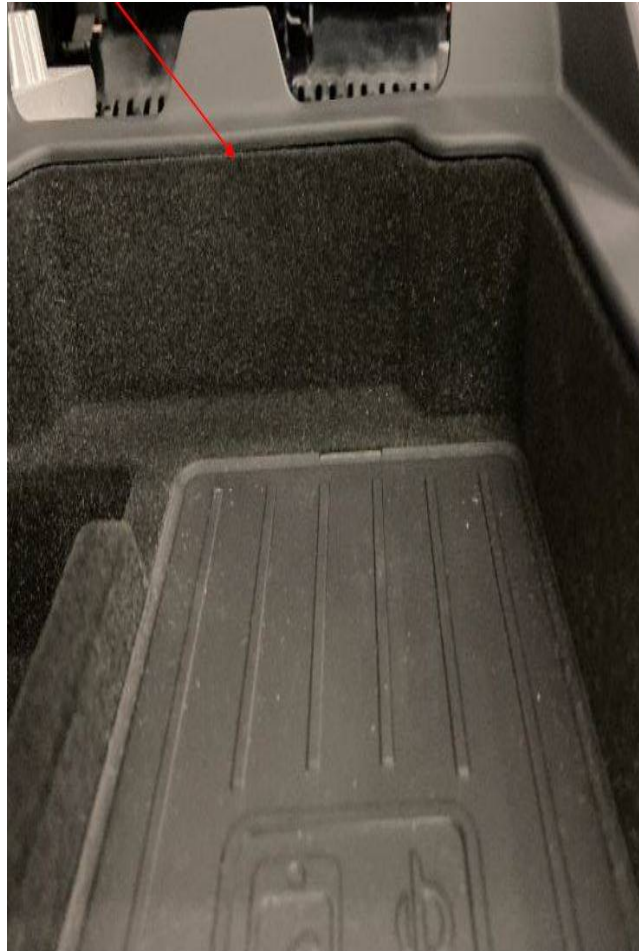
Figure 3. Center console upper section to storage bin gap, even and approx.0.5 mm wide.

7. Recheck the gap of the center console upper section (Figure 3). The gap should be even and approx.0.5 mm.
