# Technical Service Bulletin

**90 Instrument cluster: the Audi virtual cockpit displays a colorful line (pixel error)  
90 22 41 2064983/3 January 31, 2022. Supersedes Technical Service Bulletin Group 90 number 21-31  
dated December 22, 2021 for reasons listed below.**

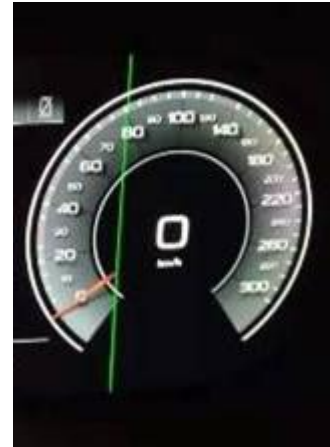
- A red, green, or blue continuous vertical line is displayed on the instrument cluster (pixel fault) (Figures 1 - 2).
- The line may be vertical or horizontal.

**Figure 1.** The vertical line through the instrument cluster display.

There is a hardware issue in Audi virtual cockpit.

1. Please take photos of the area of concern and upload them into DOC-IT with the repair order. Photos should:
  - Have a date stamp and VIN reference.
  - Be taken in focus and with sufficient light.
2. Please replace the instrument cluster, J285 (address word 0017) according to the Elsa Repair Manual. The replacement part should have a production date of Jan 1, 2022, or newer.

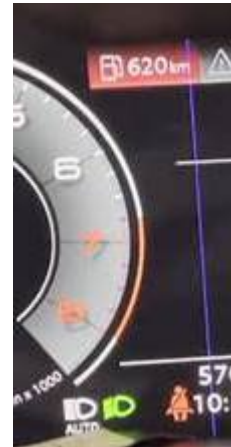
**Figure 2.** The vertical line through the instrument cluster display.
