46 Brake noise analysis and handling

46 22 27 2034181/19 January 31, 2022. Supersedes Technical Service Bulletin Group 46 number 21-24 dated February 10, 2021 for reasons listed below.

Model(s) Year	VIN Range	Vehicle-Specific Equipment
All	2012 – 2023	All	Not Applicable

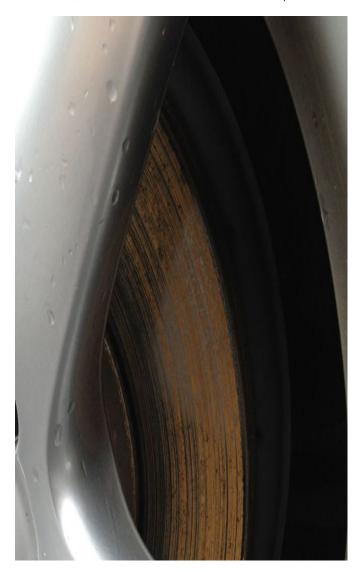
- 4. There is debris (such as small stones, grit, road salt, or sand) between the brake disc and brake pad.
- 5. Discs are covered with rust. Rust can form when the vehicle has not been driven for a long period of time (Figure 1).

Figure 1. Disc covered with rust.

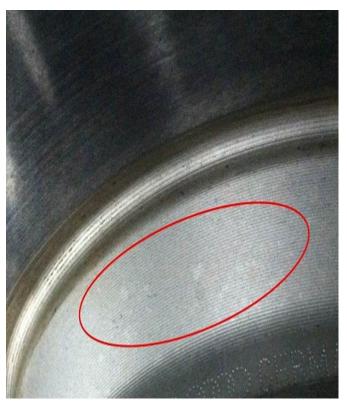
Figure 4. Small spots and discoloration due to chemical contamination from the cleaner that was sprayed directly onto the disc.
