Technical product information

V8 Kovomo engine

V8Kovomo - Engine misfires - Engine management light illuminated within the DIP

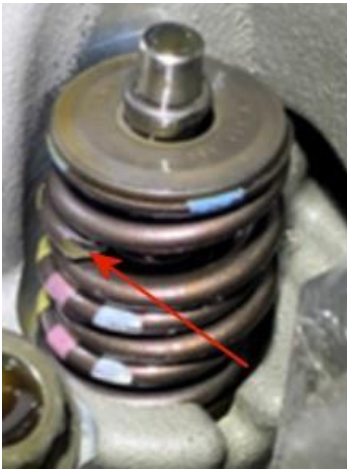
- Referring to Figure 1 - Take clear photos of the broken valve spring (from the affected cylinder head only)

VERY IMPORTANT: Ensure the photos show the location in which the valve spring is broken (ARROW) the various paint markings should also be captured
