SERVICE BULLETIN

APPLICABILITY: **2020-2022MY** Legacy and Outback
2022MY WRX
2022MY BRZ

NUMBER: 15-259-20R

SUBJECT: Denso Gen 4 Cockpit One (CP1)
 Infotainment System Operating TIPS

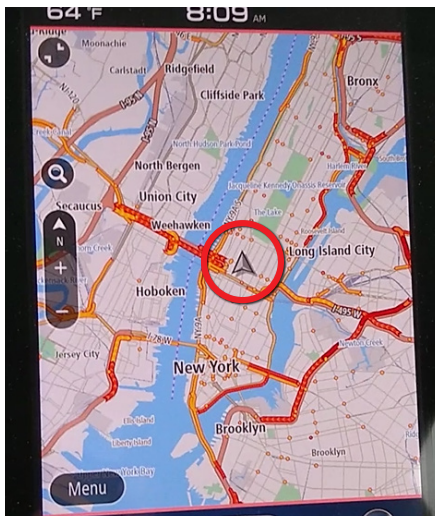
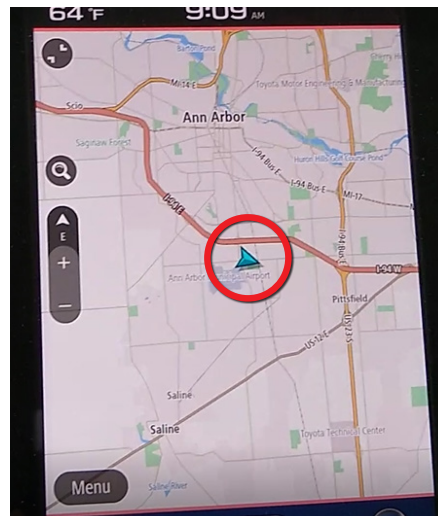
It is possible during Delivery Mode for the NAVI GPS display to show Manhattan, NY location all the time. This is a default setting for GPS in this mode. Other indicators of Delivery Mode are:

Following Delivery Mode or Memory Initialization (map arrow is gray).

Normal Operation (map icon is blue/green).

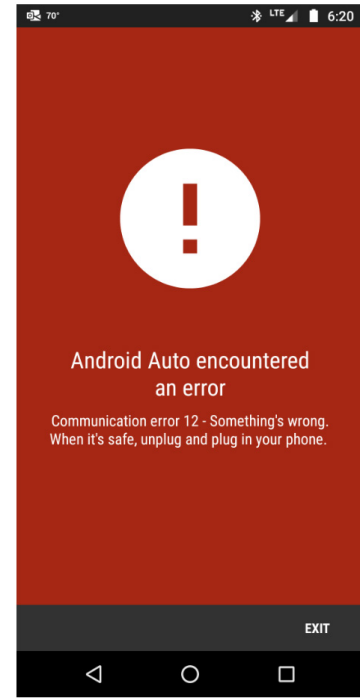
When this message is displayed on the phone after connection to the CP1 / Gen 4 Infotainment system, the Android Auto application fails to launch. Investigation has shown the source of this error is on the phone side and can be resolved by re-synching communication by disconnecting and reconnecting the phone. The communication error number (12 shown in the example) is irrelevant.

When reviewing a similar issue, explain to the customer that replacing the head unit will not resolve this condition as it is not the root cause of the error. It is a good practice to confirm an undamaged, genuine cable is used to connect the phone as well as making sure the phone is set to accept connection with a new vehicle.

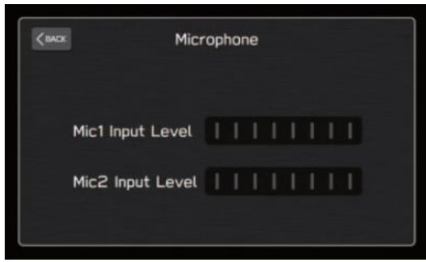
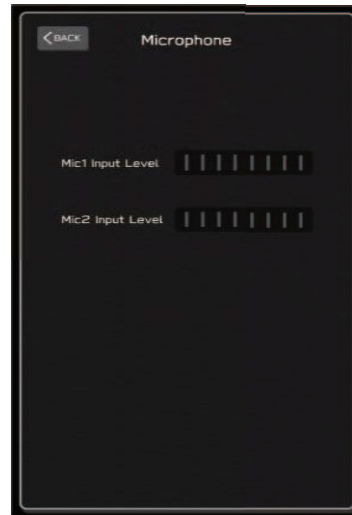
There is a known bug with the RC2003 software update released in June 2020. See Appendix B in TSB **15-261-20R** to confirm if the software of the unit being repaired is impacted by this bug. This bug affects only the display of the microphone test and in no way impacts actual microphone operation.

With the microphone display being impacted, it is recommended to use other diagnostic methods. Alternatively, troubleshoot the microphone operation using the Voice Recognition feature to confirm the unit receives voice input correctly or, make a voice call. If concerns remain, perform continuity and voltage drop testing to confirm if a poor contact or connection may exist. Reference the applicable Service Manual for related wiring diagrams for the Cockpit Control Module and microphone wiring diagrams, with or without Telematics depending upon the vehicle.

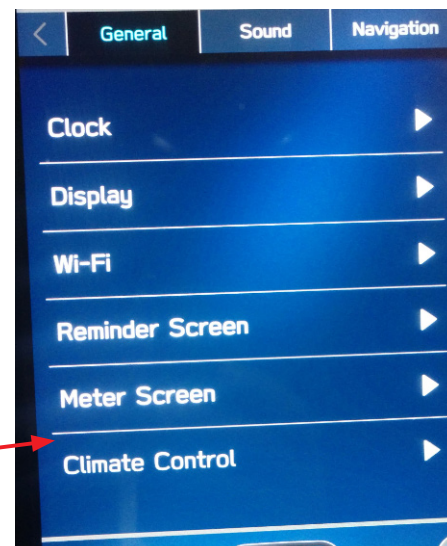
A report was received describing a missing “Camera” setting in Settings/General menu:

Camera setting PRESENT

Camera setting MISSING

After further investigation, it was determined to be a result of a needed process not being followed during replacement of the combination meter. The new combination meter was installed but not programmed properly by completing the required Variant Work. Always follow the applicable Service Manual instructions on STIS and confirm completion of all the necessary steps before condemning a possibly related system or hardware component. The Service Manual image below is an *example* of the VARIANT WORK procedure required for Combination Meter System replacement. Always follow the applicable procedure for the vehicle being repaired.

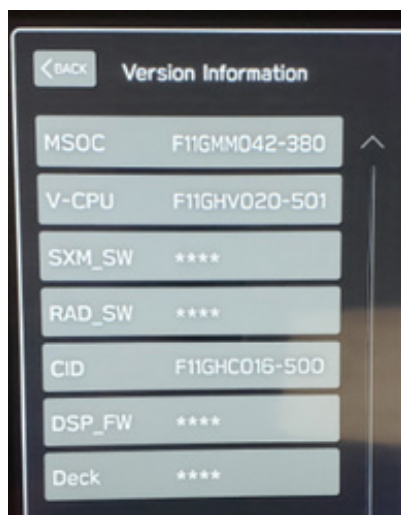
When you confirm CP1 system software version information, please assure the system has been running long enough to finish boot-up process. We don’t have a spec for how long to wait. Good practice might be to wait around 3 minutes. If you don’t wait long enough some versions would be missing or asterisk symbols (****) as shown below.

By the way it is correct to see Deck version as asterisk symbols (****), when CD Player is not installed. With that said please don’t confuse the case with no “RAD_SW” version and “DSP_FW” version displayed or showing asterisk symbols (****), even after waiting long enough for the system to complete boot-up. That would a sign for the failed software update. For more details see Subarunet message **“Recall WRH-20 / WRI-20 Denso Gen 4 CP1 software update. Critical points to avoiding unnecessary hardware replacement”** posted January 5, 2021.

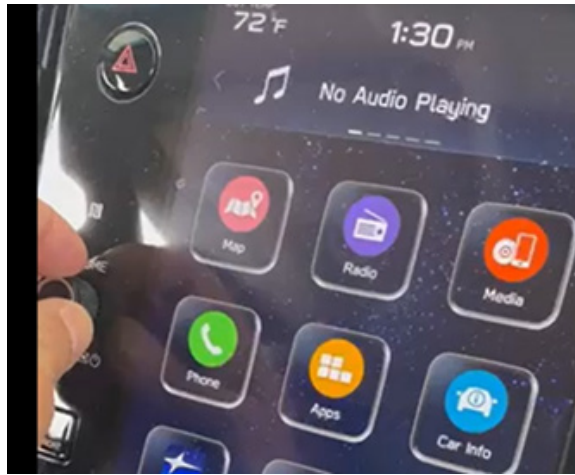
CAUSE: There have been many reports for audio playback and volume adjustment issue following CP1 reboot. Please keep in mind it might be a normal operation, if you see a message “No Audio

Playing” in the status bar area.

The message “No Audio Playing” in the status bar area indicates no audio source was selected for CP1 following reboot. Likely resulted from CP1 running projection application or streaming audio prior its shutdown. This is not a failure and the customer should not be alarmed.

RECOMMENDATIONS: please select the audio source (SXM, AM, FM, Media etc.) to enable playback (audio output)
