## Volvo Chassis - Model VN, Hood Release Cable Interference

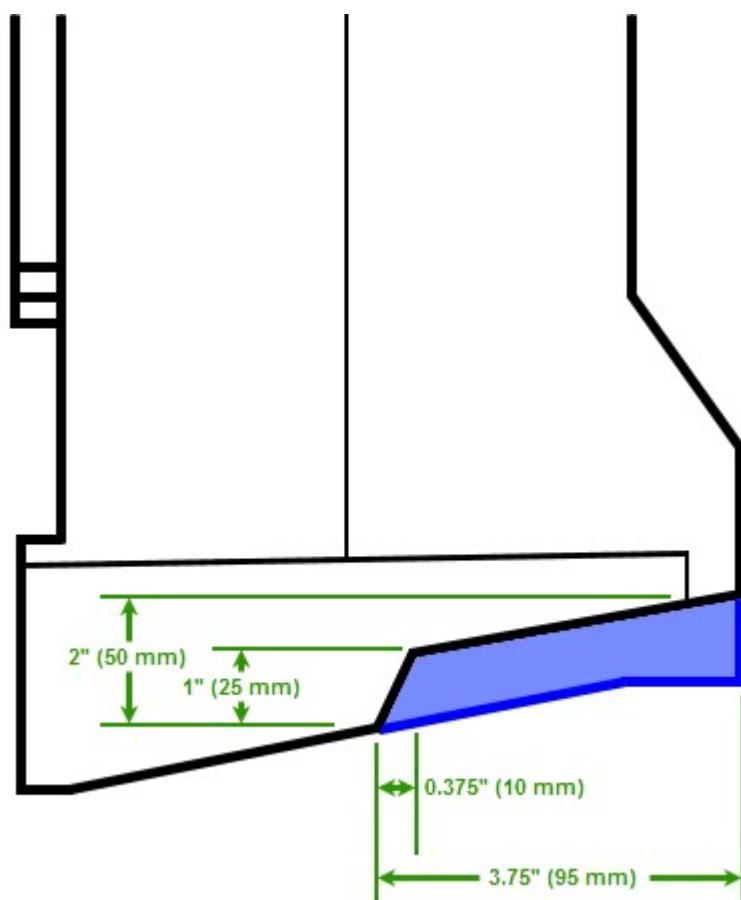
For vehicles affected by this issue, the corner of the air box will need to be modified:

Using an appropriate tool, cut the corner off of the air box. This will allow the cable to straighten out and prevent fatigue. A diagram with approximate dimensions can be found below. The blue section is the portion that will be trimmed off:

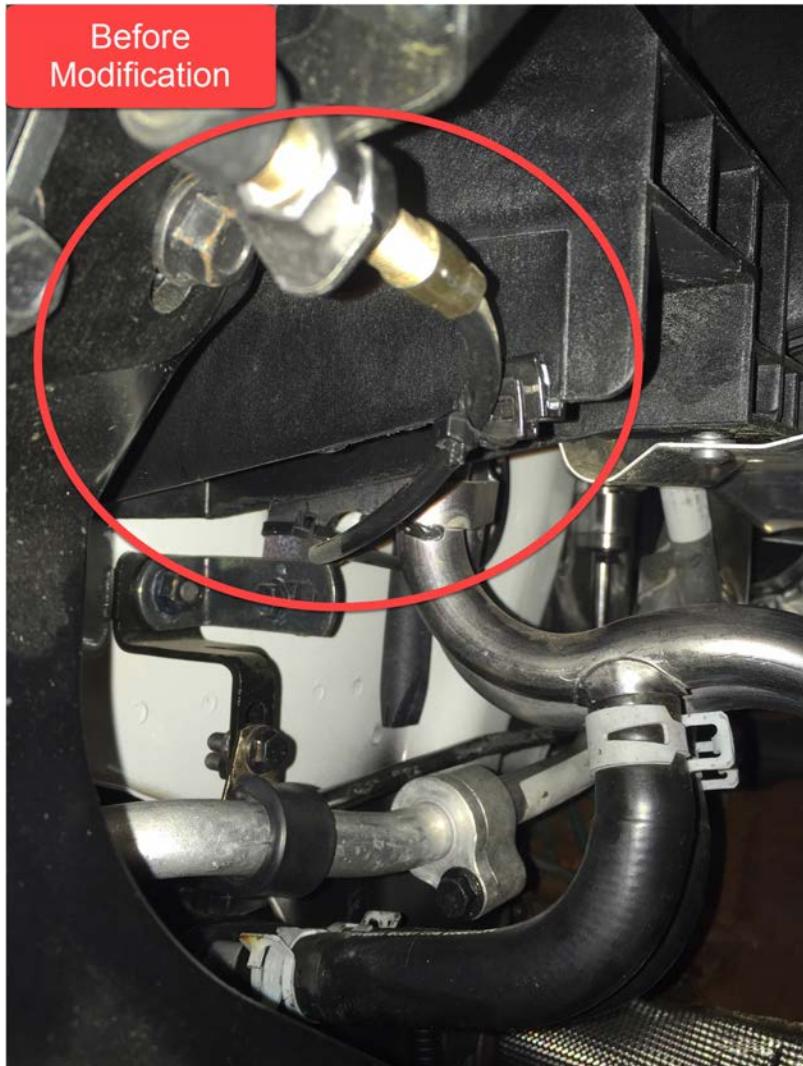
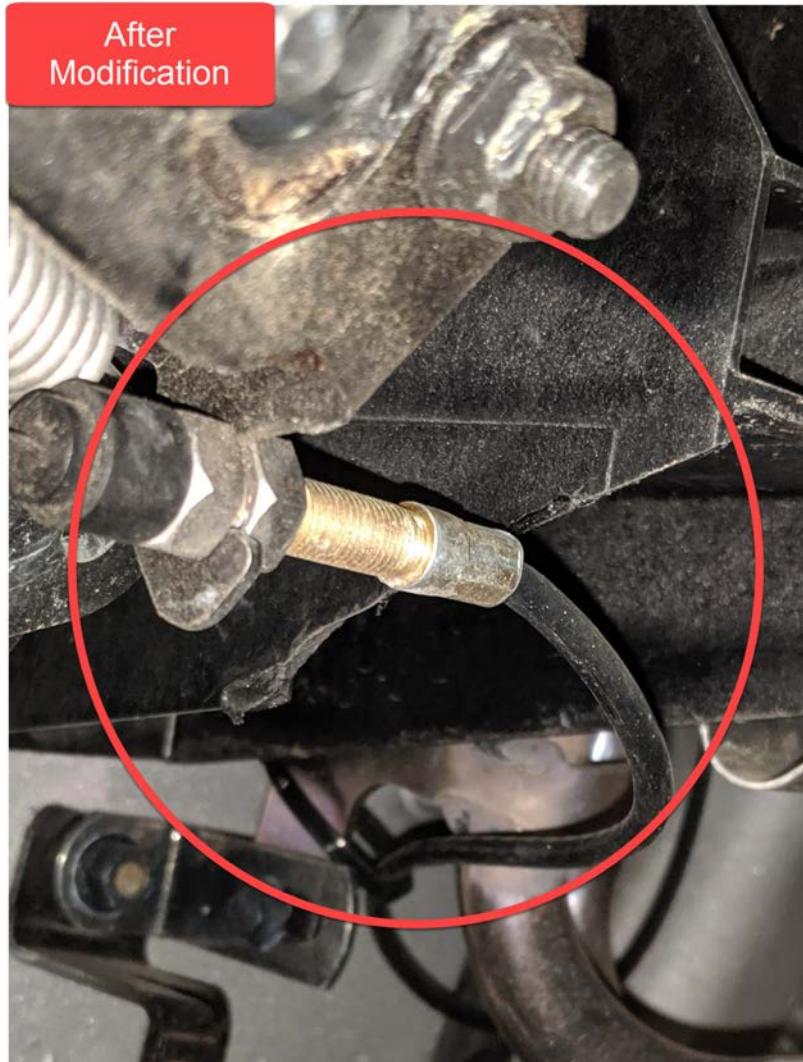
An example of an air box before and after being trimmed can be seen below:
