## Assembled Camshaft - Injector Lobe Rotation Inspection; P025700, P2A1700, Or P2A1F00, Possible Lack Of Power – US17+OBD16 and Newer Emissions

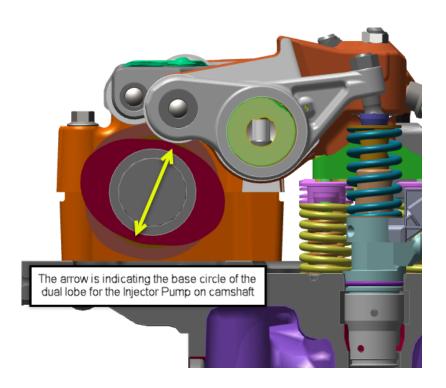
**2.** Once the timing marks are aligned for a specific Injector Pump, verify the injector rocker roller is on the base circle of the injector Live UI efer to the illustration below.

If an injector lobe rotates on the camshaft, the rotation is normally by 60 degrees. It takes approximately 15 degrees of rotation before potentially causing the faults codes listed previously or a fault for a pumping injector during the Common Rail Fuel System Test.
