Service Update

N212342980 Diesel Exhaust Fluid (DEF) Tank Harness Connector Terminal Overheat / Arcing

Release Date: February 2022

Revision: 01

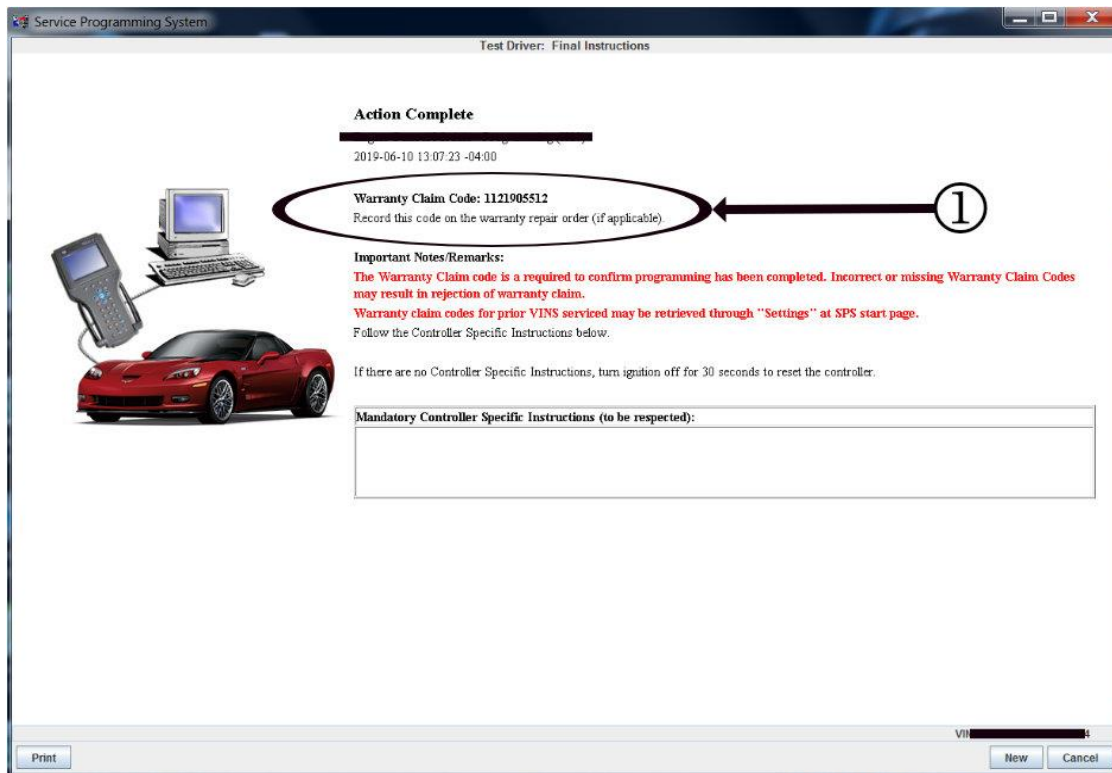
5431209

Important: To avoid warranty transaction rejections, you **MUST** record the warranty claim code provided on the Warranty Claim Code (WCC) screen shown above on the job card. Refer to callout 1 above for the location of the WCC on the screen.

- Record SPS Warranty Claim Code on job card for warranty transaction submission.
