Technical product information

Topic	Bentayga V8 Kovomo - Engine MIL light on - DTC "O2 Sensor Signals Swapped Bank 1 Sensor 2/ Bank 2 Sensor 2
Market area	China 796 VW Import Comp. Ltd (Vico), Beijing (6796),Korea, (South) E08 Bentley South Korea (6E08),United States E05 Bentley USA and rest America (6E05)
Brand	Bentley
Transaction No.	2065664/1
Level	EH
Status	Approval
Release date

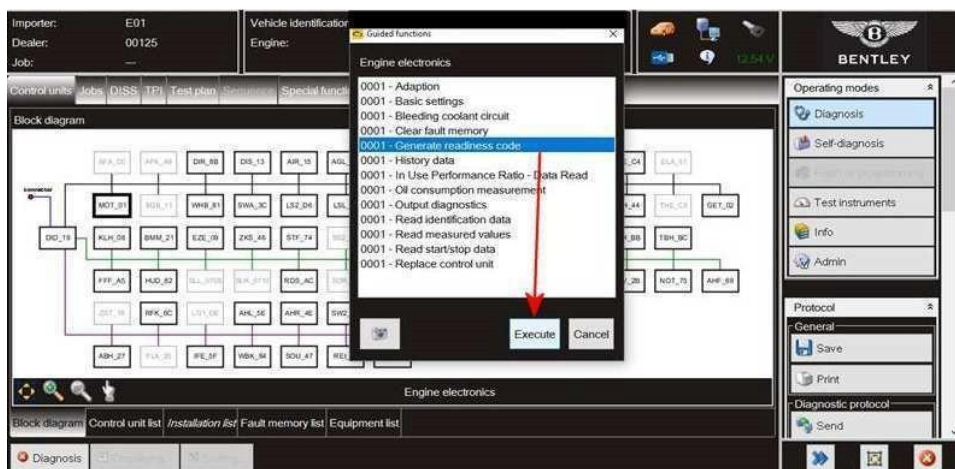
DTC P004100: "O2 Sensor Signals Swapped Bank 1 Sensor 2/ Bank 2 Sensor 2 is evident within address 0001 (Engine control unit) and MIL light active after attempting to conduct a readiness test

- Referring to Figure 1 - Select Guided functions from 01 - Engine Control Module 1
- Select Generate readiness code
- Select Execute and follow the readiness code procedure to completion as per all on screen prompts
