Technical product information

Topic	Rear Jacking point - Sill damage found during PDI
Market area	Bentley: worldwide (2WBE)
Brand	Bentley
Transaction No.	2065760/1
Level	EH
Status	Approval
Release date

Bentayga

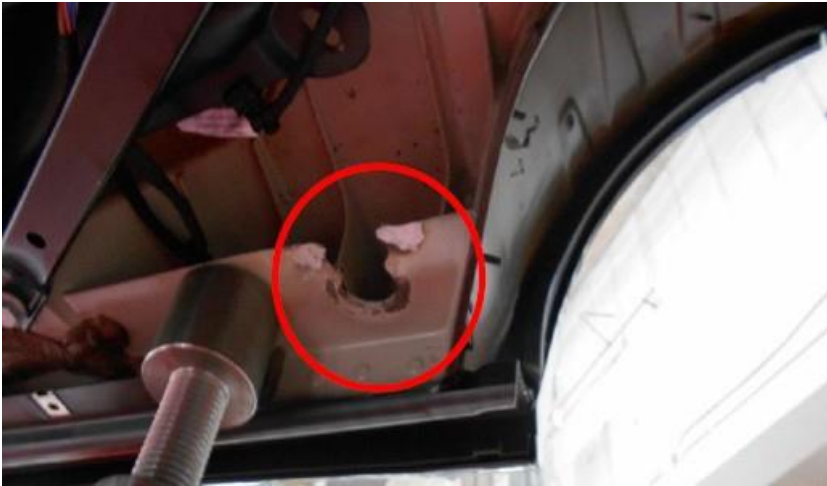
Figure 1

Damage found around the rear sill Jacking point during PDI (Figure 1)

In the event the issue is as described, please raise a technical DISS query ensuring clear photographs are attached

The operative MUST await feedback from *Product Support* before conducting any further work
