RCA-72-22-001-1: Passenger Airbag Harness Pinch Condition

Document Type	Customer Satisfaction Campaign Bulletin
Date	January 13, 2022
Affected Region(s)	USA
Affected Model(s)	R1T
Model Year(s)	2022
Approximate Build Dates Refer to the FSA Dashboard to determine if this document applies to a specific vehicle.	August 2021 - September 2021
Vehicle System	72 - Occupant Protection
Minimum Service Location	Mobile

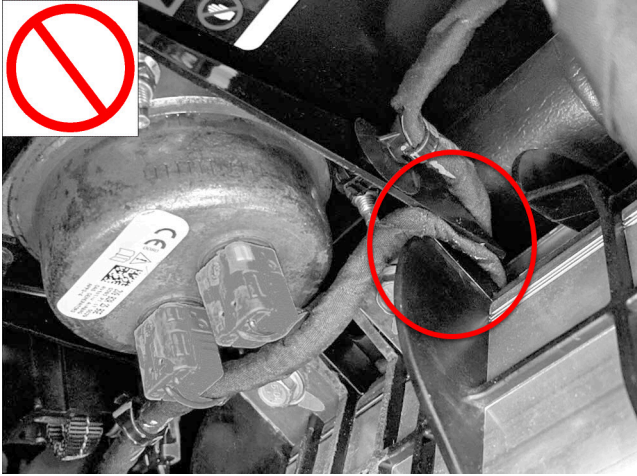
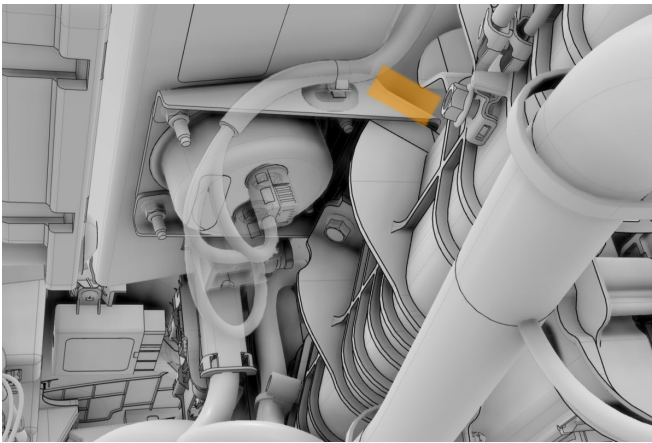
Rivian is initiating a customer satisfaction campaign for some model year 2022 R1T vehicles that may have been built with a pinch condition of the passenger airbag wire harness in the instrument panel. If the wires are damaged the airbag light will illuminate, indicating a fault in the system. Rivian is launching this campaign for customer satisfaction and for the continuous improvement of Rivian vehicles.

2. Make sure that no harnesses are routed forward of the airbag bracket. If necessary, route any harnesses out of the highlighted area.
