Technical Service Bulletin

SUBJECT:			No:	TSB-22-52A-001REV
NOISE FROM FRONT SEAT BACK - REVISED			DATE:	January 2022
			MODEL: See Below	
CIRCULATE TO:	[] GENERAL MANAGER	[X] PARTS MANAGER		[X] TECHNICIAN
[X] SERVICE ADVISOR	[X] SERVICE MANAGER	[] WARRANTY PROCESSO	R	[] SALES MANAGER

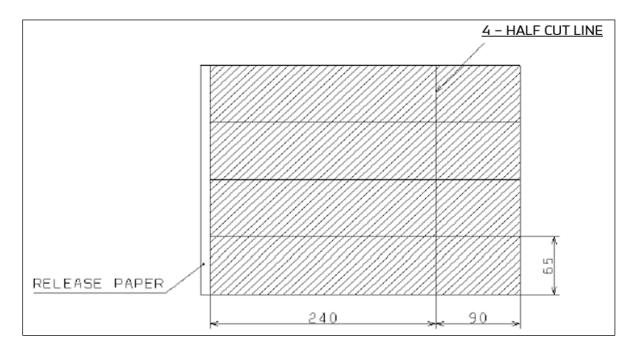
A customer may report a condition where an abnormal rubbing noise is heard from the Seat Back when a driver and/or passenger is seated in the front seat(s). This may occur due to Nonwoven Fabric Tape being improperly attached during the production process, causing direct contact between the Seat Frame and Urethane Pad. As a result, an abnormal rubbing noise may be heard.

No	Attach Nonwoven Fabric Tape to the Urethane Pad Side				
1	Prepare Nonwoven Fabric Tape According to the illustration:	Nonwoven fabric tape: 6979A696 Tape ©:65mm×240mm Tape ©:65mm×90mm			
2	Remove Seat Back Pad from the Seat As Manual.	sembly by referring to the Service			
3	Attach tape following the illustration and information below: <right-left direction=""> Align the center of the pad groove with Tape[®] center of short side (65mm) (Reference dimensions) The tape side is about 60mm from the center of the back material hole along the pad surface <up-down direction=""> Align 10 mm from bottom back surface of the pad groove with tape [®] bottom edge of long side (240 mm).</up-down></right-left>	Inner side Outer side This photo shows the back RH side of seat. **For vehicles with side airbag specification; DO NOT attach the tape to the outer side. **Attach the tape to LH side. LH and RH tape should be symmetrical. Right-left direction Tape ① Of the pad groove Up-down direction The center of the pad groove

Outer side
 Indicates RH side Seen from the back of pad
reassemble the Seat Back Pad.
