# Technical Service Bulletin

## 91 Parking assistance provides false warnings

91 22 75 2024323/9 February 7, 2022. Supersedes Technical Service Bulletin Group 91 number 21-04 dated May 18, 2021 for reasons listed below.

Model(s)	Year	VIN Range	Vehicle-Specific Equipment
All Audi	2005-2017	All	Parking Aid

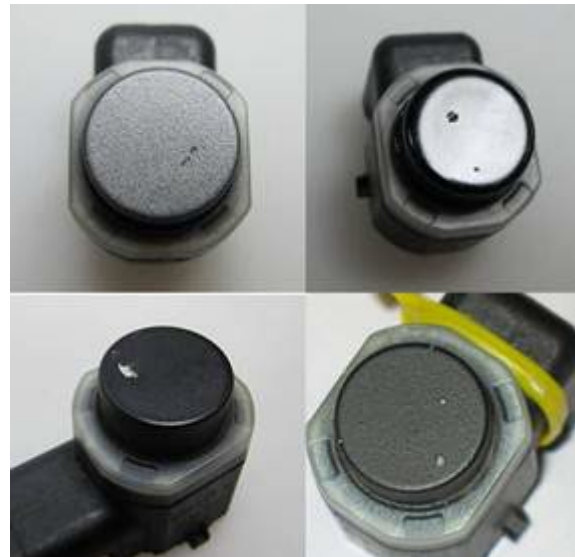
- Mechanical damage (stone chips, scratches).
- Dirt, ice, foreign bodies, and/or foil adhered to the sensor.
- Damage to the bumpers that may indicate an accident (or paint indicating a previous incident).

*Figure 3. Stone chips causing sensor failure.*

**Tip:** Exterior damage to the vehicle, including stone chips and scratches, is not covered by Audi Warranty. When painting sensors, the special painting instructions for parking sensors in the paint repair manual must be observed.

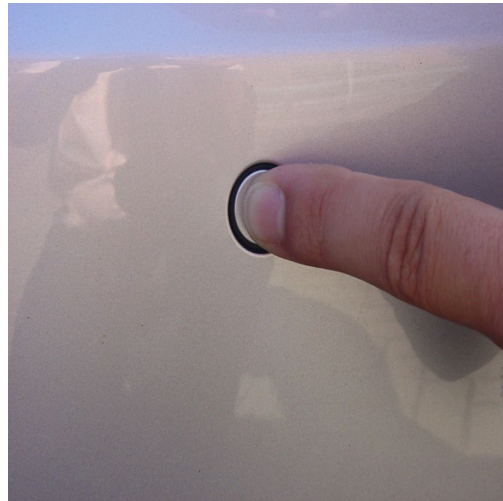
*Figure 4. A pressure check on a parking aid sensor.*

4. Pressure check for a tight fit and correct attachment of the parking sensors (Figure 4). If the sensor is not snug or feels loose, remove the bumper and reinstall the sensor.

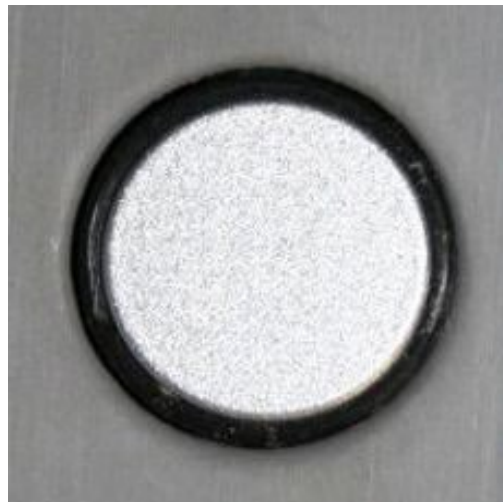
*Figure 5. A correctly seated decoupling ring.*

5. Check that the decoupling ring is correctly seated (Figures 5 - 7). If the ring is folded or bulging, remove the bumper and reinstall the sensor.

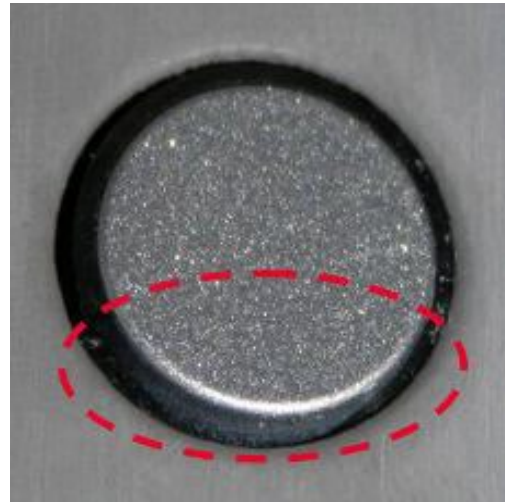
**Figure 6.** An incorrectly seated decoupling ring (bulging).

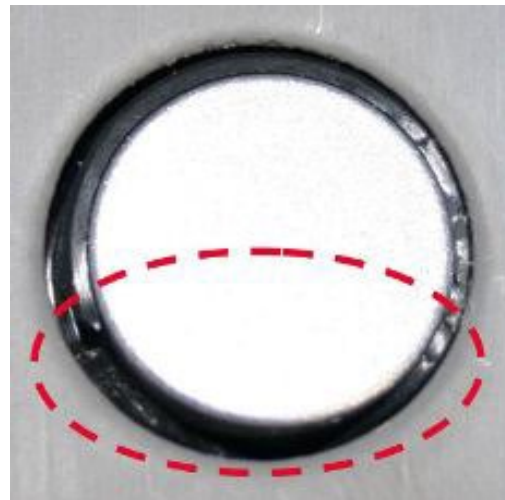
**Figure 7.** An incorrectly seated decoupling ring (folded).

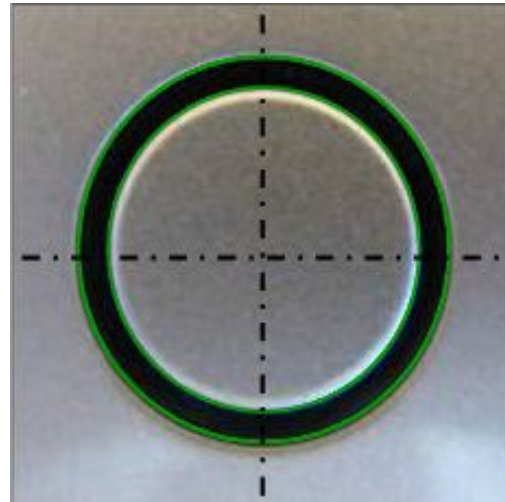
*Figure 8. A correctly centered parking aid sensor.*

6. Verify that the sensor is centered inside of the mounting hole (Figures 8 - 9). If the sensor is mounted off-center, remove the bumper and reinstall the sensor.

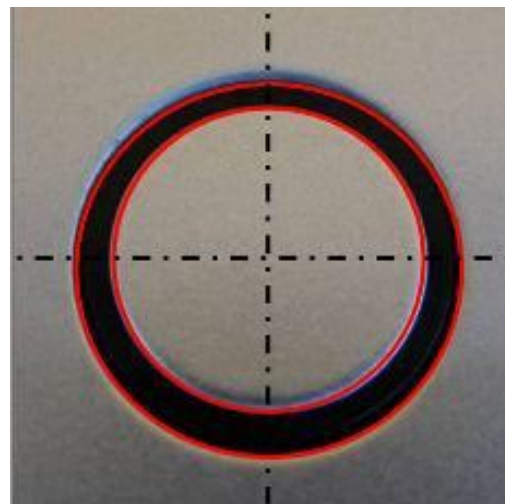
*Figure 9. An off-center parking aid sensor.*

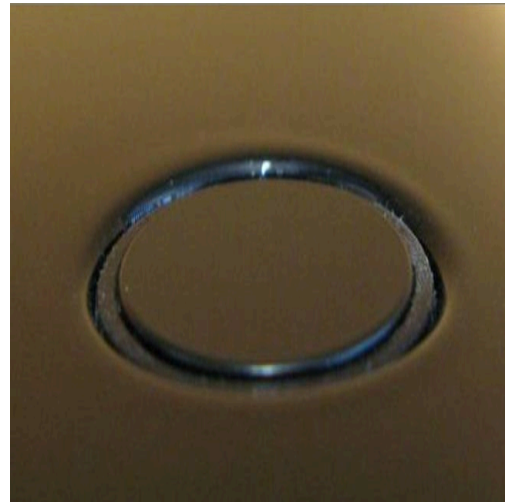
*Figure 10. A correctly installed parking aid sensor.*

7. Ensure the sensor sits flush with the bumper (Figures 10 - 11). If the sensor is recessed or bulging, remove the bumper and reinstall the sensor.

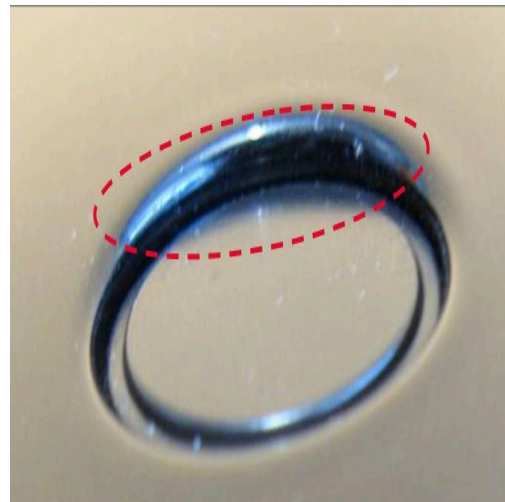
*Figure 11. A recessed parking aid sensor.*

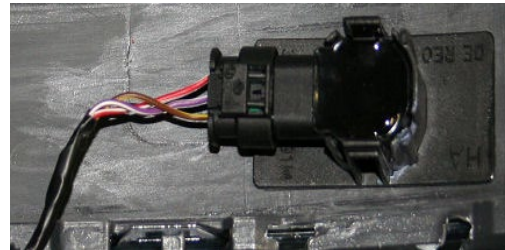
*Figure 12. A correctly installed cable with sufficient length.*

9. Check the cables in the bumper for damage and sufficient length (Figures 12 - 13). Cables that are too short can cause damage to the harness.

- If the cable is damaged, repair the cable using VAS Repair Kit 1978.
- If the cable is too tight, correct the routing by moving the support clip so the cable is no longer under tension.

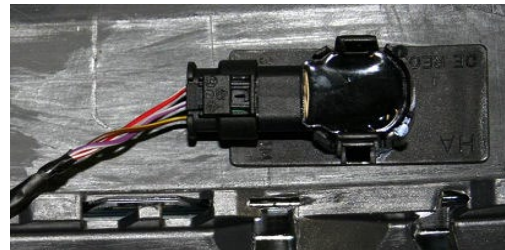
*Figure 13. A sensor cable with insufficient length.*

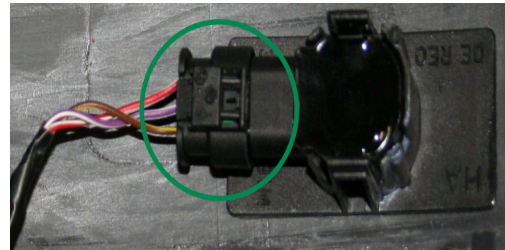
*Figure 14. A correctly installed parking aid sensor connector.*

10. Check the connectors on the parking sensors and the socket box for correct installation (Figures 14 - 15). If the connectors are not installed properly, reinstall.

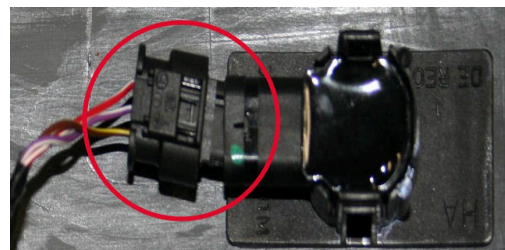
**Figure 15.** A parking aid sensor connector that is not seated correctly.
