TECHNICAL SERVICE BULLETIN

Uneven Steering Effort

22-2022
01 February 2022

Ford 2015-2019 Transit

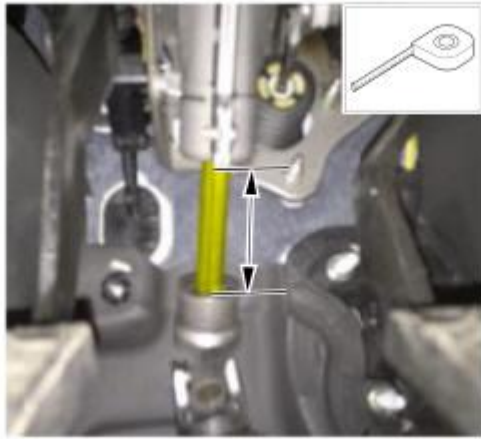
Figure 2

3. Measure the steering column slider length. (Figure 2)

4. Is the steering column slider length 73 mm +/- 1 mm?
