Service Bulletin

Bulletin No.: 21-NA-286

Subject: Rear Hands-free Liftgate Feature Intermittently Inoperable or Difficult to Operate

Brand:	Model:	Model Year:		Breakpoint:		Engine:	Transmission:
		from	to	from	to		
Buick	Envision	2021	2022	SOP	November 20, 2021

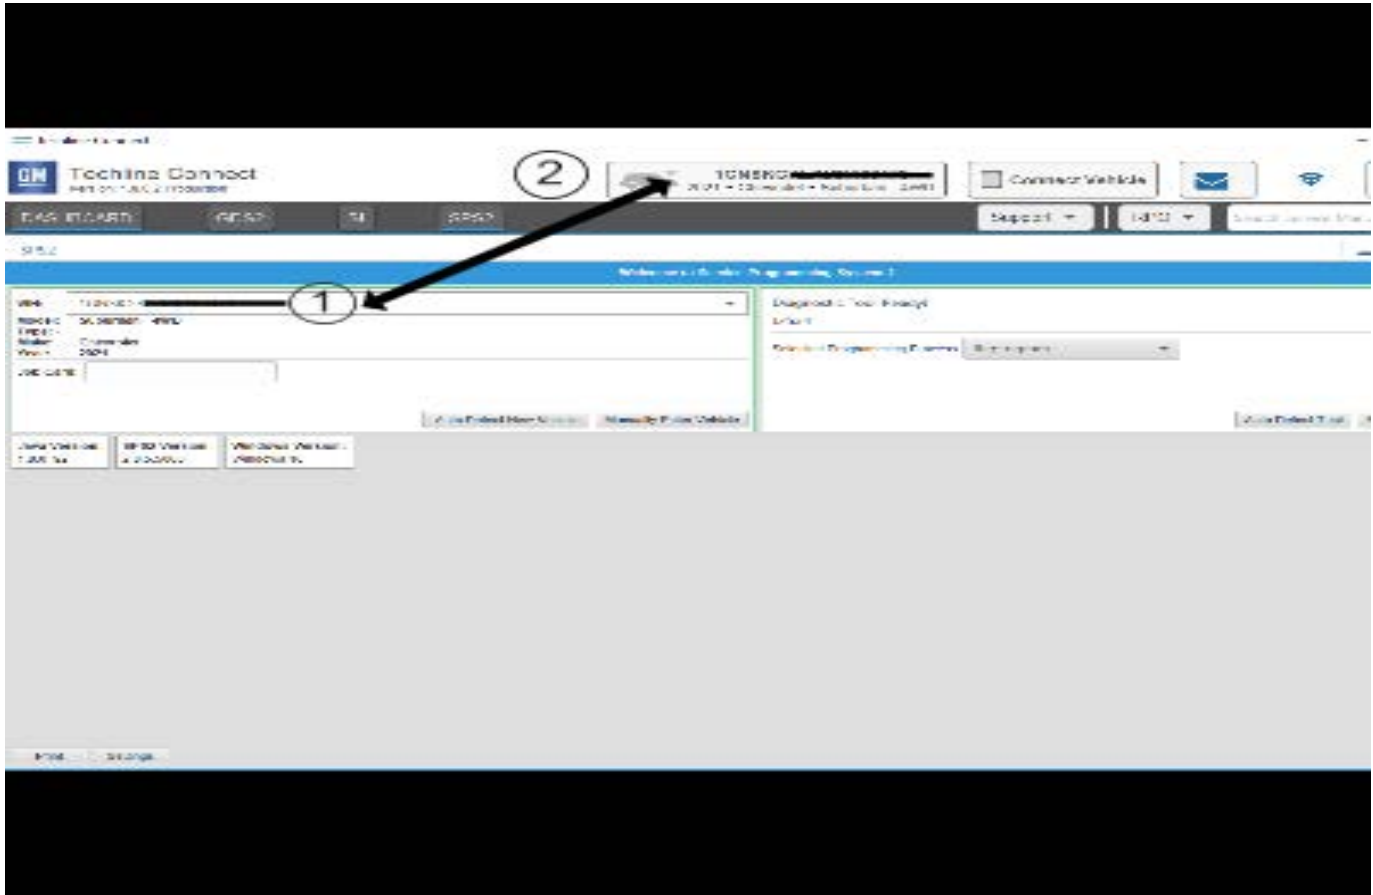
5743643

Caution: Be sure the VIN selected in the drop down menu (1) is the same as the vehicle connected (2) before beginning programming.

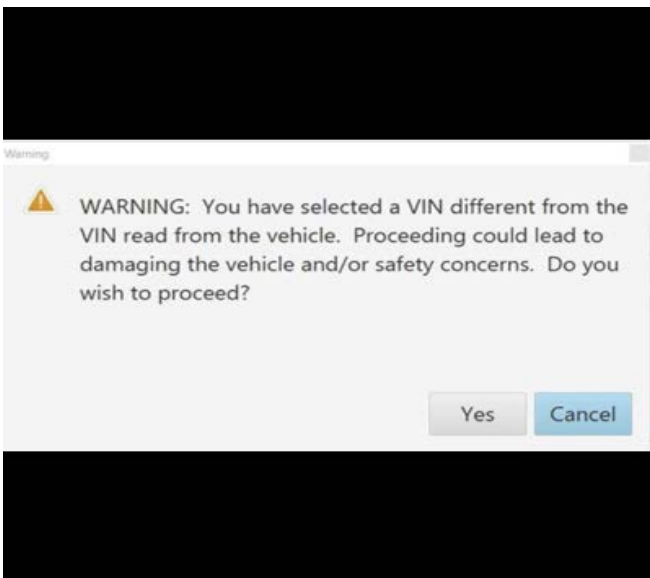
5877000

Important: If the vehicle VIN DOES NOT match, the message below will be shown

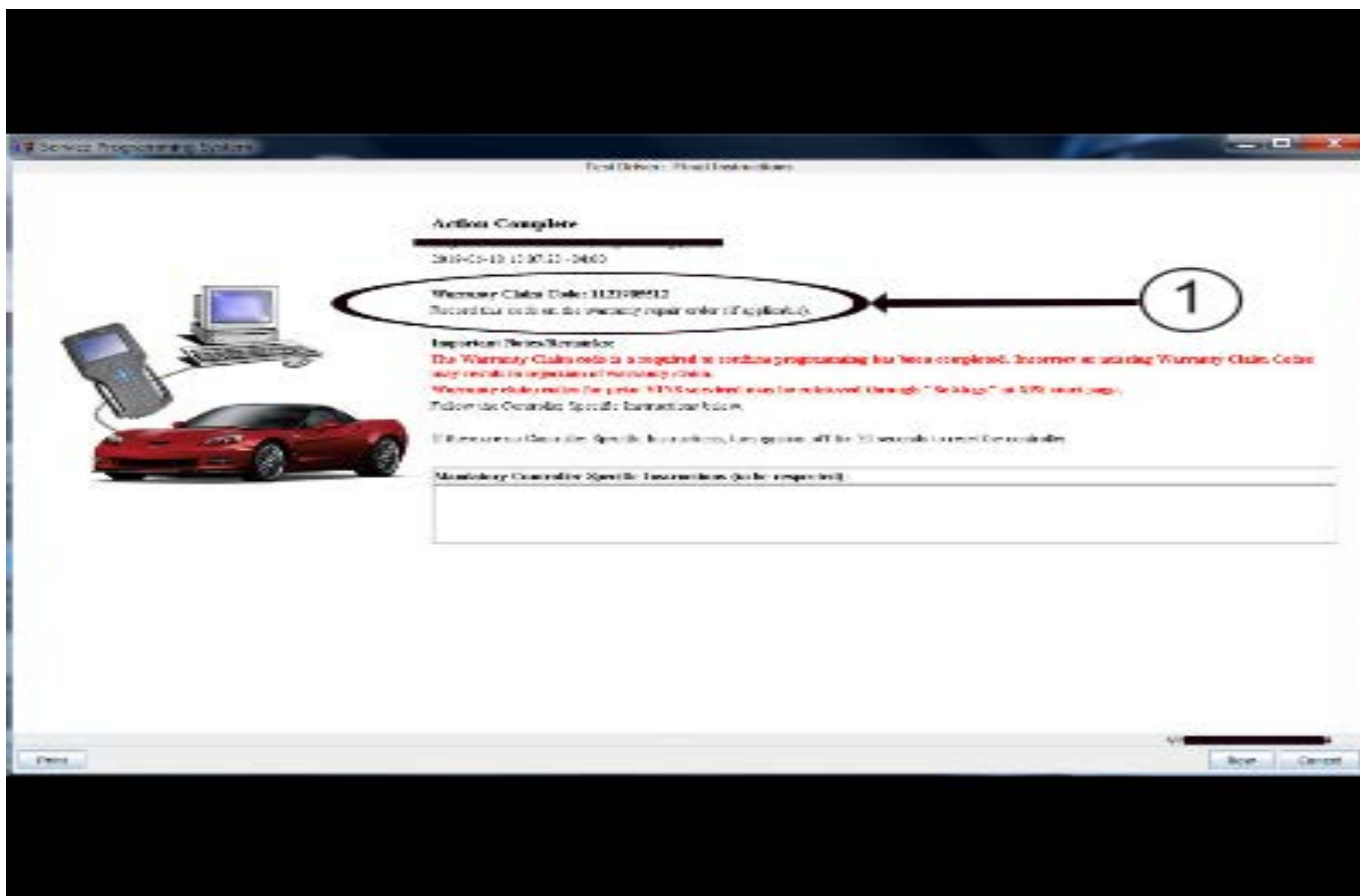
5431209

Important: To avoid warranty transaction rejections, you **MUST** record the warranty claim code provided on the SPS Warranty Claim Code (WCC) screen shown above on the job card. Refer to callout 1 above for the location of the WCC on the SPS screen

2. Record SPS Warranty Claim Code on job card for warranty transaction submission.
