PIT5887 Diagnostic Aid: Intermittent Vehicle Powers Up But Will Not Crank

Brand:	Model:	Model Years:	VIN:		Engine:	Transmissions:
			from	to		
Chevrolet	Equinox	2021 - 2022	All	All	LYX	All
GMC	Terrain	2021 - 2022	All	All	LYX	All

Involved Region or Country:	North America
Condition:	Intermittent No Crank. Vehicle Powers Up Normally.
Cause:	Oxidized B+ Nut or Stud On The Starter Solenoid.

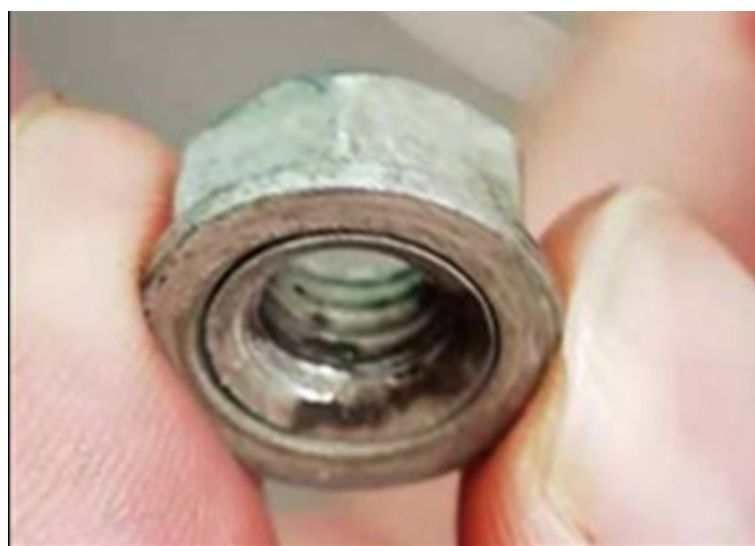
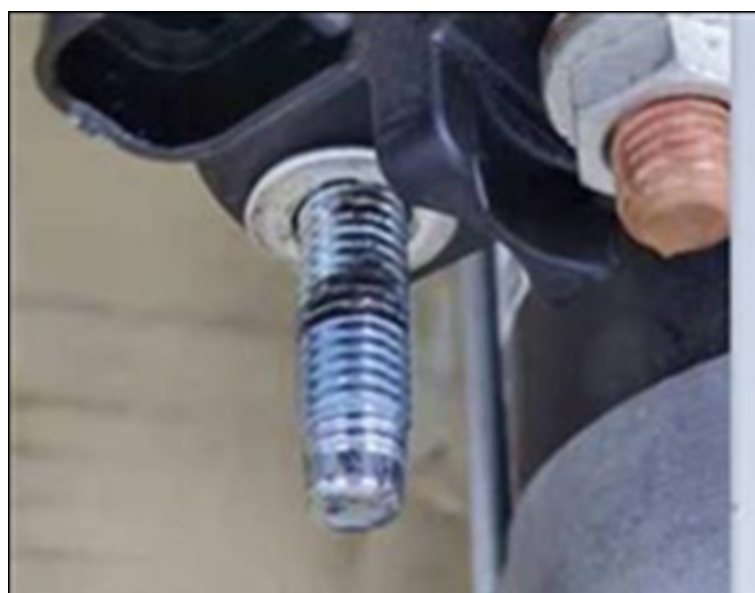
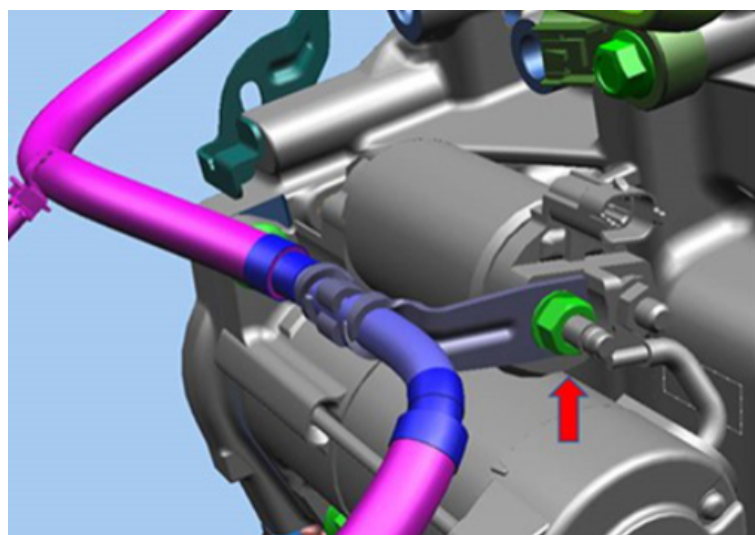
If a vehicle presents with an intermittent power up but no crank concern verify the BCM Power Mode Data shows Crank, The ECM Electrical Data shows active Crank Request and Crank Relay Command. If data is correct, check for power at the B+ terminal at the starter. If present, inspect the B+ stud on the starter for oxidation as shown below.

If it's oxidized as shown in the photos, you should replace the nut and clean the stud terminals and re-check starter function. If this corrects the concern, release the truck. If not, continue with starter diagnosis / replacement.
