TSB #	TSB 22-02		
Description/Title:	Gemini / Compass E-Start		
Affected Product Line(s):	Certain model year 2022 Gemini and Compass motorhomes		
Service Campaign # :	RC000253	Released Date:	2/7/2022
Codes:	Inspect Only: TMCTS80272Y	Document Date:	2/7/2022
	Repair: TMCTS80272W		
Time Allowed:	Inspect Only: 0.1	Document Revision:	Α
	Inspect with Repair: 0.3

Gemini/Compass emergency start harness issue. One solenoid wire is spliced into the wrong circuit.

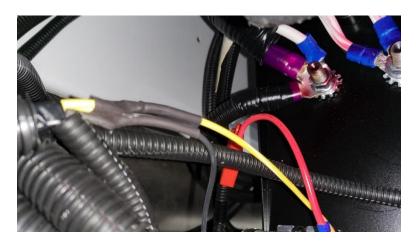
1. Find the yellow/white wire connected to S2 on the solenoid.

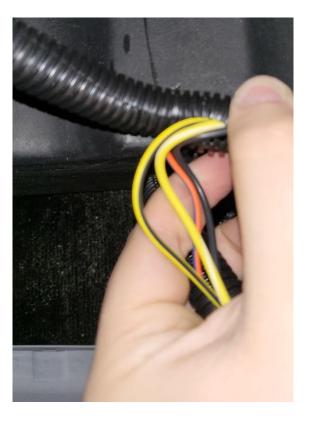
2. Find the yellow/black wire coming out of the 4-way connector.
