# Technical Service Bulletin

**20 MIL on or difficulty refueling, DTC P045100, P044100, P202500, and/or P045300 are stored in the ECM 20 22 41 2050276/7 February 8, 2022. Supersedes Technical Service Bulletin Group 20 number 20-26 dated April 23, 2020 for reasons listed below.**

Model(s)	Year	VIN Range	Vehicle-Specific Equipment
A6, and A7	2016 – 2018	All	3.0 liter engine

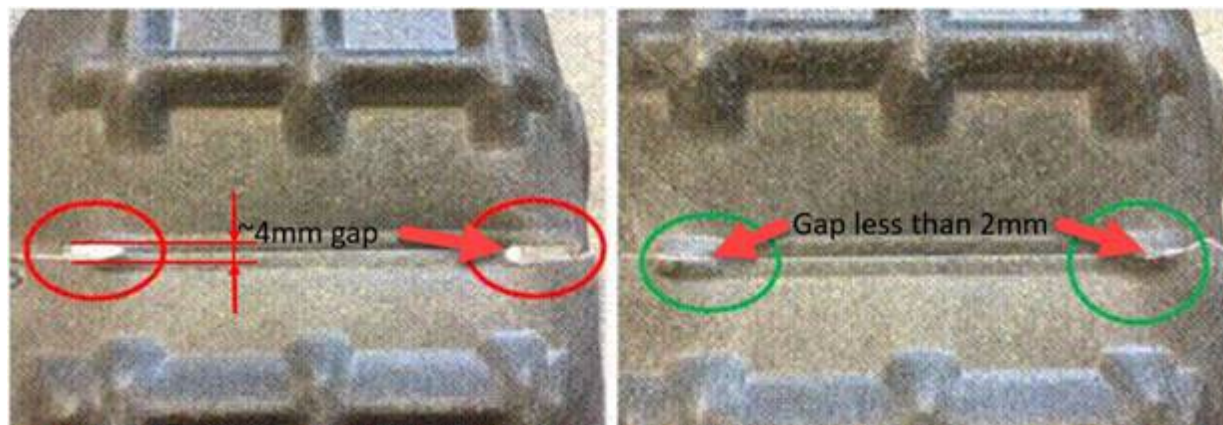
*Figure 1. How to determine which steps to take Version 1 (~4mm gap) or Version 2 (gap less than 2mm).*

### Version 1 (A6 only):

1. If the updated wheel liner has not yet been installed. Then install the updated wheel liner, which has closed slots around the NVLD filter.
  - Remove the EVAP canister, ventilation tube, and NVLD pressure switch.
  - Remove all components mounted on the EVAP canister.

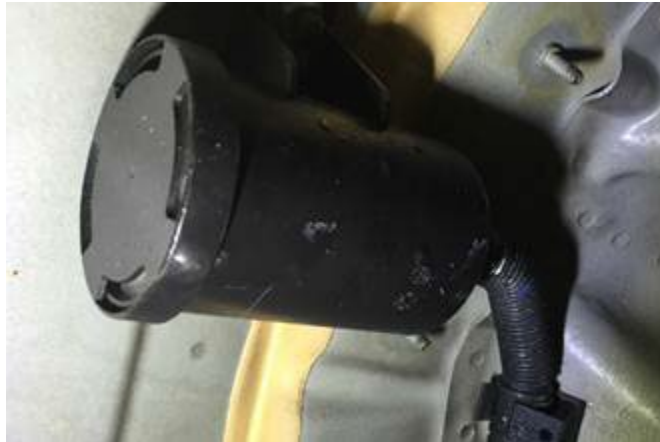
*Figure 2. Ventilation tube of the EVAP canister.*

- If it weighs more than 2650 grams, replace the EVAP canister + attached filter, ventilation tube (Figure 2), and NVLD pressure switch (J909).
- If it weighs less than 2650 grams, then replace the ventilation tube and the J909.

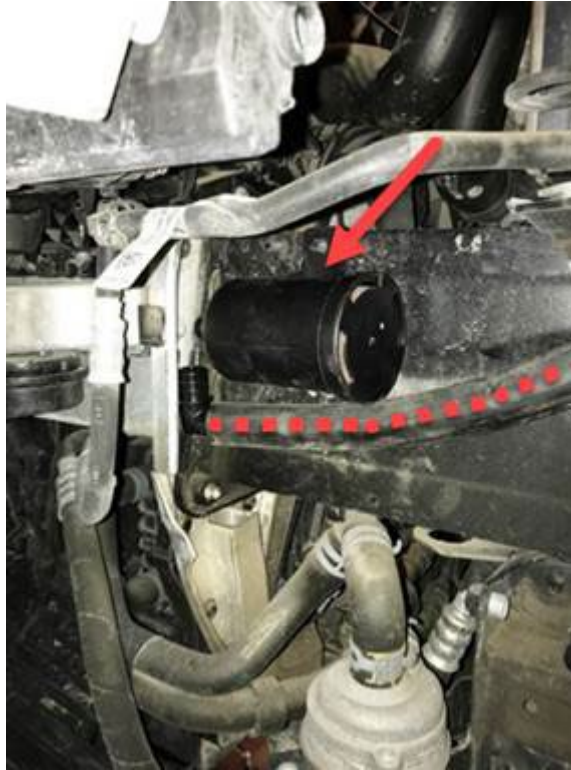
*Figure 3. Installing the new NLVD filter.*

1. Replace the EVAP canister only if the weight is greater than 2650 grams.
  - Install a new J909.
  - Install the NLVD filter (new part number, Version 2) in the engine compartment on the left frame rail just in front of the ABS module, secure with M6 nut. (Figure 3).

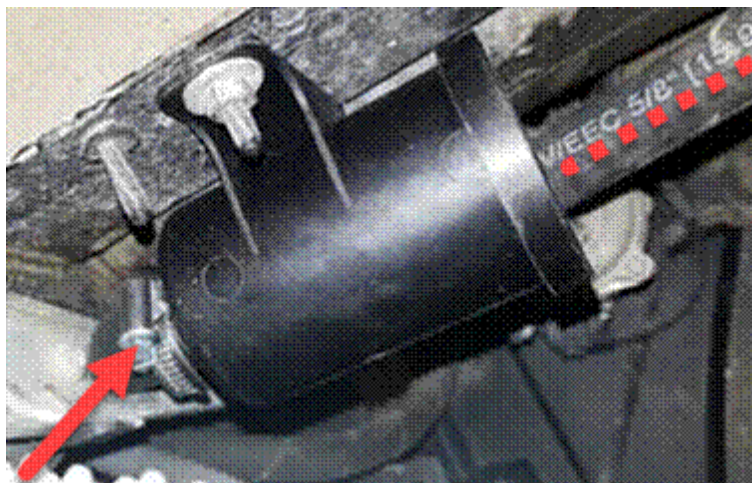
*Figure 4. Connecting the NLVD filter.*

2. Connect the filter to the 5/8" ID rubber hose via 1x plastic elbow and 1x rubber elbow (Figure 4).

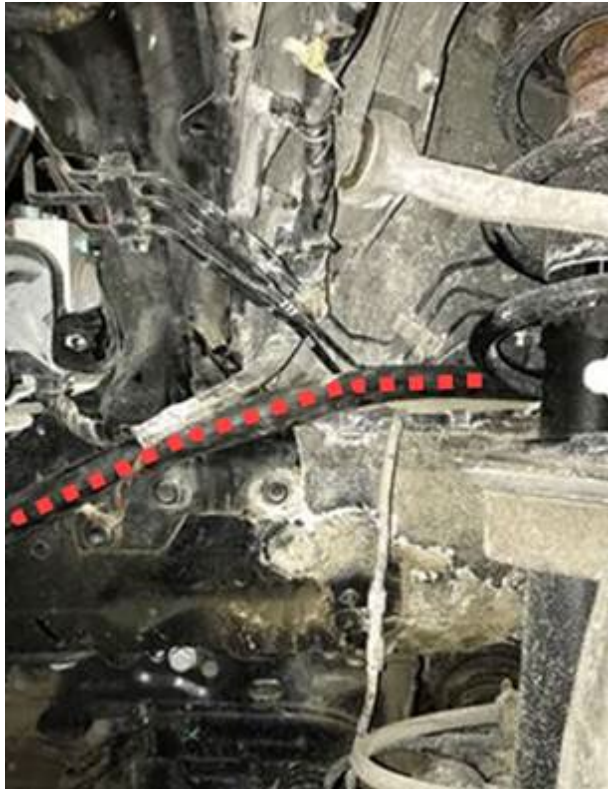
*Figure 5. Route the 5/8" ID rubber hose from the new filter position to the J909.*

3. Route the 5/8" ID rubber hose behind the strut and brake lines from the new filter position to the J909, along the orange battery cable (Figures 5 and 6). Then secure with zip ties.

5/8" ID rubber hose needs to be routed in a way that there are no sharp bends to prevent kinking.

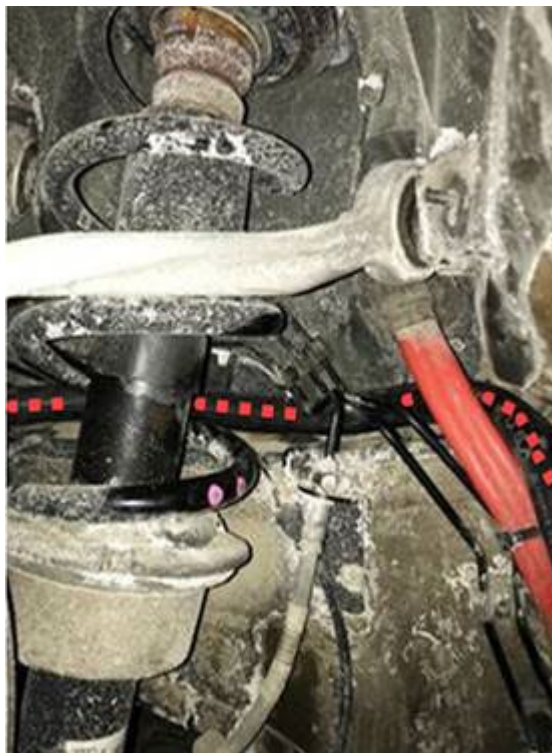
*Figure 6. Routing the rubber hose.*

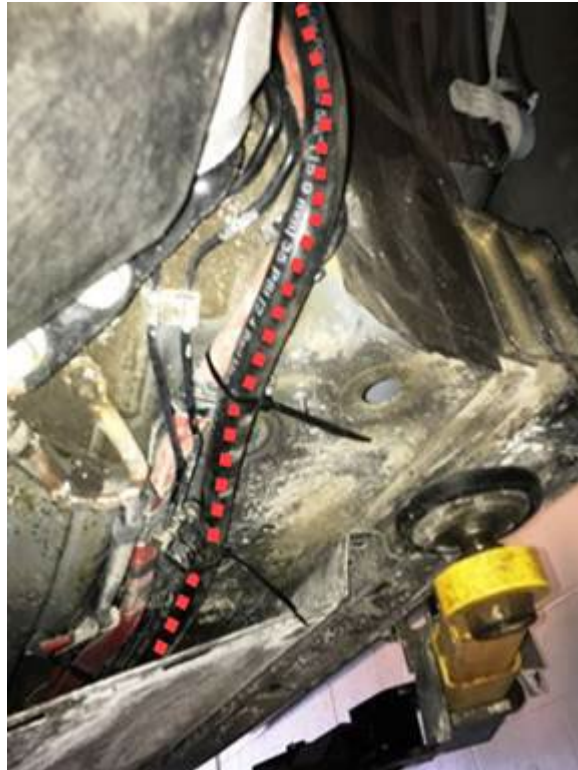
*Figure 7. Where to zip tie the rubber hose to the battery cable.*

4. Routing details to the J909, along the orange battery cable. Add zip-ties every 12 inches (Figure 7).

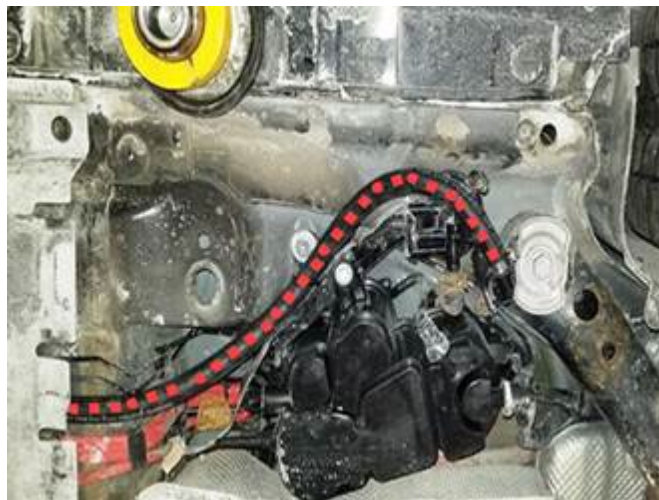
*Figure 8. Connecting to the J909.*

5. Before connecting 5/8" ID rubber hose to 90 degree connector, cut to length, as needed. Connection details to the J909 are shown in (Figures 8 and 9).

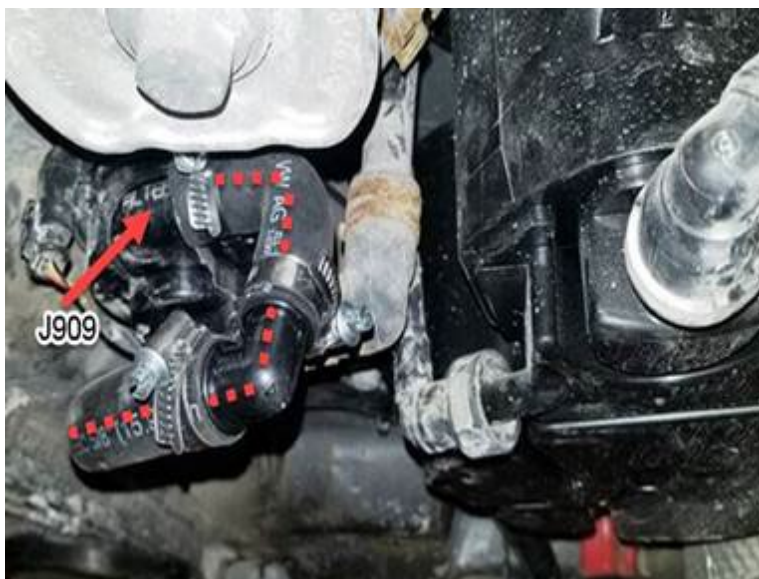
*Figure 9. Closer look at the connections.*
