Campaign No. 2022010007, January, 2021

SUBJECT: **Model 907 Sprinter, Model Year 2021**
Tighten Spring Loaded Rear Step

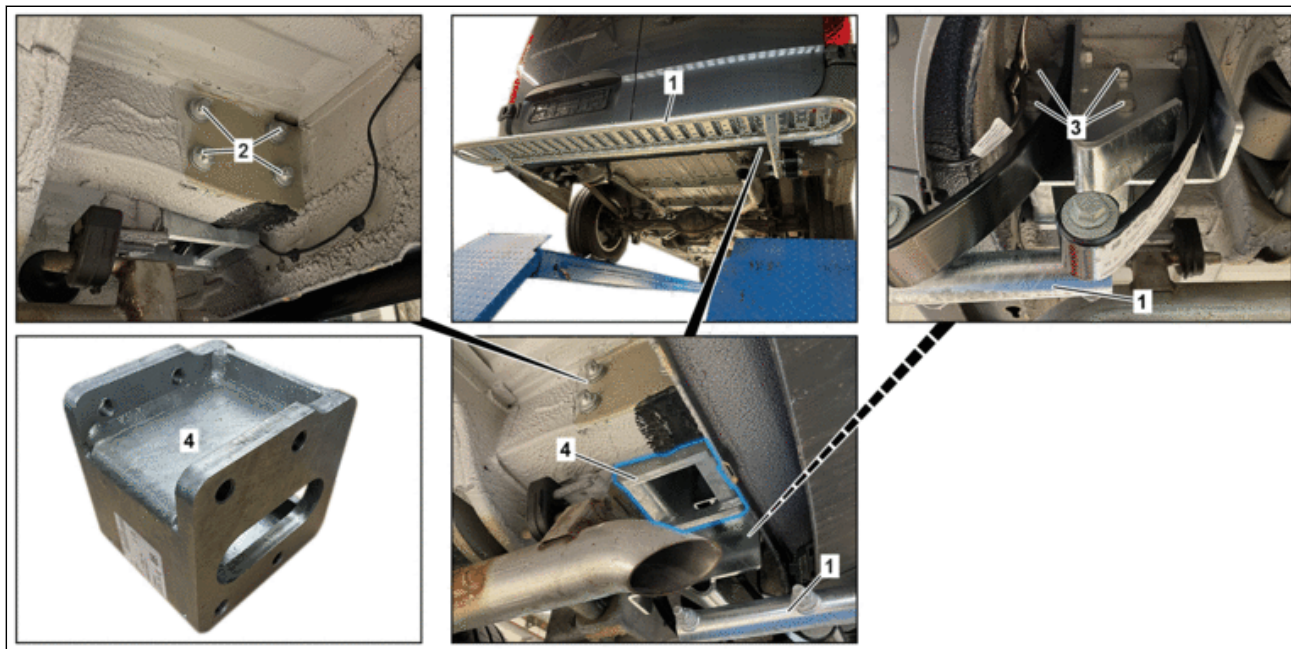
D88.30-A047-79

1 Spring-mounted step
 2 Bolts

3 Bolts
 4 Fastening bracket

| 4 | Replace mounting support (4) of spring-mounted step (1). | To do so, remove screw/bolts (2, 3). Replace screws (2, 3) too. Screw/nut, sprung running board to longitudinal member | BA88.30-Z-1001-03KTS |

| Number | Designation | Model 907, 910 |
|---|--|---|
| BA88.30-Z-1001-03KTS | Screw/nut, sprung running board to longitudinal member | 94Nm |
