TECHNICAL SERVICE BULLETIN

Soft Top Roof - Loose Exterior Fabric On Rear Window

22-2055
21 February 2022

Ford 2021-2022 Bronco	Soft top roof
--------------------------	---------------

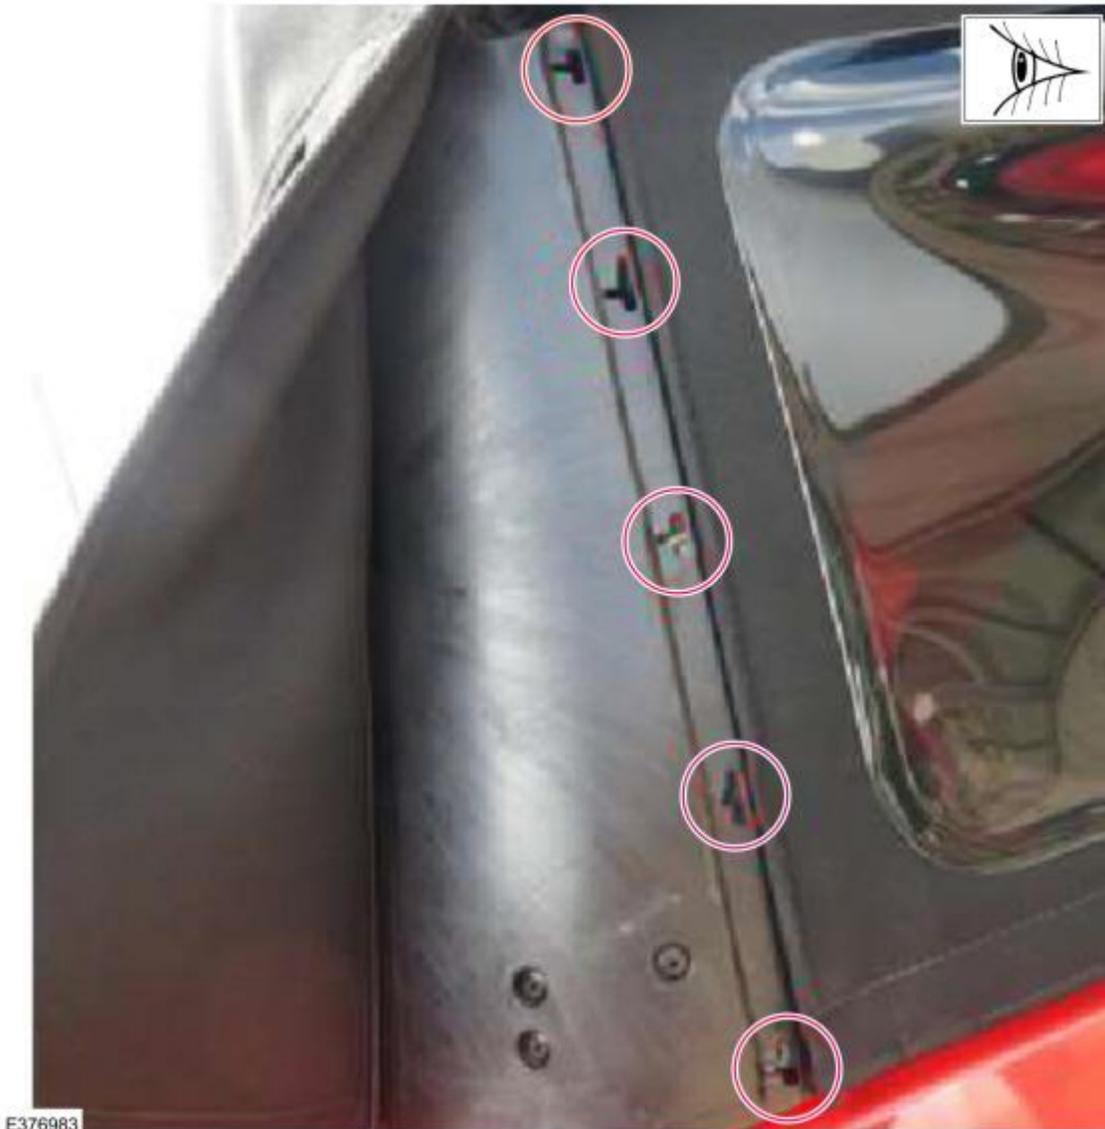
Figure 1 - Right D-pillar shown, left side similar

1. Visually inspect the 5 clips that run vertically along each D-pillar on the rear window (Figure 1)

2. Are any of these clips broken causing the rear window fabric to become loose?

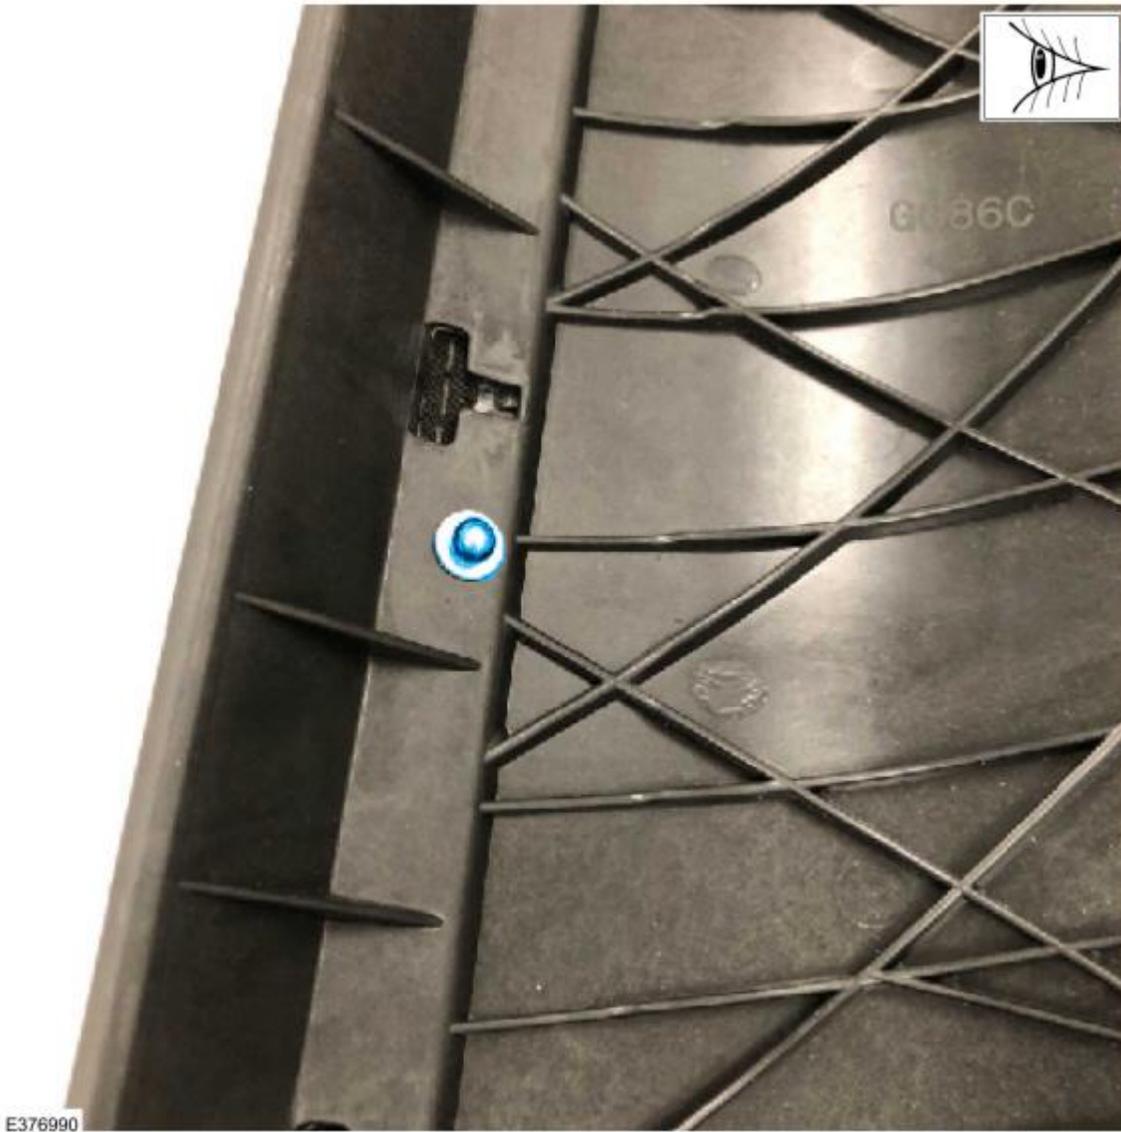
Figure 8

NOTE: The 5 mm gap between the D-pillar and the rear window plastic strip is critical. If this gap is too large or small, the rear window to rear quarter window fitment and appearance will be jeopardized.

12. Install all 5 rivets, one at a time, using one 5 mm flat washer as support around the back of each rivet. During this process, maintain the 5 mm gap as mentioned in Step 10. (Figure 8)
