# Technical product information

<b>Topic</b>	Oil leak from the oil separator/breather connection - Intake manifold whistle - Emission control warning within the DIP
<b>Market area</b>	Russische Föderation (5RU),Australia E04 Bentley rest Asia and Australia (6E04),China 796 VW Import Comp. Ltd (Vico), Beijing (6796),Germany E02 Bentley rest Europe (6E02),Japan E03 Bentley Japan (6E03),Korea, (South) E08 Bentley South Korea (6E08),United Arab Emirates E06 Bentley Middle East and Africa (6E06),United Kingdom E01 Bentley UK (6E01),United States E05 Bentley USA and rest America (6E05)
<b>Brand</b>	Bentley
<b>Transaction No.</b>	2066040/1
<b>Level</b>	EH
<b>Status</b>	Approval
<b>Release date</b>

## W12 TSI - Bentayga - New GT/GTC - New Flying Spur

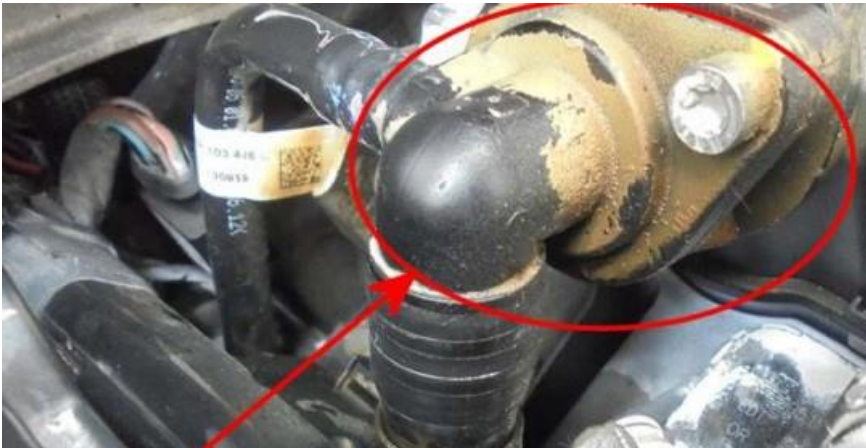
Figure 1

Oil leak between the oil separator tank and the Bank 1 breather line connection (Figure 1)

NOTE: Oil leak detection spray is evident within Figure1, the use of detection spray in the example shown highlights the location of the leak

- 1) Referring to Rep.Gr 17 - Gain access to the oil separator tank
- 2) Referring to Figure 2 - Replace the following parts and all associated parts as detailed within the applicable Rep.Gr and the ETKA parts catalogue

NOTE: When refitting the new replacement breather line and O-rings, ensure the fixings shown in Figure 2 - Item 13 are secured to 10Nm
