Technical product information

Topic	Bentayga V8 Kovomo - DTC P310B00 with Symptom Code 2638 - Check Engine Lamp - Fuel Pressure Regulation
Market area	Bentley: worldwide (2WBE)
Brand	Bentley
Transaction No.	2058484/6
Level	EH
Status	Approval
Release date

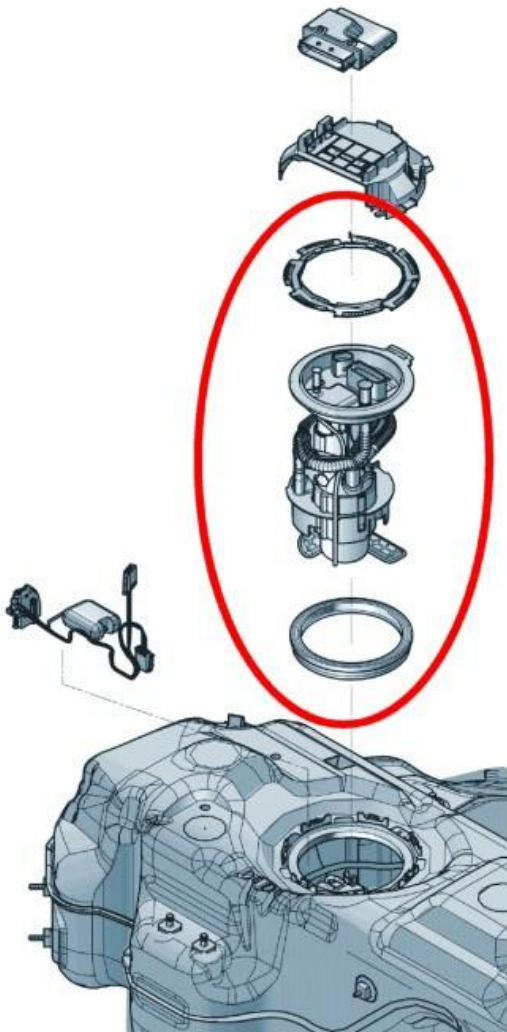
Figure 1

- Check Engine Lamp Illumination with DTC "P310B00 and symptom code 2638 with an "Adaption of Fuel Pump (FP)" figure of minus 100 to minus 200 kPa – *Figure 1* - the Fuel Delivery Module within the fuel tank should be replaced – *Figure 2*

To check the “Adaption of Fuel Pump (FP)” figure within the fault memory, refer to Engine control Unit “01 – Engine Control Module 1” - From “Extended ambient conditions” note the value of the “Adaption of Fuel Pump (FP)” – Figure 1.

- Refer to Repair Group 20 Fuel supply, gas operation / 4.0L V8 TSI / Fuel pump, fuel level sensors, and jet pump (RH) – To remove and fit.
