Technical Service Bulletin

Topic	Rotating display/screen noise - Diagnosis for complaints relating to noise during operation and/or during a drive cycle
Market area	Russische Föderation (5RU),Australia E04 Bentley rest Asia and Australia (6E04),China 796 VW Import Comp. Ltd (Vico), Beijing (6796),Germany E02 Bentley rest Europe (6E02),Japan E03 Bentley Japan (6E03),Korea, (South) E08 Bentley South Korea (6E08),United Arab Emirates E06 Bentley Middle East and Africa (6E06),United Kingdom E01 Bentley UK (6E01),United States E05 Bentley USA and rest America (6E05)
Brand	Bentley
Transaction No.	2065895/1
Level	EH
Status	Released for publishing
Release date	Feb 11, 2022

Various rotating display/screen noises during operation

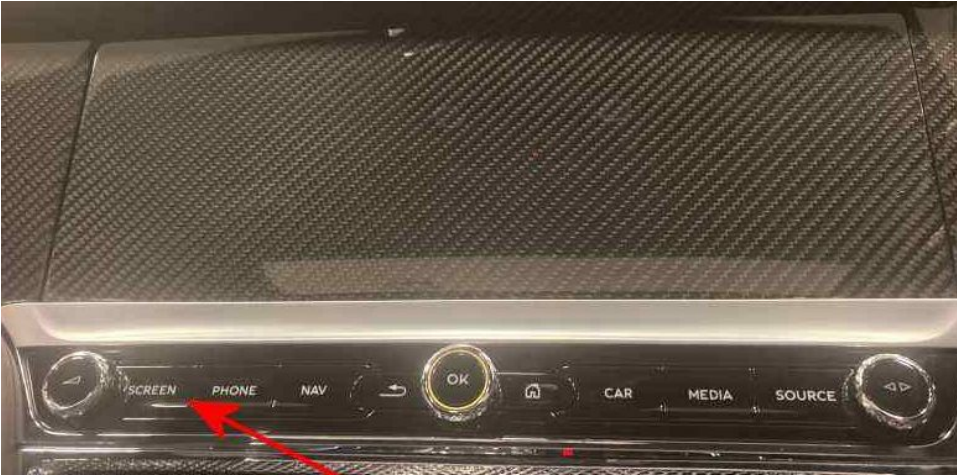
Figure 1

- Remove any foreign objects or debris that may be obstructing the rotational motion of the display
- Press the Screen button (Figure 1) for at least 20 seconds
- NOTE: The rotating display will perform the "learn" sequence and then return to the last selected face

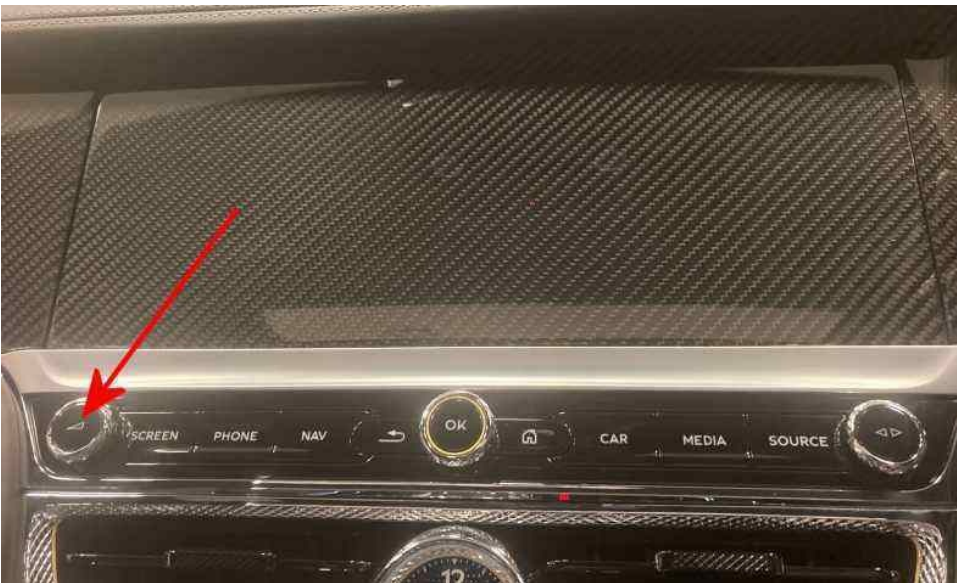
Figure 2

- If the rotating display still fails to operate - Press and hold the Volume button (Figure 2) for at least 10 seconds - This will reset the Infotainment system.

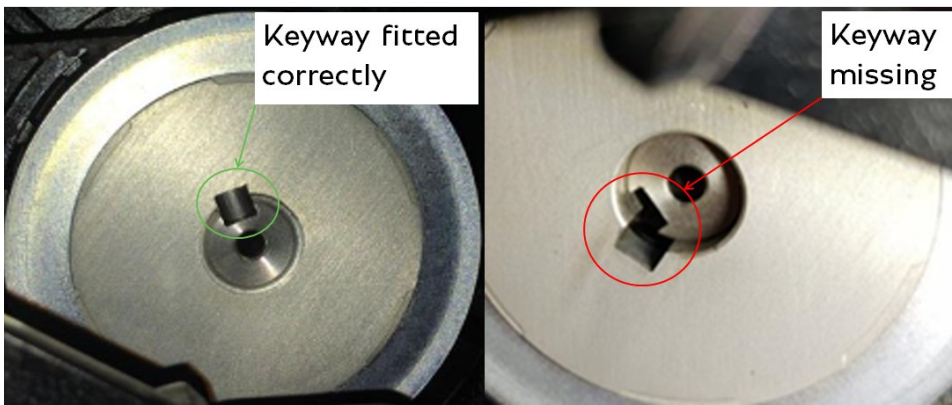
Figure 3

Scenario 1 - Grinding noise during operation

- Referring to Rep.Gr 91 - Remove rotating display
- Check the pulley wheel for fitment/security and ensure keyway is present and fitted correctly (Figure 3)

In the event that either defect is present raise a DISS technical query with photos/videos attached and await feedback before conducting any further work

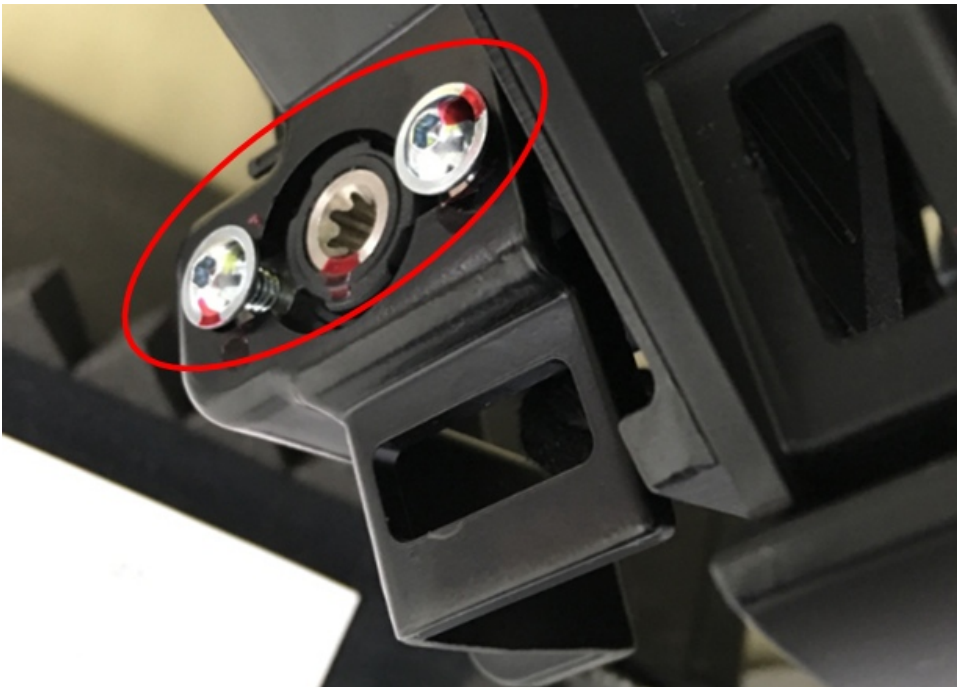
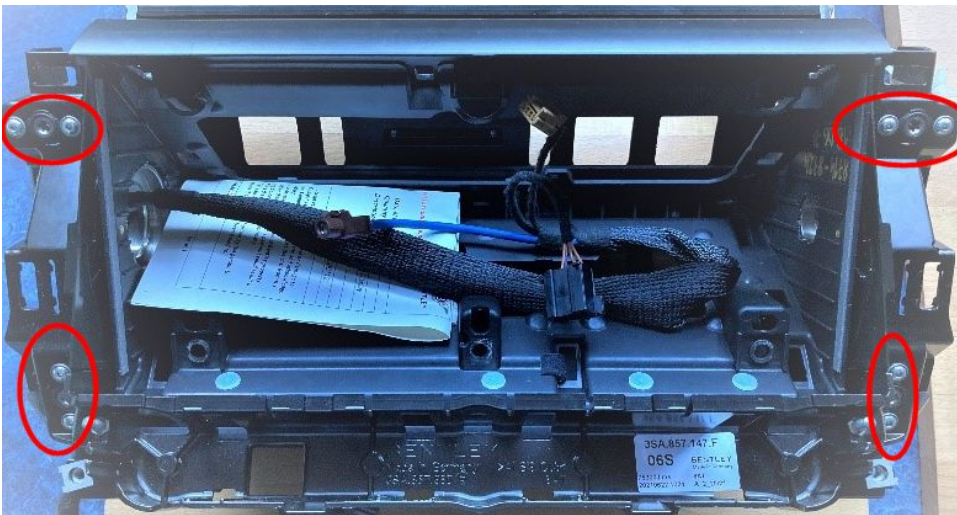
Scenario 2 - Rattling noise during operation

- Refer to Rep.Gr 91 - Remove the rotating display
- Referring to Figures 4 and 5 - Check and if necessary tighten the fixing screws highlighted (3Nm), there are 8 fixing screws in total.

- Referring to Rep.Gr 91 - Refit the rotating display and retest.

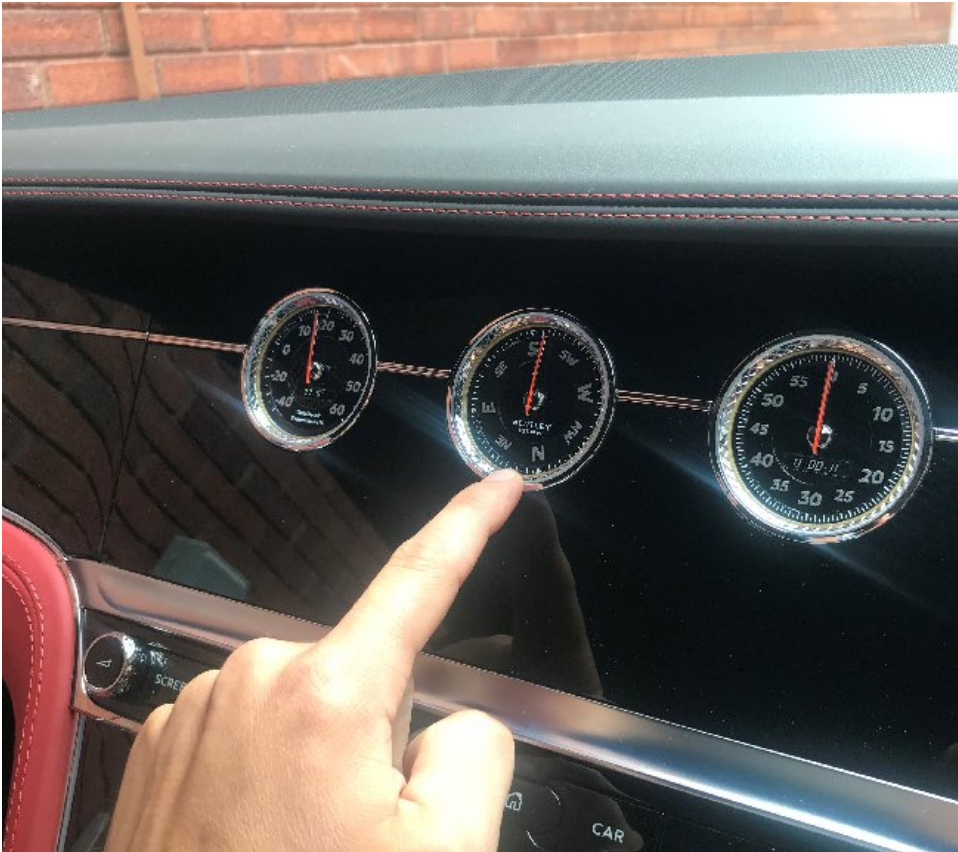
Figure 6

Scenario 3 - Squeak/creak/rattle from the dials during operation

When noise is evident from the dials, press on outer bezels (Figure 6) If the noise disappears when the bezels of the dials are pressed then replace the dials as per the applicable Rep.Gr

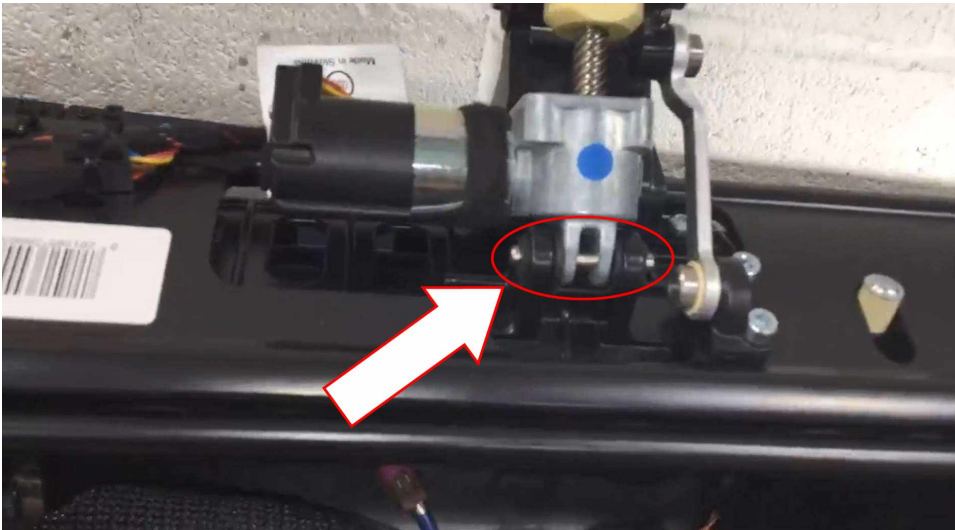
Figure 7

Scenario 4 - Creak/rattle from rotating display whilst driving/uneven operation during rotation

TIP: This symptom can in some cases be evident due to excessive movement within the rotating display motor pivot assembly (Figure 7)

NOTE: To check the motor pivot assembly for excessive movement the rotating display clocks and dials should be removed – Refer to Rep.Gr 91

- Refer to the Bentley Hub and refer to the video referencing TPI 2065895/-
- Should the movement be as shown in the video, the rotating display unit should be replaced
