ANA1 - Check Chassis Settings on the Rear Axle and Correct Them if Necessary (Recall Campaign)

Revision: This bulletin replaces bulletin Group 4 10/22 ANA1, dated February 18, 2022.

Model Year: **As of 2021 up to 2022**

Model Line: **Cayenne (9YA)/Cayenne Coupé (9YB)**

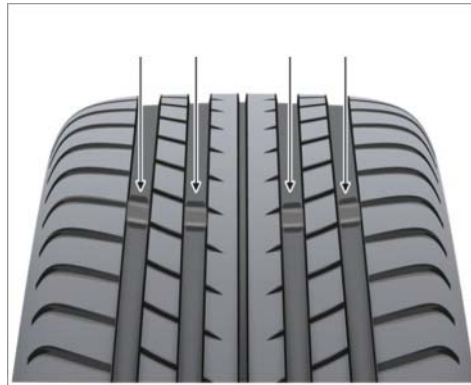
Check tires

<p>Differential wear: Measure tread depth as in Fig. ⇒ <i>Check tires -Arrows-</i> across all main tread grooves per tire rear axle (inside to outside), and between the driver and passenger side of the rear axle ⇒ then create max. difference ≤ 2 mm/ 0.078 in</p>	<p>Tread depth: Measuring tread depth over all main profile grooves ⇒ take minimum value ≥ 4mm/ 0.157 in (summer) ≥ 5mm/ 0.197 in (M&S)</p>	<p>Shoulder wear: Visual inspection of the inner and outer shoulders of the rear-axle tires Visual inspection as per sample photos</p>
---	--	--
