# Technical product information

<b>Topic</b>	Rotating display/screen - Fault diagnosis for operational complaints
<b>Market area</b>	Russische Föderation (5RU),Australia E04 Bentley rest Asia and Australia (6E04),China 796 VW Import Comp. Ltd (Vico), Beijing (6796),Germany E02 Bentley rest Europe (6E02),Japan E03 Bentley Japan (6E03),Korea, (South) E08 Bentley South Korea (6E08),United Arab Emirates E06 Bentley Middle East and Africa (6E06),United Kingdom E01 Bentley UK (6E01),United States E05 Bentley USA and rest America (6E05)
<b>Brand</b>	Bentley
<b>Transaction No.</b>	2065894/1
<b>Level</b>	EH
<b>Status</b>	Approval
<b>Release date</b>

Various rotating display operational complaints

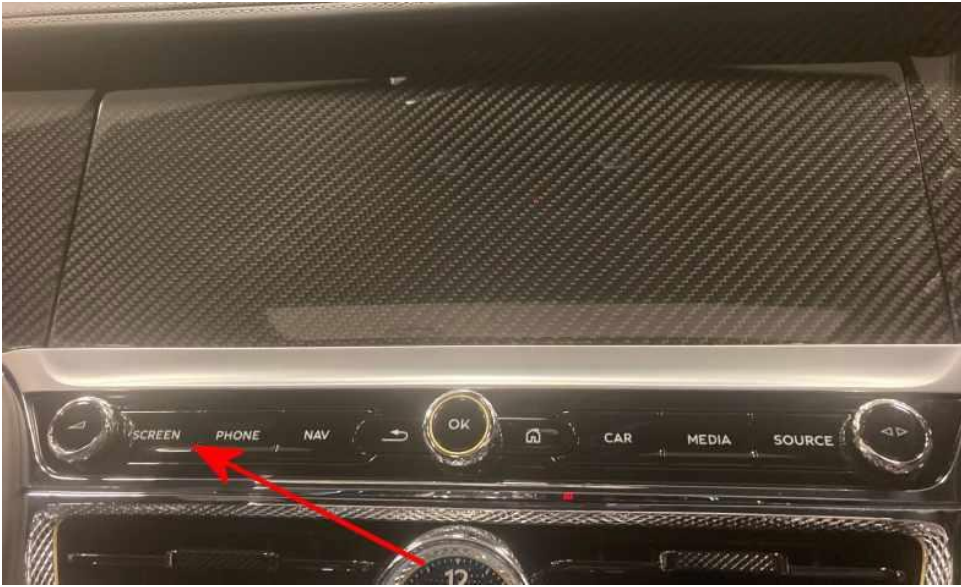
Figure 1

- Remove any foreign objects or debris that may be obstructing the rotational motion of the display
- Press the Screen button (Figure 1) for at least 20 seconds

NOTE: The rotating display will perform the "learn" sequence and then return to the last selected face

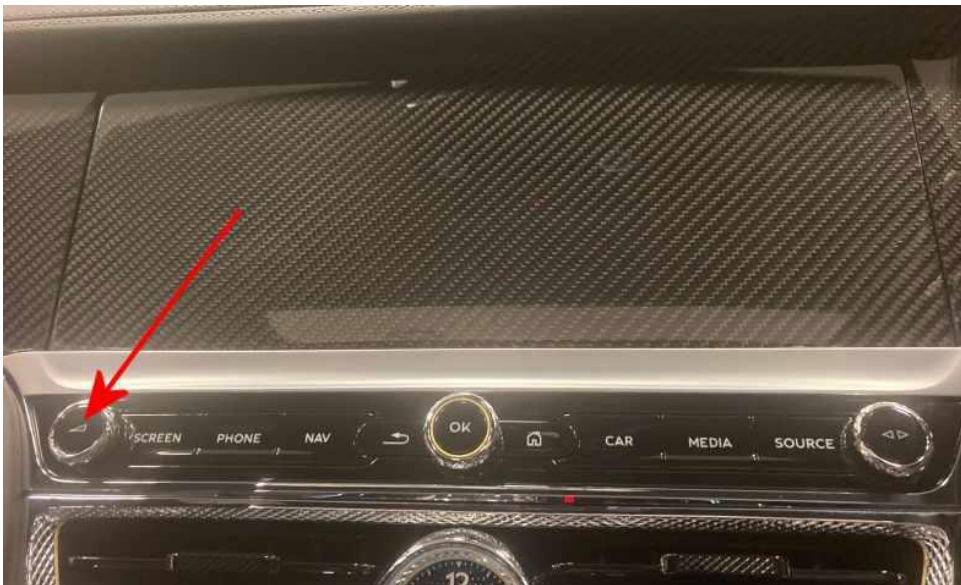
Figure 2

- If the rotating display still fails to operate - Press and hold the Volume button (Figure 2) for at least 10 seconds - This will reset the Infotainment system.

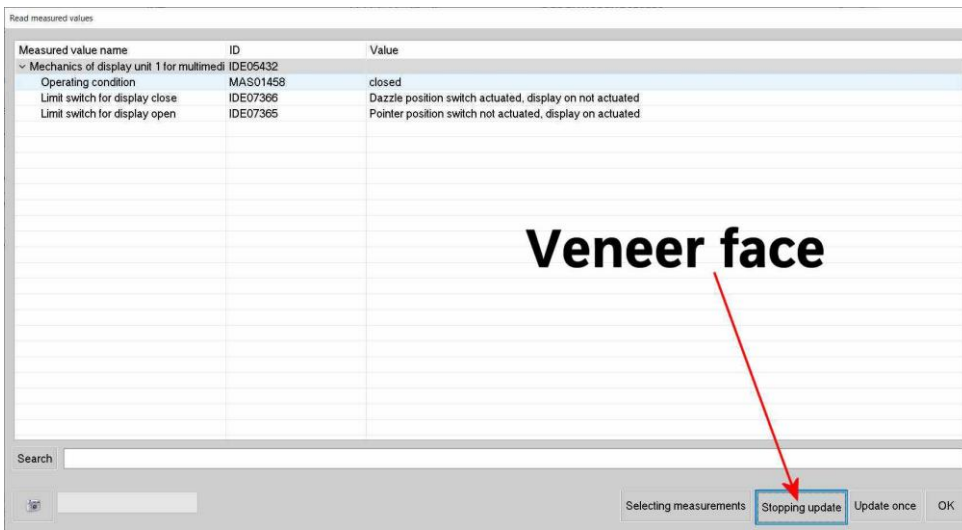
- Figure 3 shows the MWB when the veneer face is visible

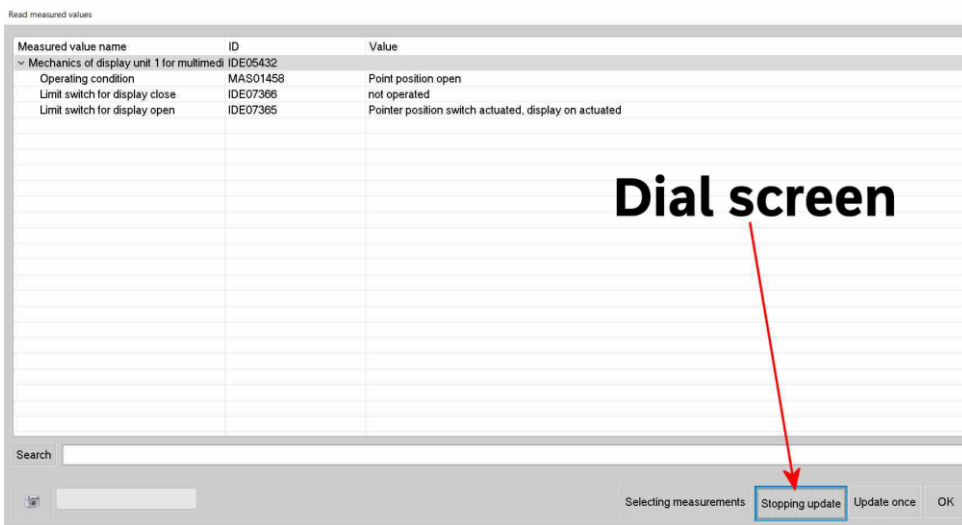
- Figure 4 shows the MWB when the Dial screen is visible

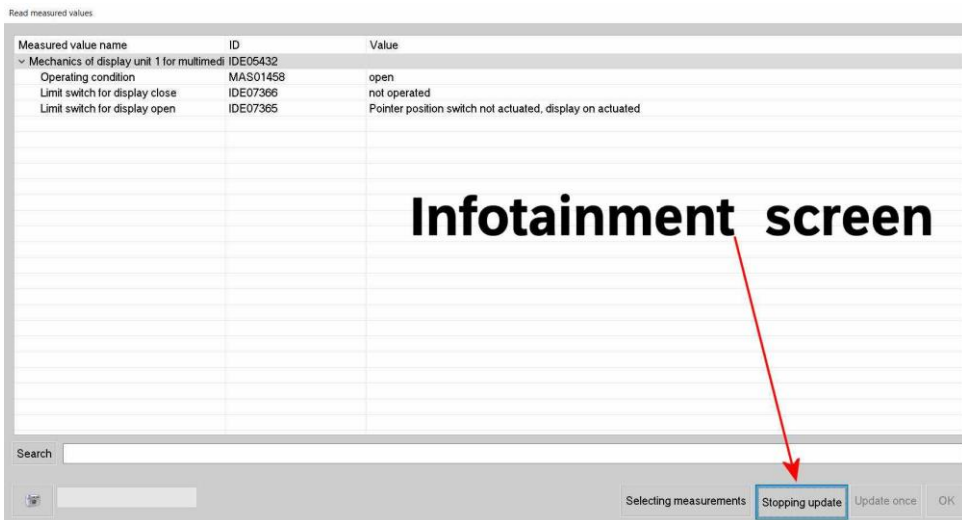
- Figure 5 shows the MWB when the Infotainment screen is visible

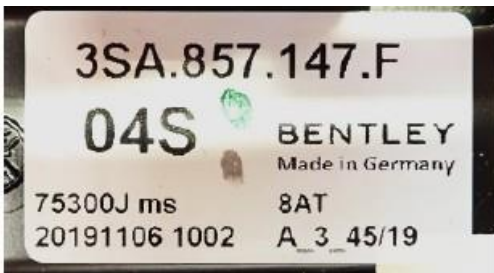
Figure 6

- Take a photo of the BRD prior to packaging (Noting any damage)
- Take a photo of the BRD identification number (Figure 6 as an example)

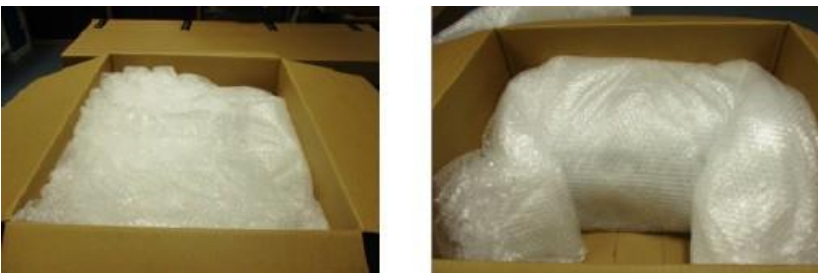
Figure 7

- All returned BRD's must be packaged in the replacements original packaging (Figure 7) to avoid any damage during return transit
