Technical product information

Topic	Rotating screen alignment
Market area	Russische Föderation (5RU),Australia E04 Bentley rest Asia and Australia (6E04),China 796 VW Import Comp. Ltd (Vico), Beijing (6796),Germany E02 Bentley rest Europe (6E02),Japan E03 Bentley Japan (6E03),Korea, (South) E08 Bentley South Korea (6E08),United Arab Emirates E06 Bentley Middle East and Africa (6E06),United Kingdom E01 Bentley UK (6E01),United States E05 Bentley USA and rest America (6E05)
Brand	Bentley
Transaction No.	2065896/1
Level	EH
Status	Approval
Release date

New Continental GT - New Continental GTC and New Flying Spur

The gap and fit between the "veneer face" fascia panel of the Bentley rotating display (BRD) and the passenger and drivers side fascia panels may differ from one side to the other

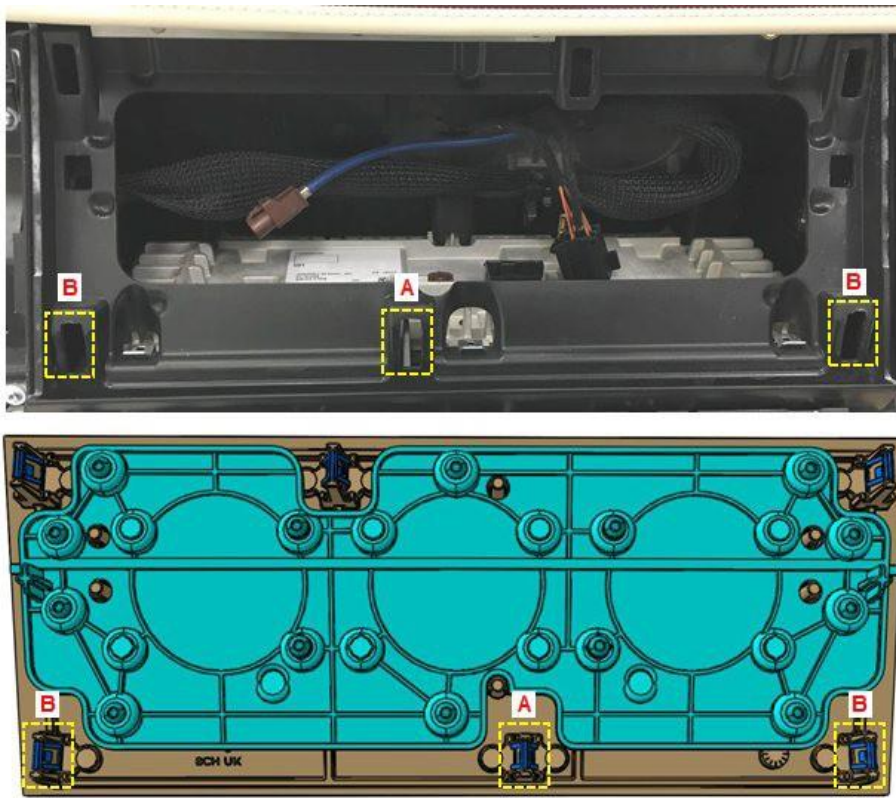
Figure 3

The veneer face fascia panel is fixed to the "BRD" by six locator pins and receiving holes (Figure 3)

The following locator pins (A & B) control the position of the fascia panel as follows:

A = Side to side axis

B = Up and down axis

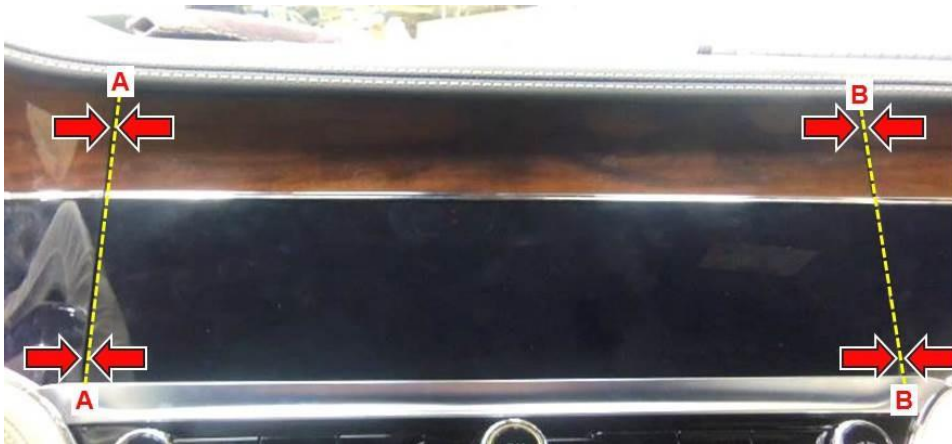
Figure 4

Measure the gaps (A & B) between the veneer face fascia panel and the passenger and drivers side fascia panels (Figure 4)

The specified gapping is 1.5mm +/- 0.5mm tolerance. The gap between the "BRD" veneer face fascia panel and passenger and drivers side fascia panels MUST be parallel on both sides.

IMPORTANT: The minimum functional gaps for A & B is 1mm

If the gaps are not within the specified values then adjust as follows.

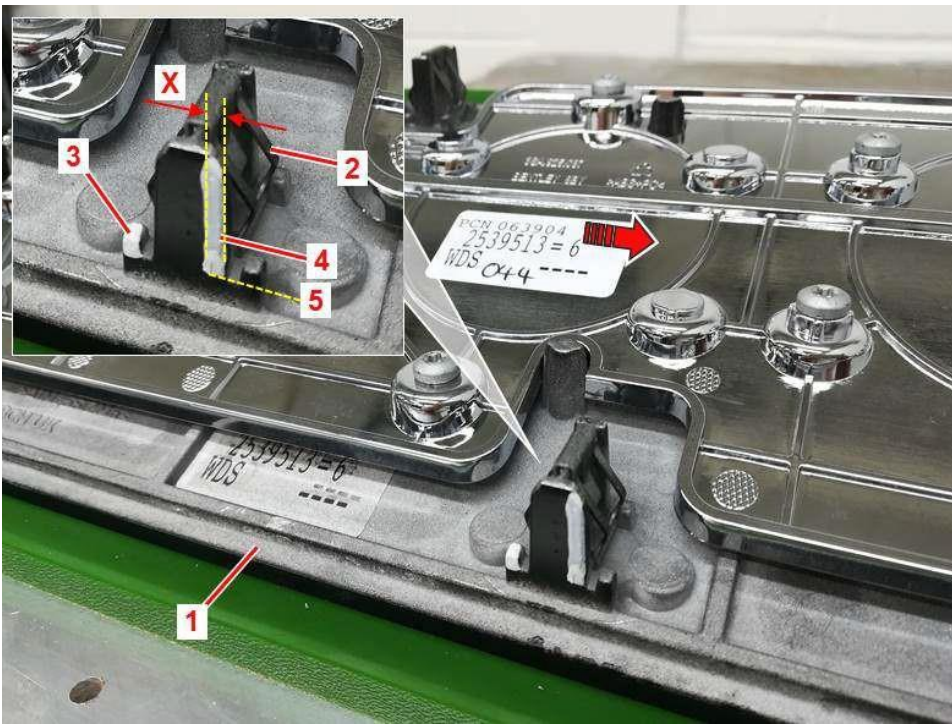
i Only the centre lowermost locator pin shown governs the side to side movement of the fascia panel. Only this locator pin will require modifying.

Place the veneer face fascia panel (1) face down on a soft, clean and protective work surface and mark accordingly the direction in which the panel needs to move (arrow) as shown in Figure 5

Remove the spring retaining clip (2) from the lowermost locator pin. If the fascia panel requires moving by 0.5mm then remove the same amount of material (X) from the appropriate side of the lower centre locator pin (4) as shown on the aluminium substrate casting. In addition, file the trailing RPS point (3) flat, level with the recess (Figure 5)

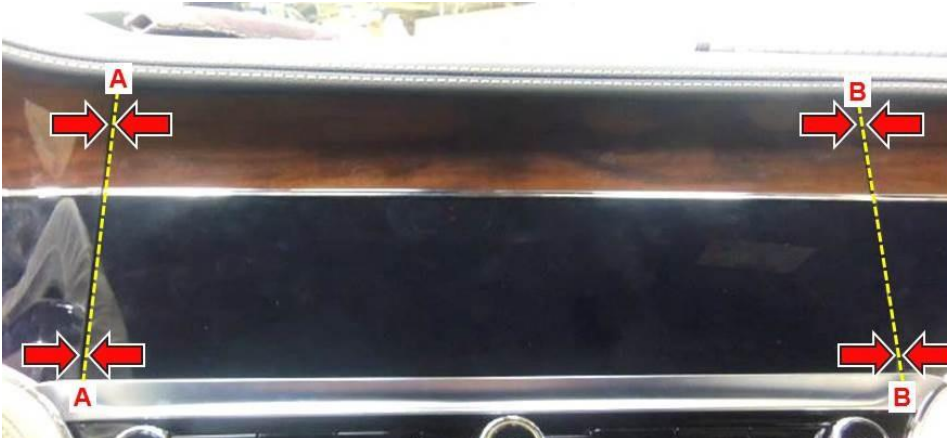
Figure 8

Measure the gaps (A & B) between the veneer face fascia panel and the passenger and drivers side fascia panels (Figure 8)

The correct gapping must be 1.5mm +/- 0.5mm tolerance. The gap between the veneer face fascia panel and passenger and drivers side fascia panels MUST be parallel on both sides.

IMPORTANT: The minimum functional gaps for A & B is 1mm

If the gaps are not within the specified values then add/remove anti-creak tape to adjust accordingly.

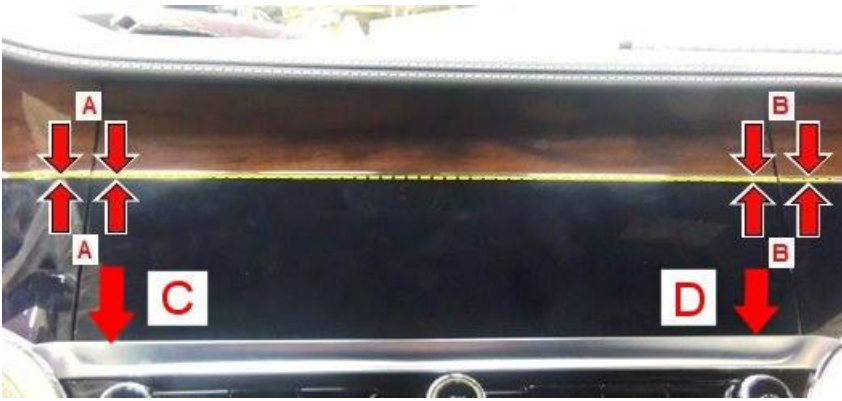
Figure 9

Visually check the chrome brightware strip on the “veneer face” fascia panel is aligned with the chrome strips at points A & B on the passenger and drivers side fascia panels (Figure 9)

Check that the minimum functional gap is maintained between the bottom of the BRD and the switch pack at points C & D

The specified tolerance in the vertical plane (A & B) is 0.5mm.

The specified minimum functional gap between the BRD and the switch pack (C & D) is 1mm.

If the chrome brightware strip on the “vener face” fascia panel is out of line, carry out the following to adjust the panel.

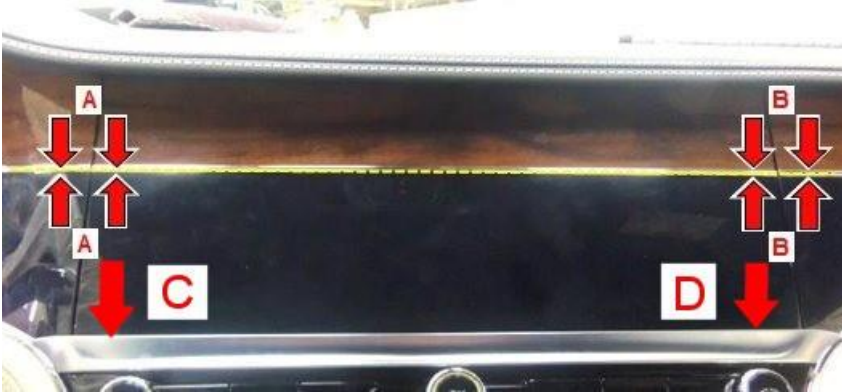
Figure 12

Visually check that the chrome brightware strip on the “veneer face” fascia panel is aligned with the chrome strips at points (A & B) on the passenger and drivers side fascia panels (Figure 12)

Check that the minimum functional gap is maintained between the bottom of the BRD and the switch pack at points (C & D)

The tolerance in the vertical plane (A & B) is 0.5mm.

The specified minimum functional gap between the BRD and the switch pack (C & D) is 1mm.

If the chrome brightware strip on the “veneer face” fascia panel is still out of line, and is not within the specified tolerance then add/remove anti-creak tape to adjust accordingly.

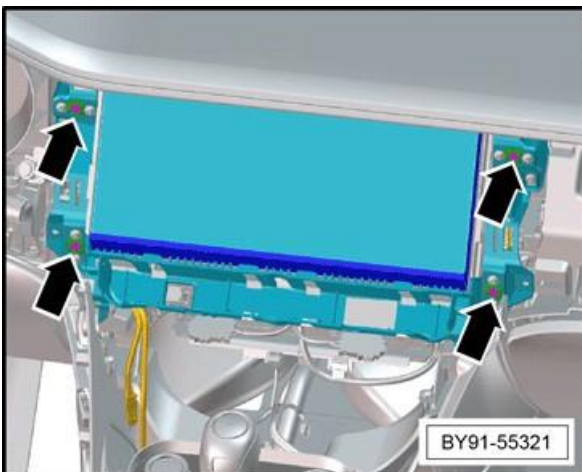
Figure 13

The setting screws (arrows) are factory sealed and any attempt to make adjustments via these four screws may result in failure of the rotating display and/or information display touch screen.

Under no circumstances should any attempt be made to adjust the “BRD” module inboard or outboard by adjusting any of the four setting screws (arrows) shown in Figure 13.

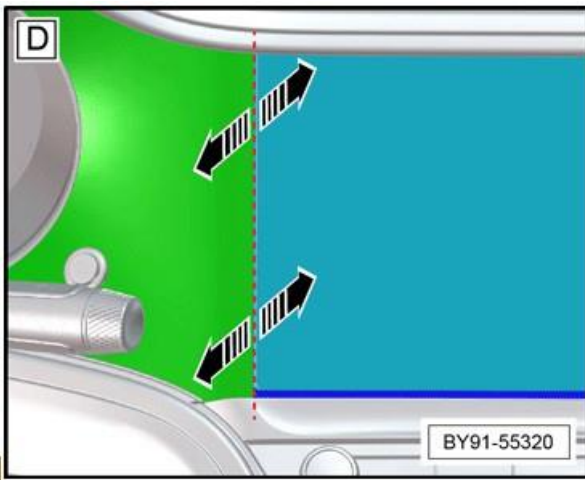
Figure 14

Measure the profile (D) between the “BRD” veneer face fascia panel and the passenger and drivers side fascia panels (Figure 14)

The specified setting dimension for the “BRD” fascia panel is -0.5mm (under flush) +/- 0.5mm tolerance and MUST be equal on both sides. If either of the passenger and drivers side fascia panels are out of tolerance and require adjustment, make a note of which point requires adjustment and by how much on each panel.

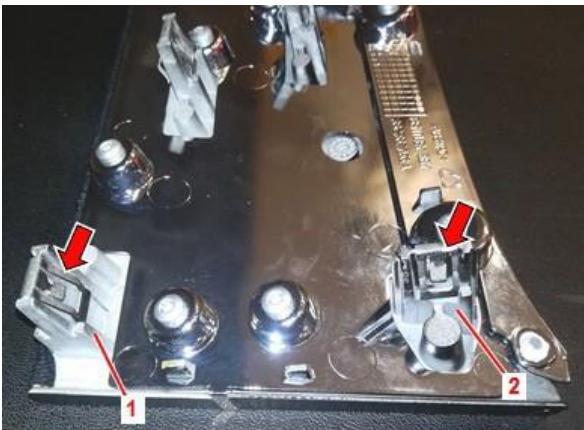
Figure 15

i Note. The locator pin (1) is for adjustment the top of the fascia panel and locator pin (2) is for adjusting the bottom of the fascia panel. All other locator pins are not affected.

With the fascia panel face down on a soft, clean and protective work surface, remove the appropriate spring clip(s) (arrow) as required (Refer to Figures 15 and 16)

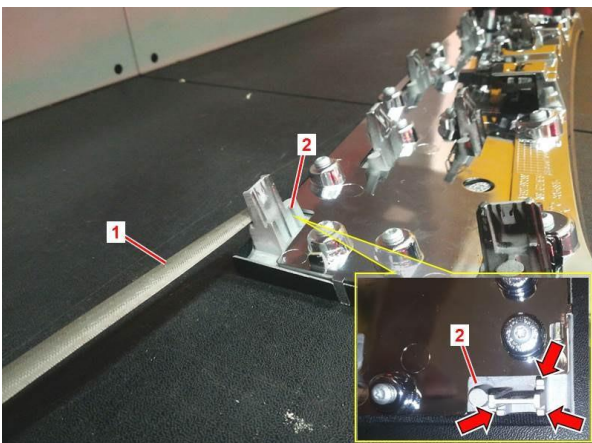
i Note. Referring to Figure 16 - The upper locator pin (2) has three “RPS” points (arrows) whereas the lower locator pin only has two

Carefully file the “RPS” points (arrows) by the required amount that the fascia panel needs to move in.

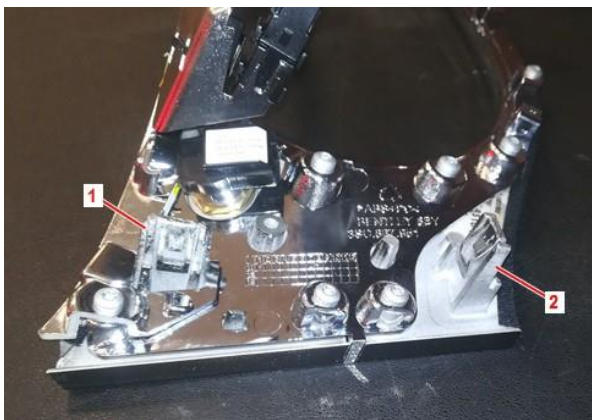
Figure 18

i Note. The locator pin (1) is for adjusting the bottom of the fascia panel and locator pin (2) is for adjusting the top of the fascia panel. All other locator pins are not affected (Figure 18)

With the fascia panel face down on a soft, clean and protective work surface, remove the appropriate spring clip/s from the locator pin.

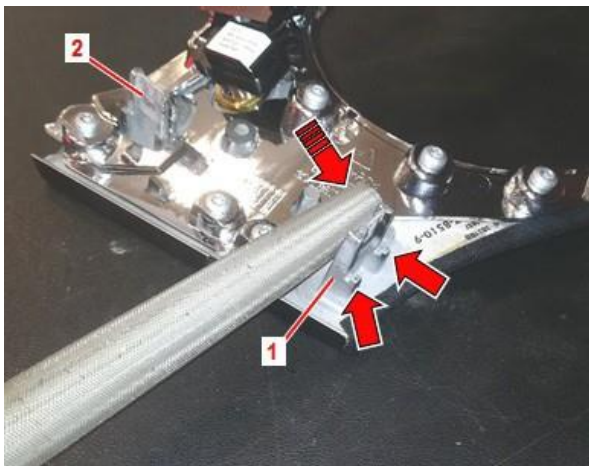
Figure 19

i Note. The upper locator pin (1) has three “RPS” points (arrows) whereas the lower locator pin (2) only has two “RPS” points.

Carefully file the “RPS” points (arrows) by the required amount that the fascia panel needs to move in (Figure 19)
