9YA, 95B, 971 - Broken Valve Springs

Vehicles Affected

Models	Model Year	Model Type	VIN Range	Vehicle-Specific Equipment
Cayenne	As of 2021 up to 2022	All models (9YA)	N/A	N/A
Macan	As of 2021 up to 2022	S, GTS, Turbo (95B)	N/A	N/A
Panamera	As of 2021 up to 2022	All models (971)	N/A	N/A

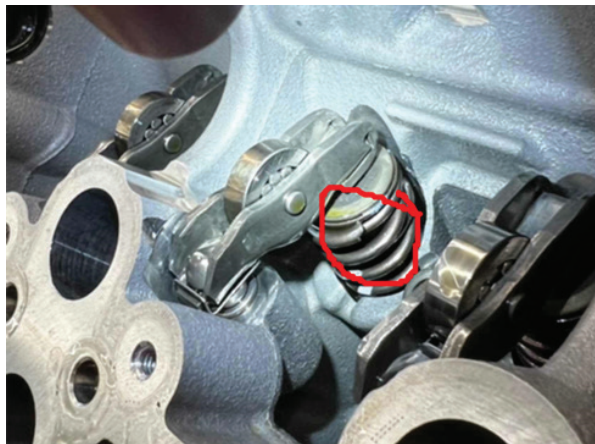
Figure 1 - Broken Valve Spring

The aforementioned faults/condition may be the result of a broken valve spring as shown in **Figure 1**. A manufactured batch of valve springs associated with the issue highlighted in this bulletin were quarantined by *Parts Withdrawal GR13D590 –PAB109623* (published December 8, 2021). Any remaining stock of springs not quarantined or new parts received are therefore considered safe to use for installation.

In many cases, failures occur in less than 1000km (620 mls) of runtime, of which the majority are below 500 km (310 mls).

In the event one or more valve springs are broken, then **ALL VALVE SPRINGS MUST BE REPLACED (INTAKE AND EXHAUST)**. Please perform the repairs in accordance with the respective workshop instructions.
