## Window lifter operating unit cover trim

Topic number	LI72.10-N-074330
Version	1
Function group	72.10 - Front door
Date	2/4/22
Validity	Models 907, 910
Reason for change

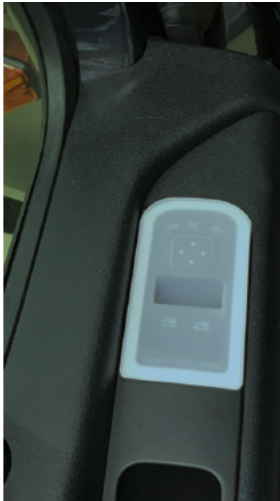
Cover trim position in door trim

Attach silicone cover trim over operating unit for sealing.

Silicone trim has an adhesive strip and is affixed over operating unit.

Bonding surface area must be cleaned and degreased prior to bonding.

To affix, remove protection from bonding surface, position cover trim and press on.

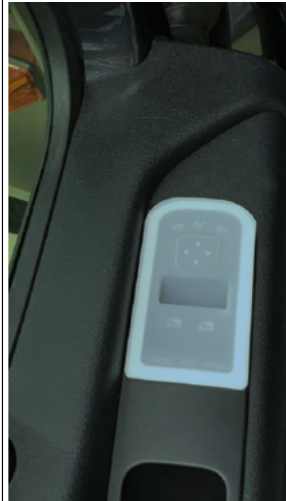
Cover trim position in door trim
