# TECHNICAL SERVICE BULLETIN

## Hard Top Headliner Loose And/Or Sagging

**22-2073**  
01 March 2022

Ford 2021-2022 Bronco
--------------------------

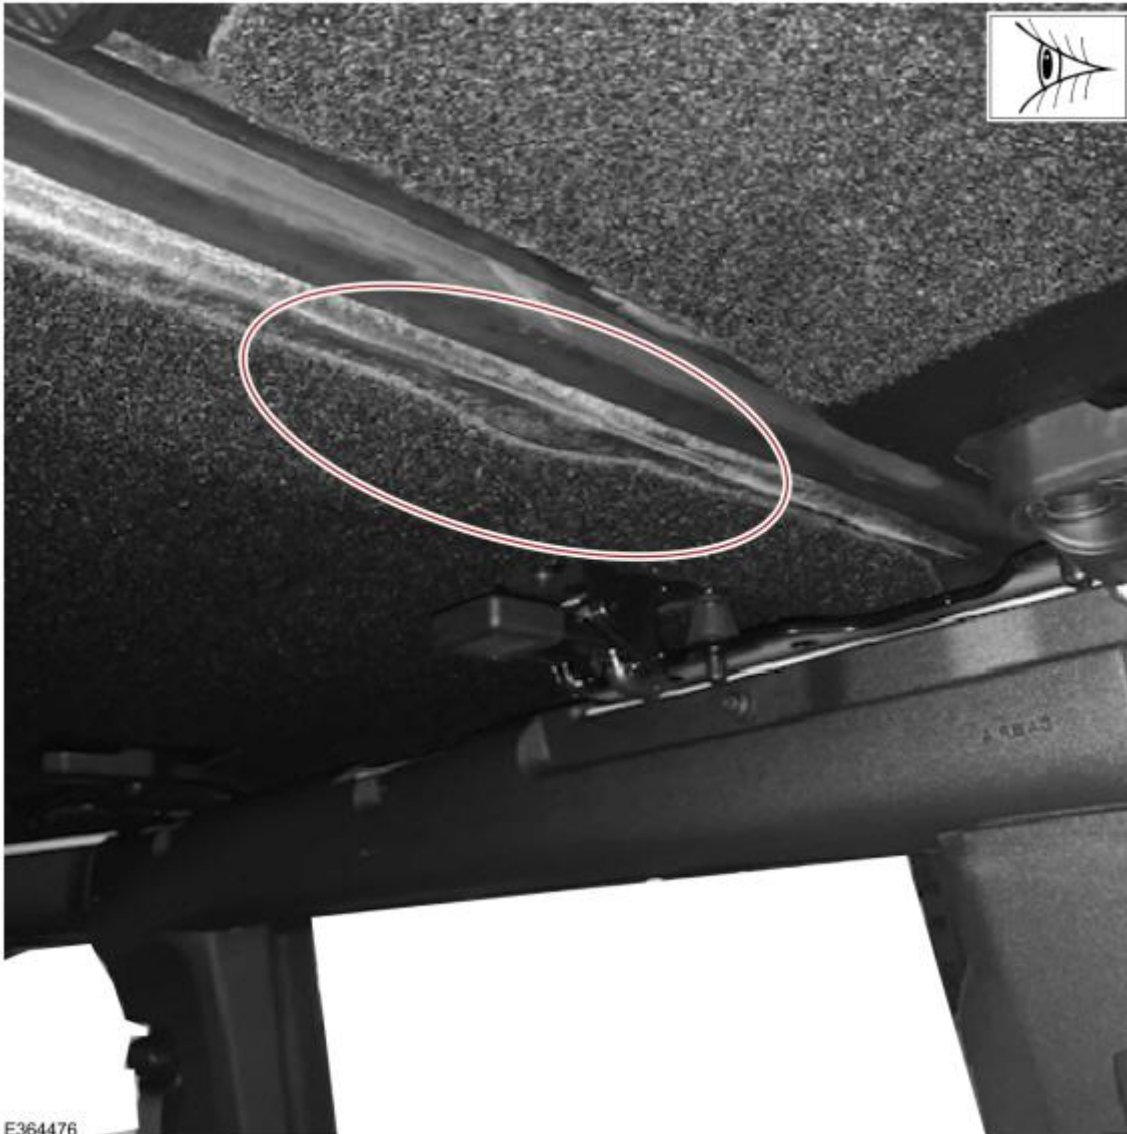
Figure 1

1. Inspect the interior headliner. Is the headliner loose and/or sagging? (Figure 1)
