# HYUNDAI

## Technical Service Bulletin

GROUP <b>CAMPAIGN</b>	NUMBER <b>22-01-014H</b>
DATE <b>FEBRUARY, 2022</b>	MODEL(S) <b>See Applicable Vehicles Below</b>

**SUBJECT:** D-AUDIO 2.0V UPDATE FOR WIRELESS CARPLAY,  
(SERVICE CAMPAIGN T7T)

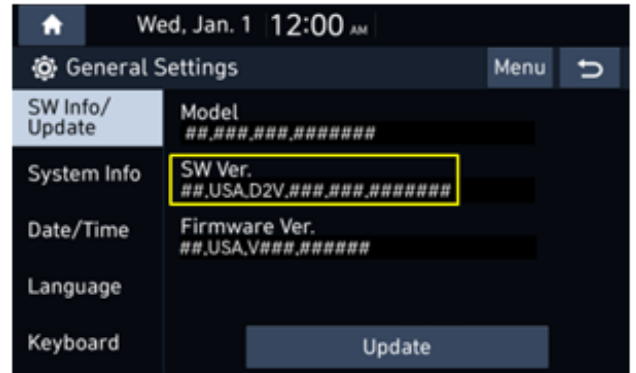
4. Check installed S/W version
  - Santa Cruz (NXT)/ Tucson (NX4a):  
If installed version is earlier than Sep. 2021, installed same S/W twice.
  - Elantra (CN7a), Sonata (DN8a), Santa Fe (TMa):  
If installed version is later than Sep. 2021 (including Sep. version) install once.

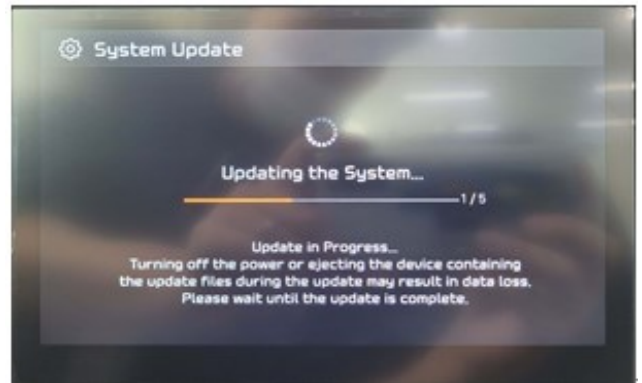
There will be multiple occurrences where the Hyundai logo will appear, or the display will be black during the update process. This is normal. This system will restart.

7. Updates are done automatically, so please wait until the update is complete.  
(Approximate time ~ 15 minutes)

**Ensure SW version date is 211112.**
