Technical Service Bulletin

GROUP CAMPAIGN	NUMBER 22-01-011H
DATE FEBRUARY, 2022	MODEL(S) PALISADE (LX2)

SUBJECT: VEHICLE INSPECTION AND DRIVE PLATE REPLACEMENT
(SERVICE CAMPAIGN T7U)

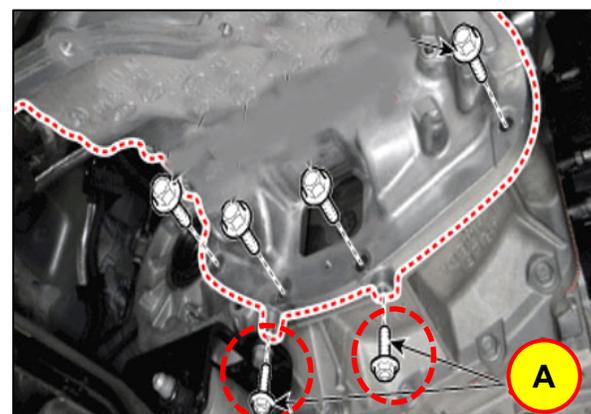
If it is difficult to hear the metallic noise, remove the vehicle undercover and remove 2 oil pan long bolts (A).

Go to Step 3 and check if the oil pan long bolts (A) are contacting the drive plate.

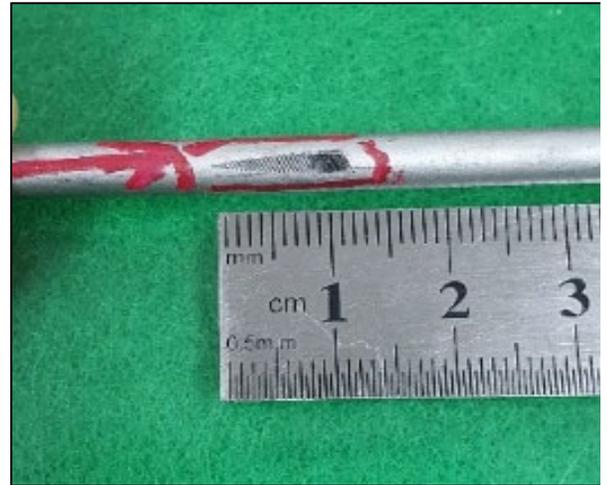
3. If the bolt has contact marks indicating the bolt has contacted the drive plate as shown, replace the drive plate and 2 long bolts according to the Palisade shop manual: **Automatic Transaxle System (A8LF1), Automatic Transaxle System, Automatic Transaxle, Repair Procedure.**

If the bolt has no contact marks, re-install and tighten the existing bolts to specification.

Torque: 7~9 lb-ft (1.0~1.2 kgf.m, 10~12 N.m)
