ITB17-001C

FLUID LEAK CAUSED BY TRANSFER ASSEMBLY RIGHT SIDE DRIVE SHAFT SEAL

APPLIED VEHICLES: 2019-2021 QX50 (J55)
 2014-2020 QX60 (L50)
 2014-2021 QX60 Hybrid (L50H)

APPLIED DRIVELINES: AWD only

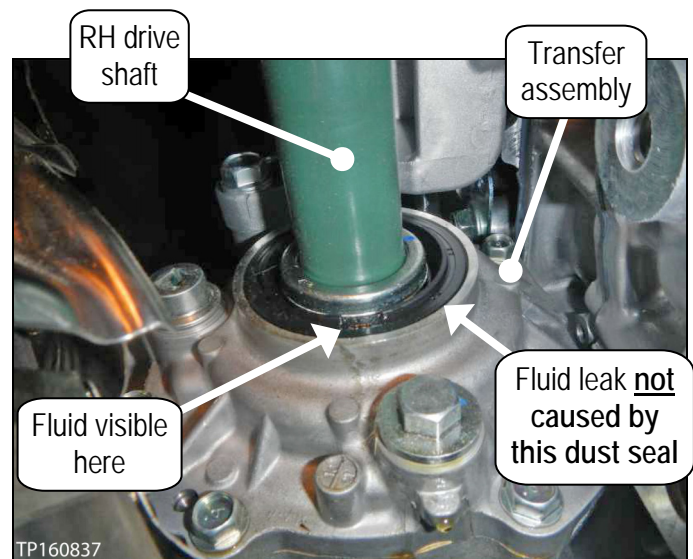
Figure 1

If fluid is leaking from the front passenger (RH) side of the transfer assembly, refer to the information in this bulletin.

NOTE: The fluid leak is not caused by the dust seal shown in Figure 1.

1. **DO NOT REPLACE** the transfer assembly.
2. Replace the drive shaft oil seal and the dust seal.
 - The drive shaft oil seal and the dust seal can be replaced without removing the transfer assembly from the vehicle.
 - It is not necessary to remove the transfer cover to replace the drive shaft oil seal and the dust seal.
 - Refer to ITB21-023 for drive shaft oil seal and dust seal replacement.

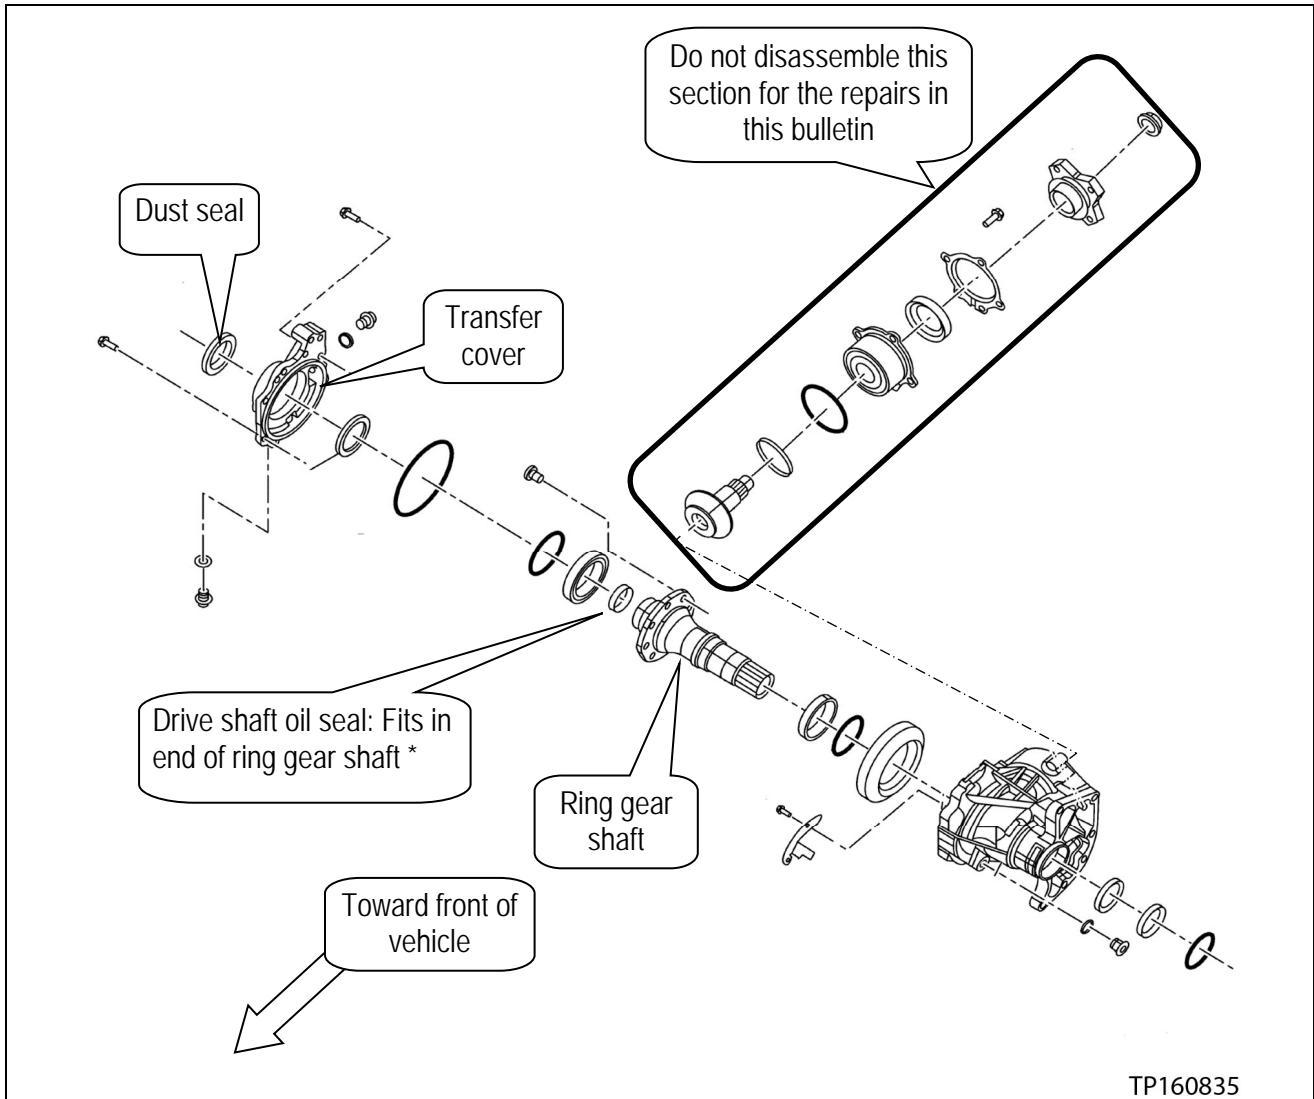
Figure 6

TY21C Transfer Assembly – Exploded View for Reference Only
