SERVICE BULLETIN

Classification: TF16-001C	Reference: NTB17-003C	Date: February 16, 2022
------------------------------	--------------------------	----------------------------

FLUID LEAK CAUSED BY TRANSFER ASSEMBLY RIGHT SIDE DRIVE SHAFT OIL SEAL

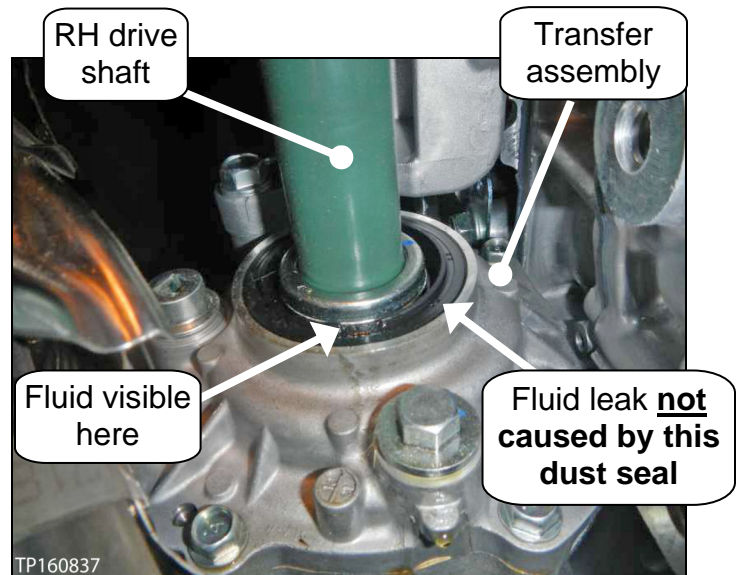
Figure 1

If fluid is leaking from the front passenger (RH) side of the transfer assembly, refer to the information in this bulletin.

NOTE: The fluid leak is NOT caused by the dust seal shown in Figure 1.

1. **DO NOT REPLACE** the transfer assembly.
2. Replace the drive shaft oil seal and the dust seal.
 - The drive shaft oil seal and the dust seal can be replaced without removing the transfer assembly from the vehicle.
 - It is not necessary to remove the transfer cover to replace the drive shaft oil seal and the dust seal.
 - Refer to NTB21-094 for drive shaft oil seal and dust seal replacement.

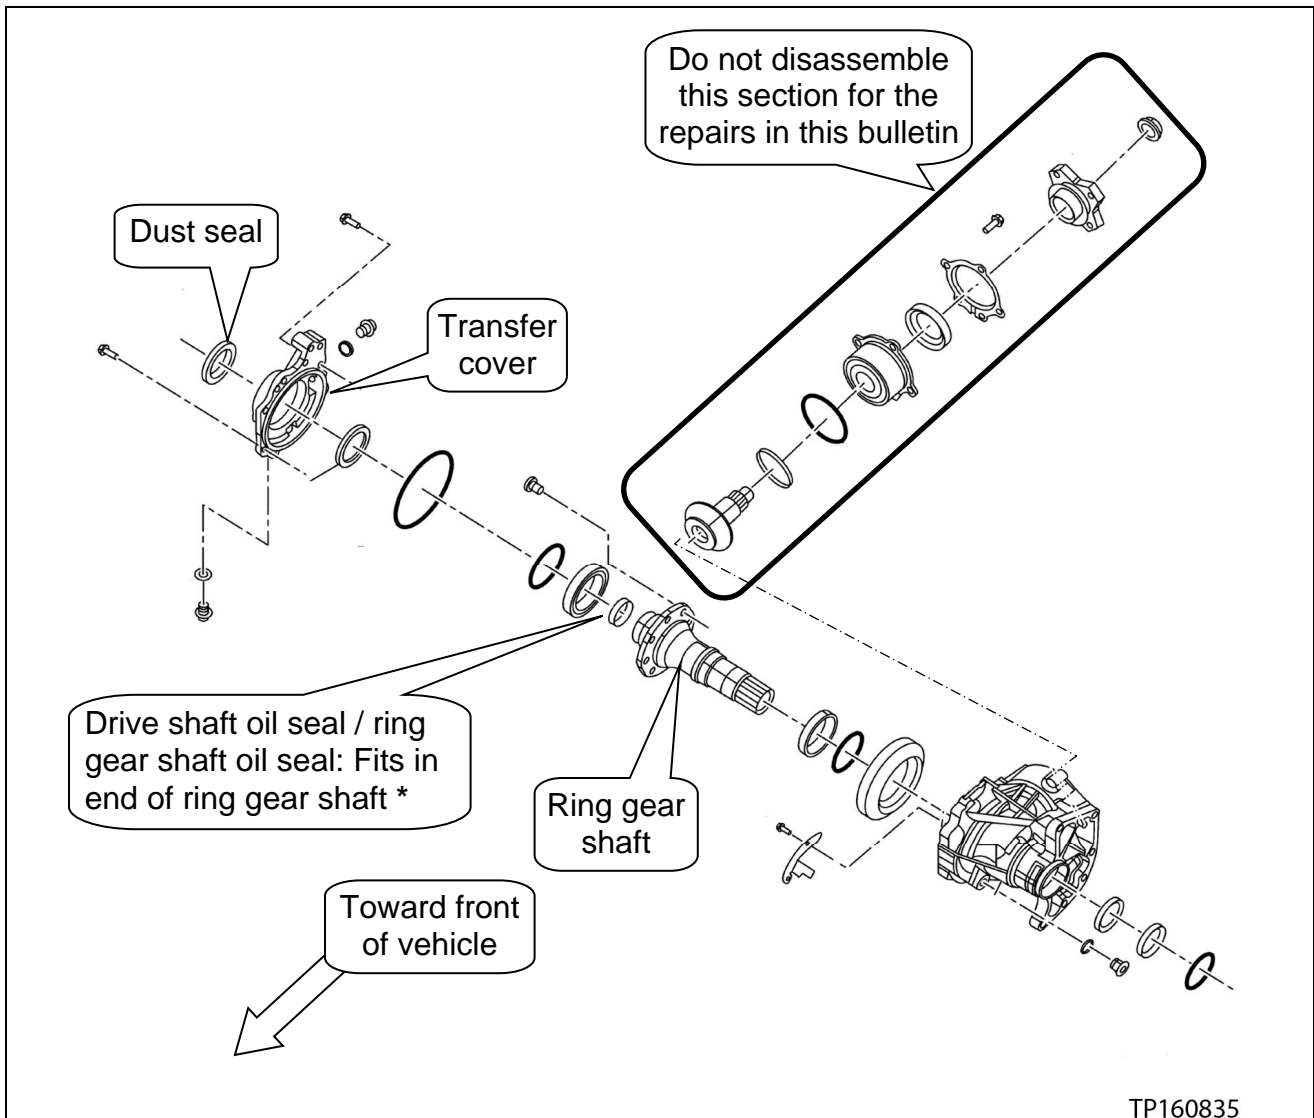
Figure 6

Typical TY21C Transfer Assembly – Exploded View for Reference Only

* The seal causing the leak is called "Drive shaft oil seal" in the ESM for all applied models except Rogue, Rogue Hybrid, Rogue Sport, and Altima. For these vehicles, it is called "Ring gear shaft oil seal".
