SERVICE BULLETIN

Classification: EL21-014A	Reference: NTB21-081A	Date: February 2, 2022
------------------------------	--------------------------	---------------------------

AUTOMATIC BACK DOOR INOPERATIVE

APPLIED VEHICLES: 2021-2022 Rogue (T33)
APPLIED GRADES: SV with Premium Package, SL, Platinum

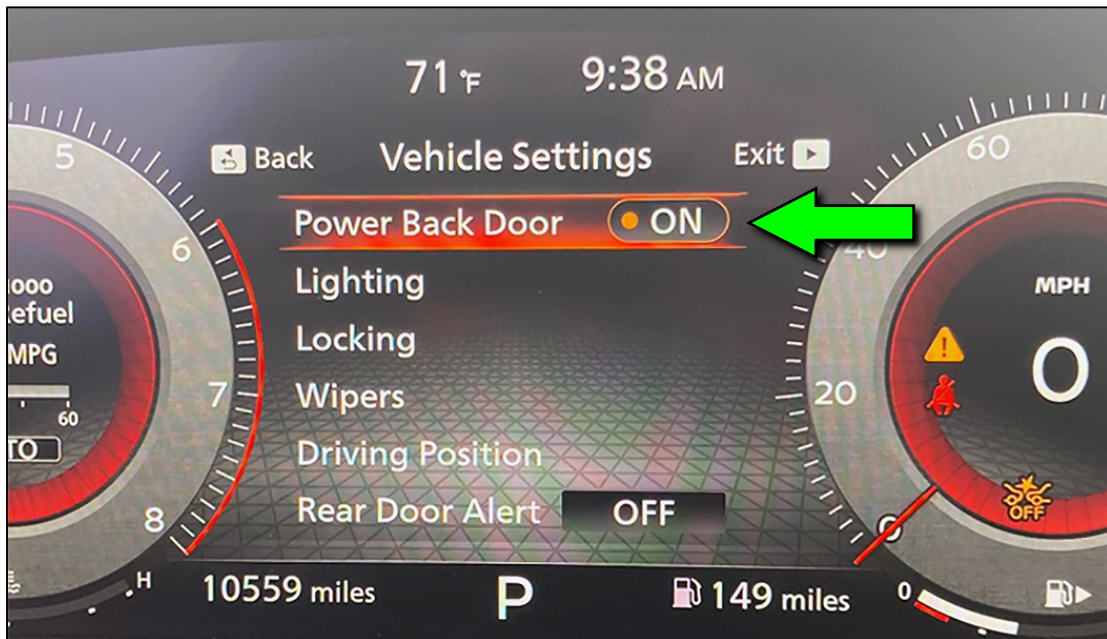
Figure 1

Before performing diagnostics on an **APPLIED VEHICLE** that appears to have an inoperative automatic (power) back door (e.g., the door will not open, close, latch, etc.):

- Confirm the **Power Back Door** is set to **ON** in the Vehicle Settings menu in the Vehicle Information Display (Figure 1).
 - To access/change the **Power Back Door** setting, use the scroll dial and ◀ ▶ buttons on the steering wheel to navigate to the Vehicle Settings menu.
