SERVICE BULLETIN

Classification: EL21-014B	Reference: NTB21-081B	Date: February 14, 2022
------------------------------	--------------------------	----------------------------

AUTOMATIC BACK DOOR INOPERATIVE

APPLIED VEHICLES: 2022 Pathfinder (R53)
2021-2022 Rogue (T33)
APPLIED GRADES: SV with Premium Package, SL, Platinum

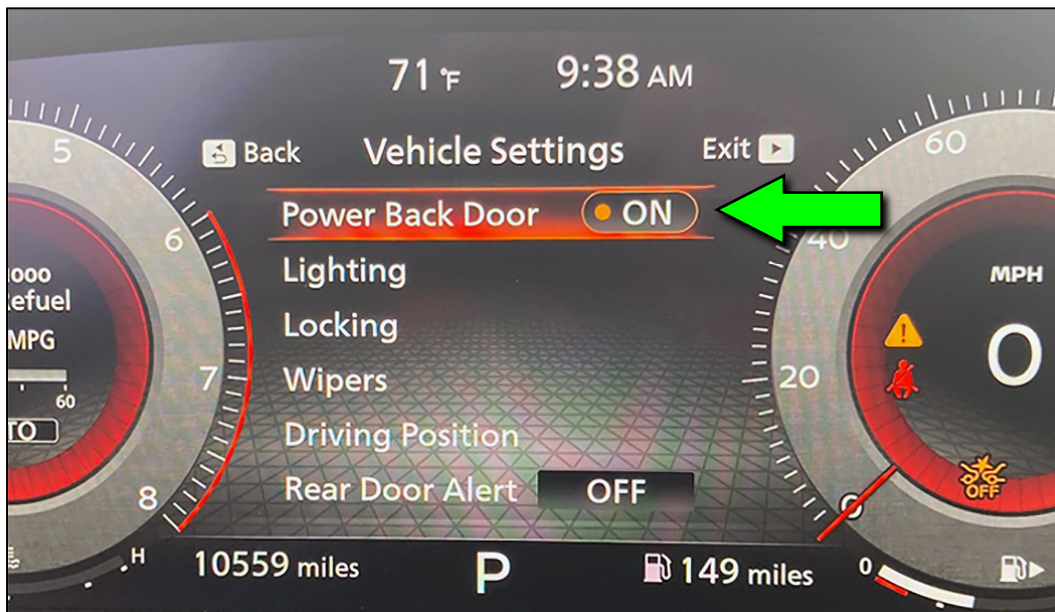
Figure 1

Before performing diagnostics on an **APPLIED VEHICLE** that appears to have an inoperative automatic (power) back door (e.g., the door will not open, close, latch, etc.):

- Confirm the **Power Back Door** is set to **ON** in the Vehicle Settings menu in the Vehicle Information Display (Figure 1).
 - To access/change the **Power Back Door** setting, use the scroll dial and ◀ ▶ buttons on the steering wheel to navigate to the Vehicle Settings menu.
