Preliminary Information

PIP5785 Whining/Whirring, Whistle, Squeaking, Groaning/Growling Noise Coming From The Front Wheel/Engine Area

Models

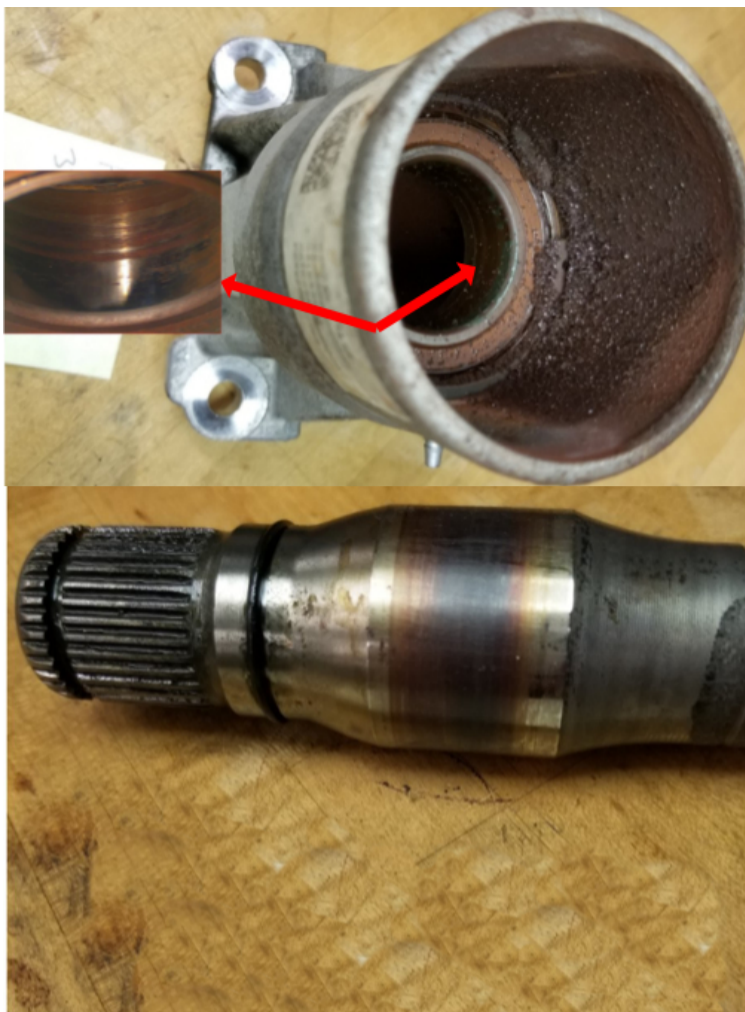
Involved Region or Country	North America
Additional Options (RPO)	F46
Condition	<p>Some customers may comment on one or more of the following conditions at low speeds during driving maneuvers up to 40 mph:</p> <ul style="list-style-type: none"> • Whining/Whirring • Whistle • Squeaking • Groaning/Growling <p>The customer might state this noise coming from the engine/wheel area</p>
Cause	This condition may be caused by fretting between the Front Intermediate Shaft(IDS Shaft) and the Front Intermediate Shaft Bearing/Housing(IDS bearing). The fretting is the result of having a slip fit interface between the bearing and the IDS shaft, and combined with a bearing that has around 0.5Nm of torque to rotate(TTR)

1. Try and replicate the customers complaint maneuver (generally the noise is heard while coasting and without brakes being applied)
2. Install Chassis Ears
3. Identify if the noise is at the Front Intermediate Shaft Housing
4. Once the noise is confirmed and isolated at the front intermediate shaft housing
5. Replace IDS Shaft and IDS Shaft Housing, refer to *Front Wheel Drive Intermediate Shaft Replacement & Front Wheel Drive Intermediate Shaft Housing Replacement in Si.*
