# Preliminary Information

## PIT5788B Slow or No Crank, Low Battery Voltage, Parasitic Draw, Dead Battery

Brand:	Model:	Model Years:	VIN:		Engine:	Transmissions:
			from	to		
Cadillac	Escalade Models	2021 - 2022	All	All	All	All
Chevrolet	Suburban	2021 - 2022	All	All	All	All
Chevrolet	Tahoe	2021 - 2022	All	All	All	All
GMC	Yukon Models	2021 - 2022	All	All	All	All

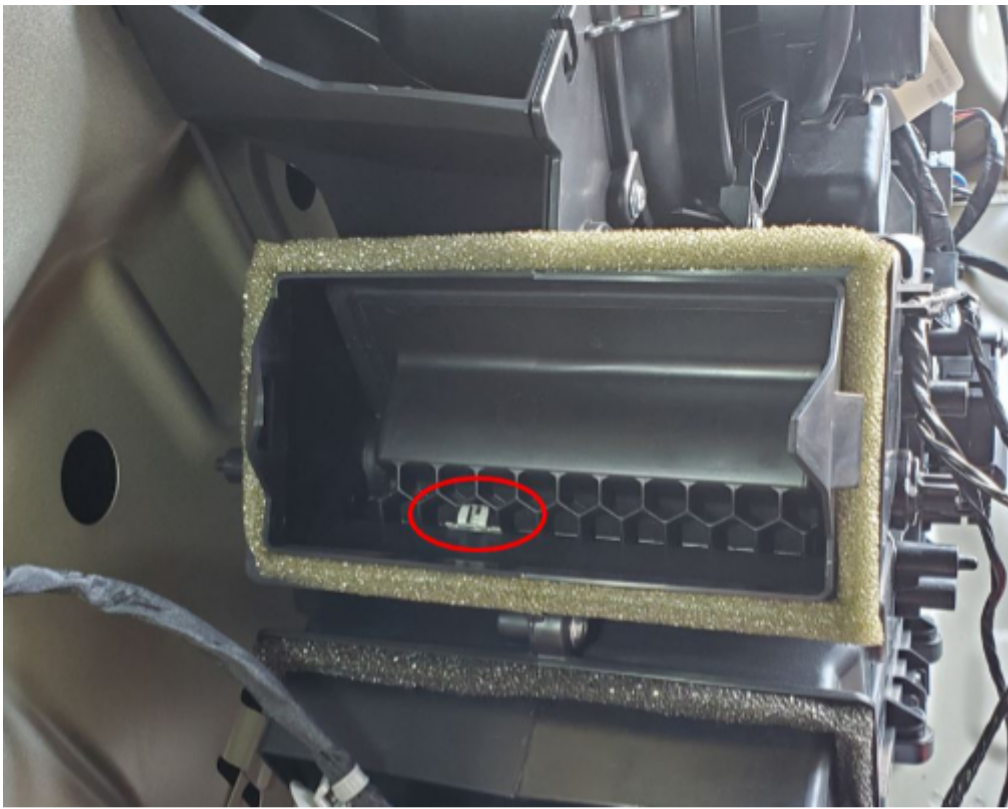
Involved Region or Country	North America
Condition	Some customers may comment on a no/slow crank due to a low or dead battery. If the rear HVAC mode door and/or temperature door operation is checked, one of the doors may not function correctly. In addition, while the vehicle is turned off, it may be noticed that the backlighting for either the front or rear HVAC controls is turning on, even though the ignition is off and the vehicle should be asleep.
Cause	<p>The cause of this concern could be the rear HVAC actuators not completing a learn procedure. The learn procedure may not complete if the door can not move through its full travel. This could be caused by, but not limited to:</p> <ul style="list-style-type: none"> <li>- Foreign object that has fallen into the rear HVAC case, as shown below. This object could limit the door from moving through its full travel.</li> <li>- An issue with either the power, ground or LIN bus circuits to one of the rear HVAC actuators.</li> <li>- A faulty rear HVAC actuator</li> </ul> <p>If one of the rear HVAC doors is not able to move through its full travel, the door learn procedure will be incomplete. If the door learn procedure is incomplete the vehicle will try to perform a relearn procedure after the vehicle is turned off. If the relearn still does not complete the vehicle will continue to perform the relearn procedure until the battery is depleted.</p>

Check the rear HVAC mode and temperature door operation. Make sure the rear mode operates from roof to floor and the temperature from full hot to full cold. If either door does not function properly, then access the rear HVAC case. Inspect the rear HVAC doors for any mechanical issues that may limit or prevent the door from moving smoothly or moving through its full range of travel and repair as necessary. Inspect for any electrical issues to each rear HVAC actuator. In some cases, we have seen connector X251A/X418 (depending on model year) not fully connected.
