## PIP5834A Service 4wd message with DTC C119E

Models

Involved Region or Country	North America
Additional Options (RPO)	NQH
Condition	Service 4wd message with DTC C119E symptom 5A Stored in the TCCM
Cause	Transfer case clutch set up

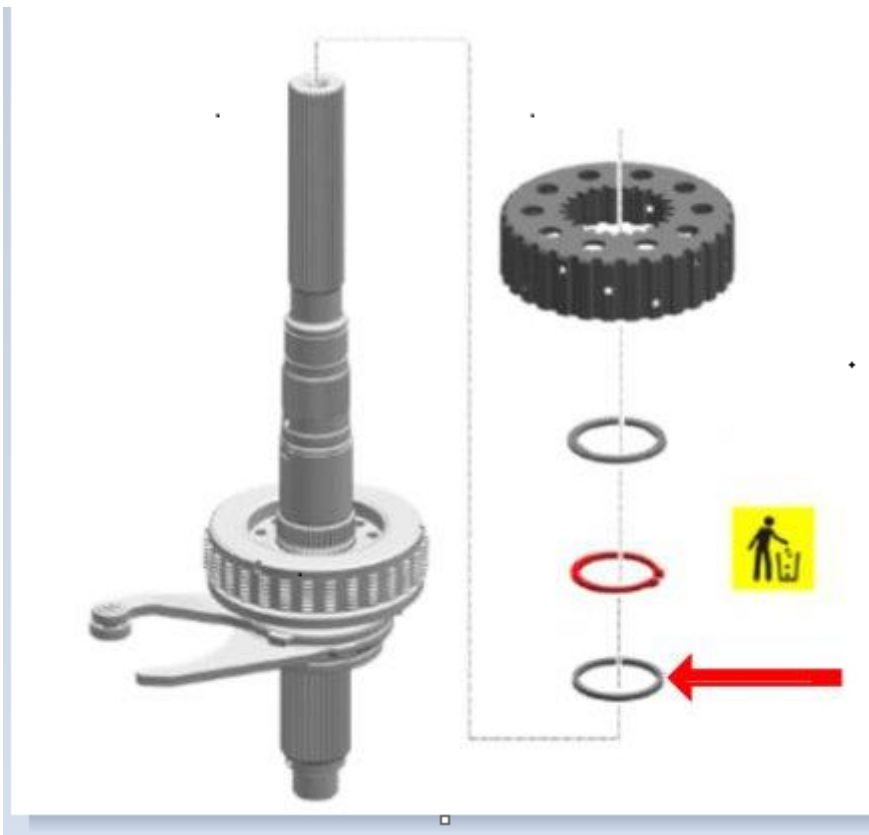
If the Transfer Clutch High Value is below 5 degrees:

2: Disassemble transfer case using appropriate procedure to gain access to the clutch pack assembly. Do not take the clutch pack any farther apart that what is needed to get to the shim pointed at below.

Remove the existing shim, measure it and then replace it with the next smaller shim available. Example shim removed is 4.8 mm then a 4.6 mm should be reinstalled.

Do not attempt to use the tools listed in the document to measure clutch pack shim for this repair.

5: Perform Transfer Case Range Actuator Learn then go into engineering data list 3 in GDS and the High Clutch Value should have increased by 10-12\*.
