Bulletin No.: PIP5840

PIP5840 Modify Sound Insulator During Service

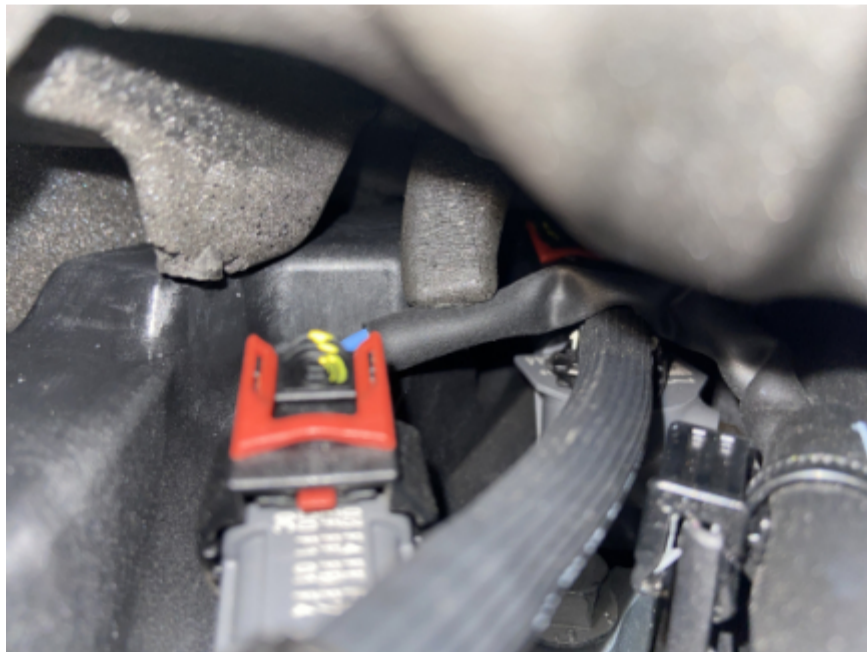
Involved Region or Country:	North America
Condition:	When performing any service that requires removal of the engine cover.
Cause:	Due to the potential of a "stand off" causing strain on electrical circuits, modify the camshaft housing cover insulator as described below.

Note how the standoff made contact and added stress to the the circuit.

Whether reinstalling the original camshaft housing cover insulator or a new one, modify it by cutting off the stand off identified in the pictures below.

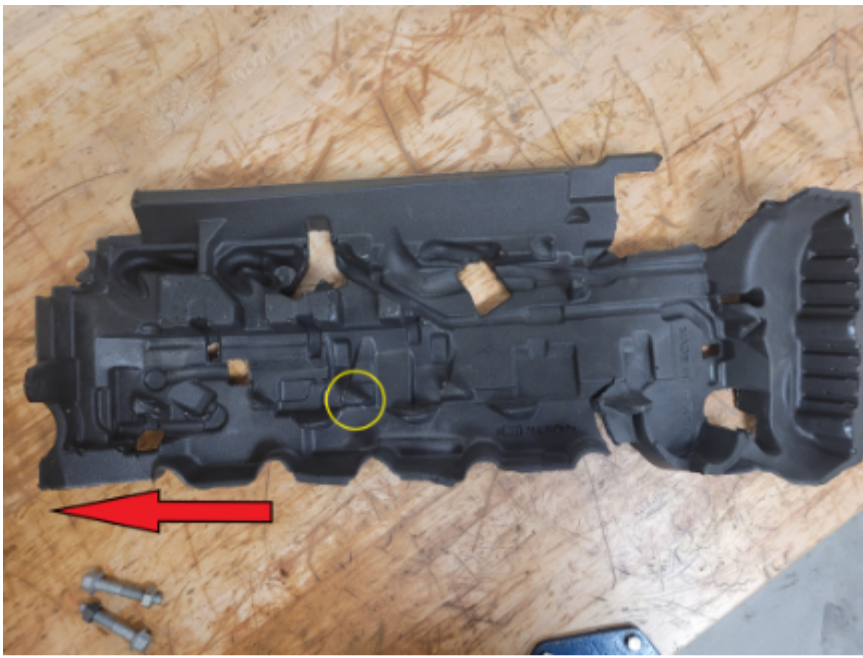
A wide angle view for orientation.
