Sliding Roof Binds When Opening or Closing

Service Category Vehicle Exterior

Section Sliding Roof/Convertible

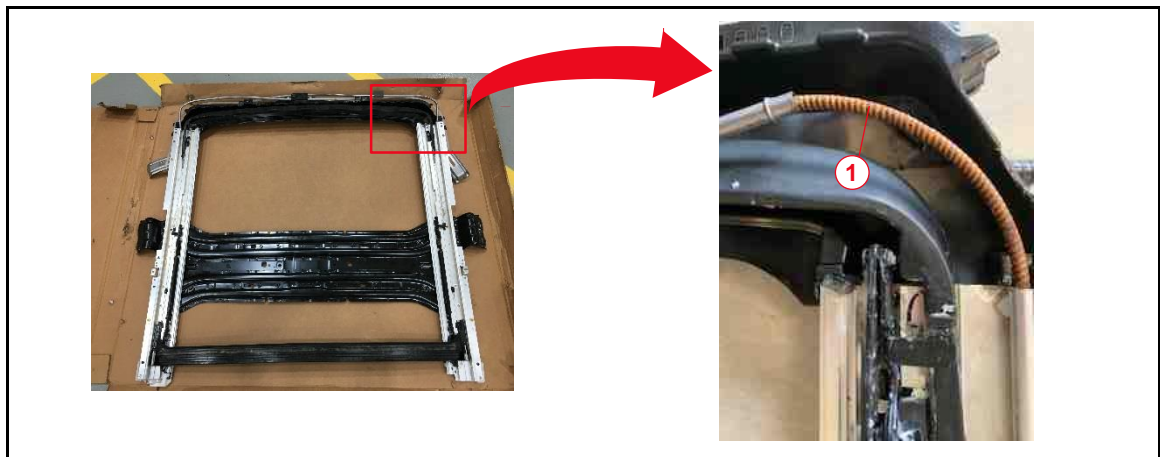
Figure 1.

Some 2018 – 2020 model year Sequoia and Tundra vehicles equipped with a sliding sunroof or moonroof may exhibit a binding, seizing, or sticking condition when attempting to open or close. In some cases, a clicking noise is present when the sliding sunroof or moonroof is stuck open or closed. This condition may be caused by rusted or seized sliding roof cables. Follow the Repair Procedure in this bulletin to address this condition.

1	Corroded Sliding Roof Cable
----------	------------------------------------

2. Replace BOTH the sliding roof housing sub-assembly AND the sliding roof cables.
 - A. Remove the sliding roof housing sub-assembly AND sliding roof cables.
 - 2018 – 2020 Sequoia:
Vehicle Exterior – Sliding Roof/Convertible – [“Sliding Roof / Convertible: Sliding Roof Housing: Disassembly”](#)
 - 2018 – 2020 Tundra:
Vehicle Exterior – Sliding Roof/Convertible – [“Sliding Roof: Sliding Roof Housing \(for CrewMax\): Disassembly”](#)
 - B. Install the NEW sliding roof drive cable sub-assembly AND the NEW sliding roof cables.
 - 2018 – 2020 Sequoia:
Vehicle Exterior – Sliding Roof/Convertible – [“Sliding Roof / Convertible: Sliding Roof Housing: Reassembly”](#)
 - 2018 – 2020 Tundra:
Vehicle Exterior – Sliding Roof/Convertible – [“Sliding Roof: Sliding Roof Housing \(for CrewMax\): Reassembly”](#)
