# SERVICE BULLETIN

Classification: BT21-029	Reference: NTB22-008	Date: February 14, 2022
-----------------------------	-------------------------	----------------------------

## DETERMINING CORRECT WINDSHIELD WASHER PUMP OPERATION

**APPLIED VEHICLES:** 2021-2022 Rogue (T33)

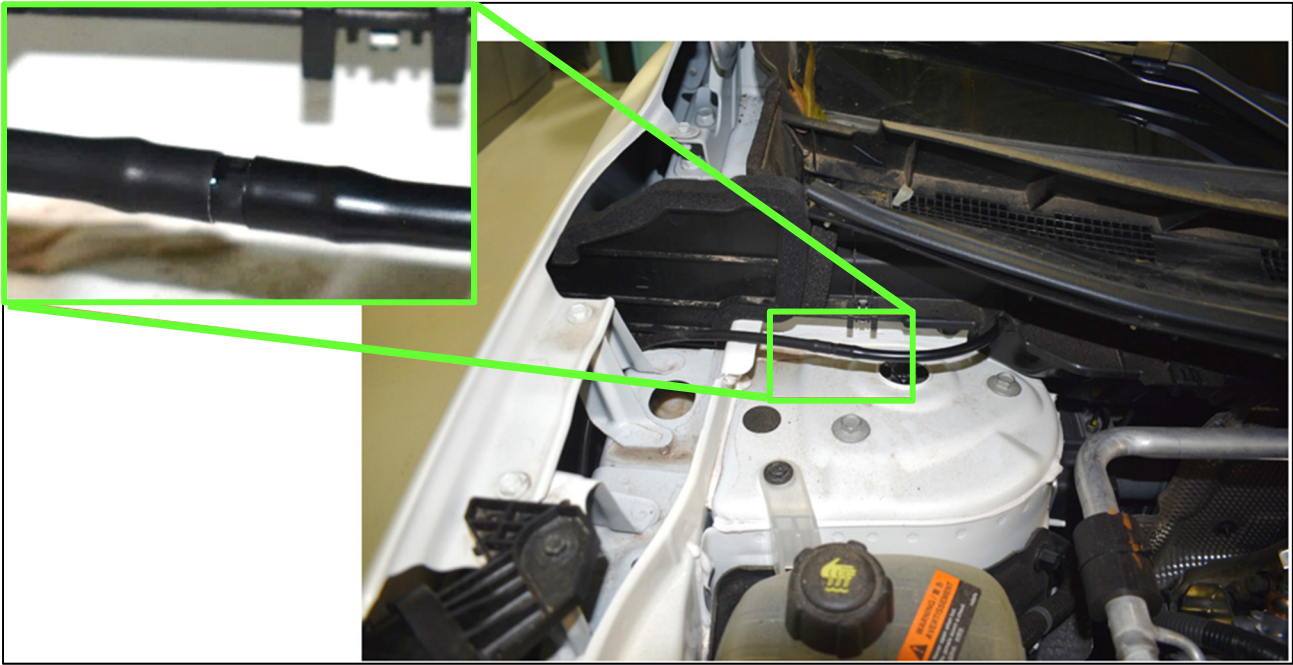
Figure 1

1. Locate the windshield washer pump tubes connected by a barbed connector. This will be found under the hood on the passenger side near the strut mount.

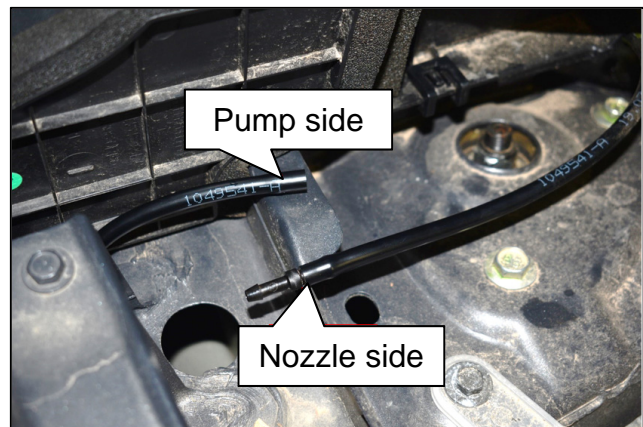
Figure 2

2. Separate the “pump side” tube from the barbed connection, and leave the barbed connector in the “nozzle side”.

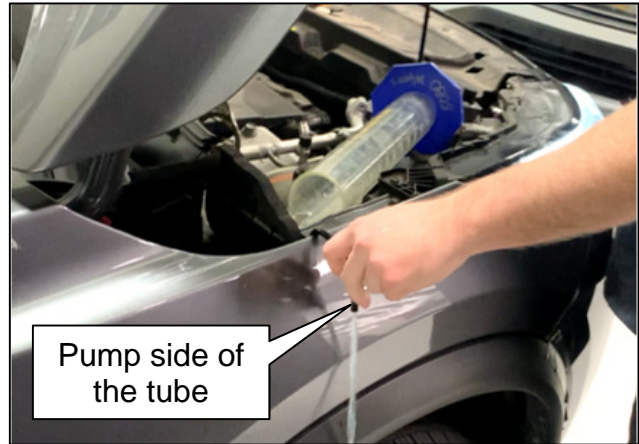
Figure 3

3. Start the vehicle.
4. Take the pump side of the tube, and aim it down into an empty container.
5. Have a helper activate the vehicle's windshield washers.
  - This is to “prime” the system, and this fluid should be discarded.

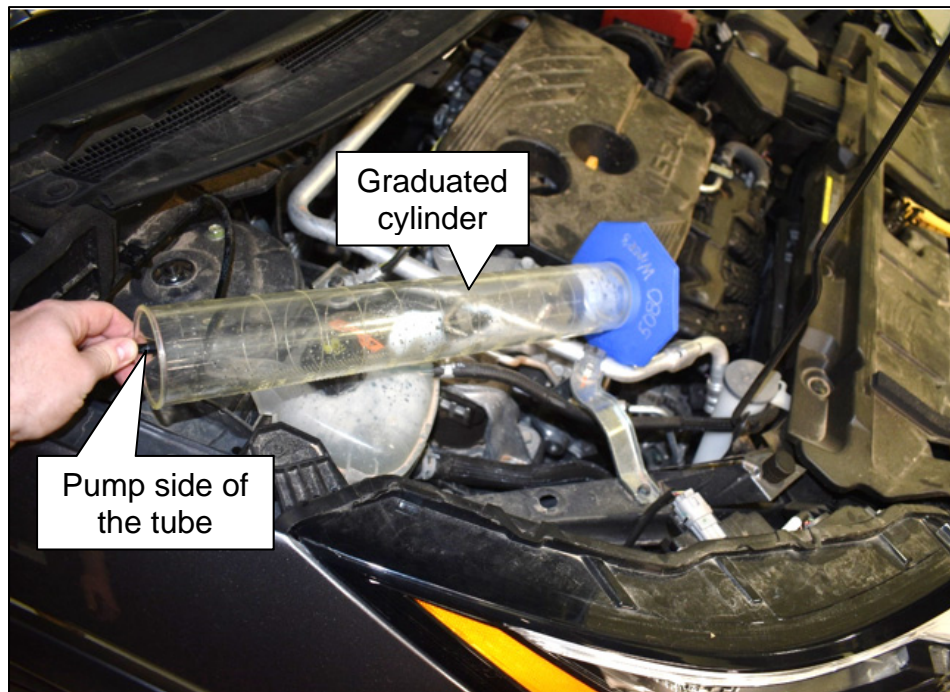
Figure 4

6. Immediately after priming the tube, place the tube into a graduated cylinder, and have your helper activate the windshield washers for five (5) complete windshield wiper strokes.

**IMPORTANT:** Measurements will not accurately reflect the pump performance if the collection of the fluid is not done immediately following priming of the pump.

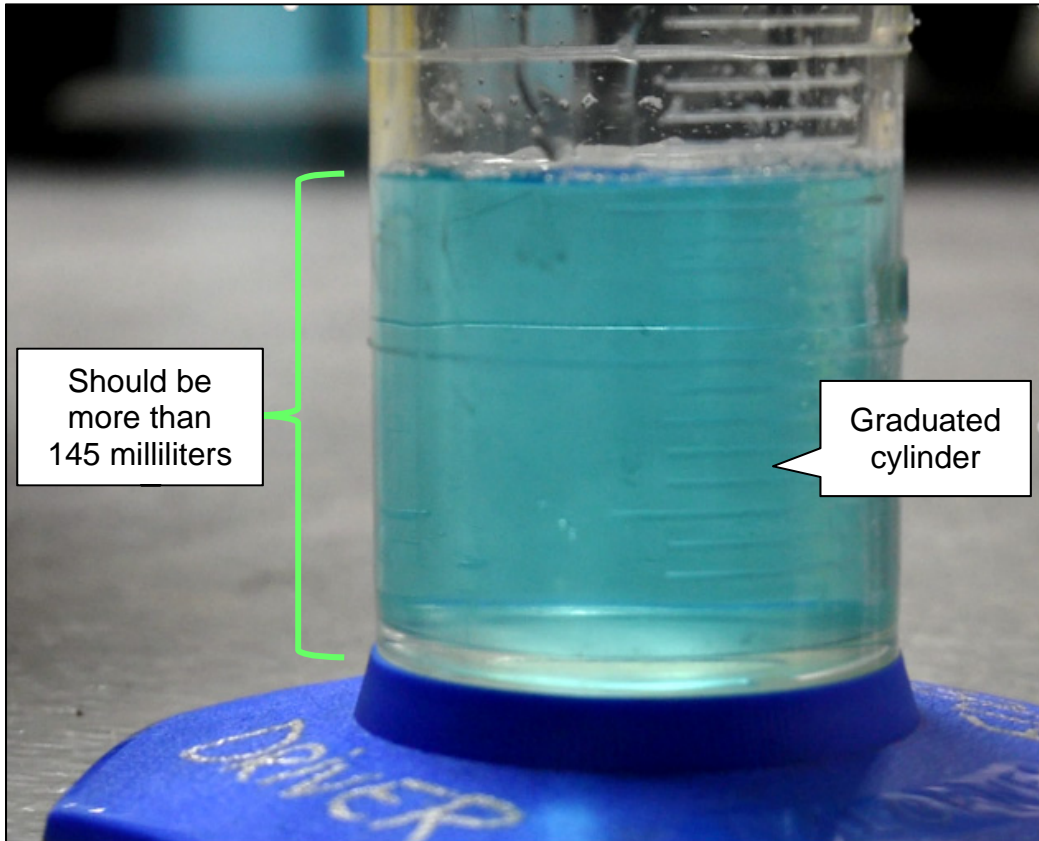
Figure 5

7. Take the pump side tube out of the graduated cylinder and set the graduated cylinder on a flat surface.

8. Check the amount of fluid that was collected from five (5) complete windshield wiper strokes.
- If the windshield washer pump is operating correctly, the fluid collected should be more than 145 milliliters.
  - If the windshield washer fluid is less than 145 milliliters, refer to the ESM for further diagnostic information.
