# SERVICE BULLETIN

Classification: EL22-002	Reference: NTB22-011	Date: February 22, 2022
-----------------------------	-------------------------	----------------------------

## FALSE MAINTENANCE ALERT NOTIFICATION

**APPLIED VEHICLES:** 2021-2022 Armada (Y62) – All grades  
 2021-2022 Maxima (A36) – All grades  
 2020-2021 Titan/Titan XD (A61) – SV w/Convenience Package, SL, Platinum Reserve, PRO-4X

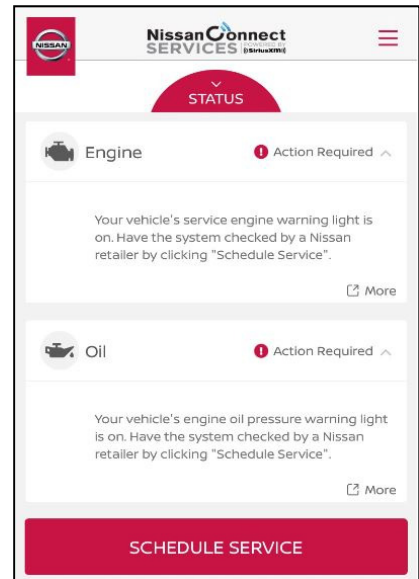
Figure 1

The customer receives a Maintenance Alert from NissanConnect Services, notifying them that the oil pressure warning light or the service engine warning light is on,

There are no warning lights ON in the instrument panel,

There are no related DTCs stored.

1. Replace the Telematics Communication Unit (TCU).
  - Ensure that the customer provides ALL Intelligent Keys for the vehicle before replacing the TCU.
2. Configure TCU.
