TECHNICAL SERVICE BULLETIN

Non-Hybrid - Radio Static And/Or Poor Radio Sound Quality When Moving

22-2040

Ford 2020-2022 Explorer	Non-hybrid
Lincoln 2020-2022 Aviator	Non-hybrid

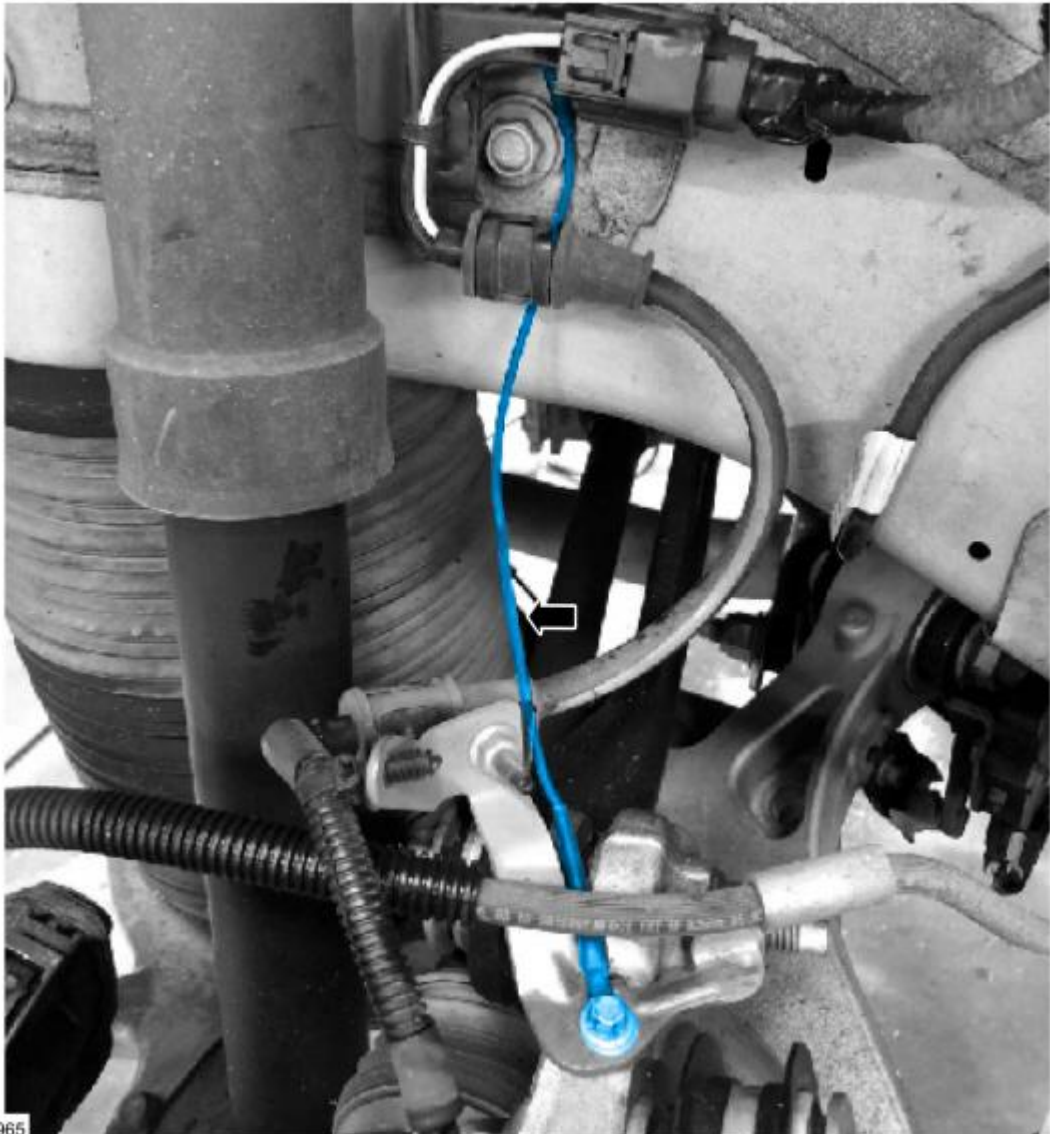
Figure 1

Issue: Some 2020-2022 Explorer/Aviator non-hybrid vehicles may exhibit radio static and/or poor radio sound quality when moving. This may be more noticeable on AM radio stations. This may be caused by an electromagnetic interference concern. To correct the condition, follow the Service Procedure to install new grounds on the rear knuckle.

1. Install new ground straps on each side of the vehicle on top of the brake hose bracket bolt on the rear knuckle. Tighten to 133 lb-in (15 Nm). Refer to Workshop Manual (WSM), Section 204-02. (Figures 1-2)

2. Install the other side of the ground straps underneath the rear wheel speed sensor harness bracket mounting stud. Tighten to 62 lb-in (7 Nm). Refer to WSM, Section 206-09. (Figures 1-2)
