# Technical Service Bulletin

## 87 Noise from the air conditioning compressor when the AC is active

87 22 20 2063467/2 March 21, 2022. Supersedes Technical Service Bulletin Group 87 number 21-14 dated May 28, 2021, for reasons listed below.

Model(s)	Year	VIN Range	Vehicle-Specific Equipment
e-tron quattro	2019 – 2022	All	Not Applicable
e-tron Sportback quattro	2020 – 2022

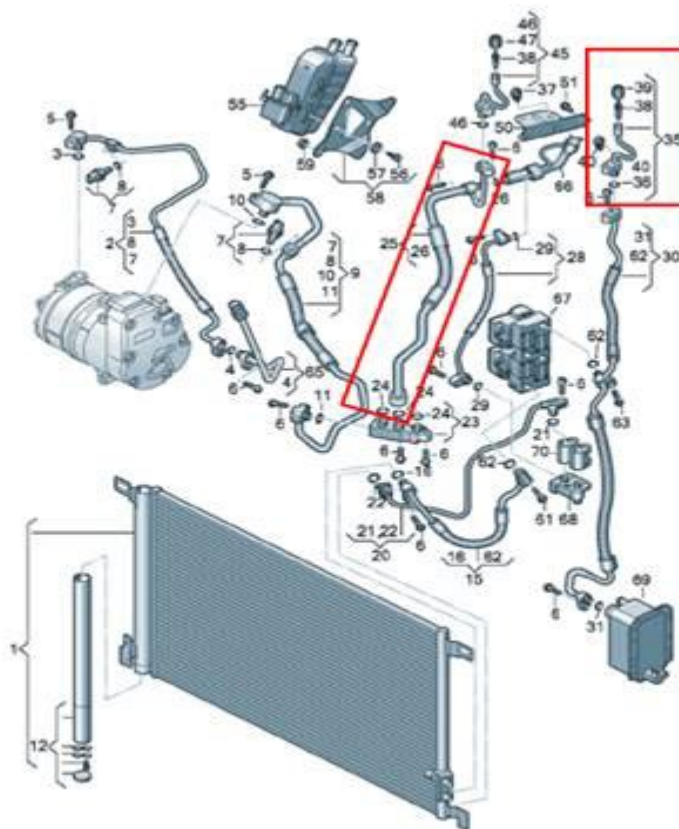
The source of this noise may be due to direct contact between the two refrigerant lines (Figure 1). When the air conditioning compressor is operating the noise created by the vibration is transferred from this point of contact and into the cabin.

**Figure 1.** The refrigerant lines are making contact.

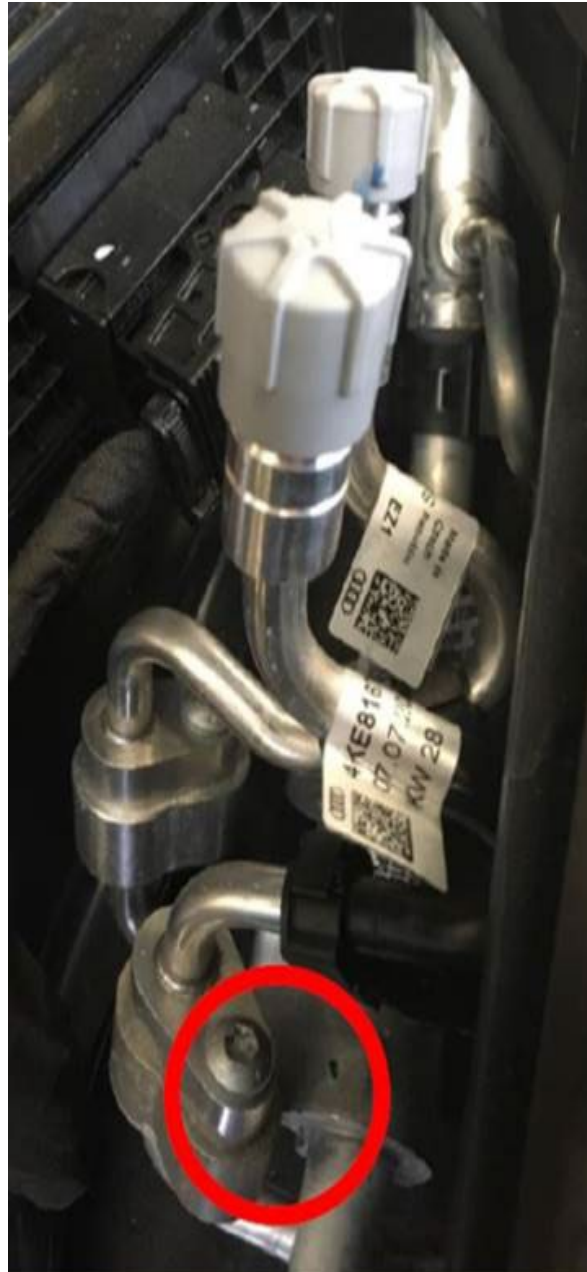
1. Figure 2 shows the refrigerant lines are close enough to make contact to elicit the noise.

*Figure 2. The refrigerant lines are making contact.*

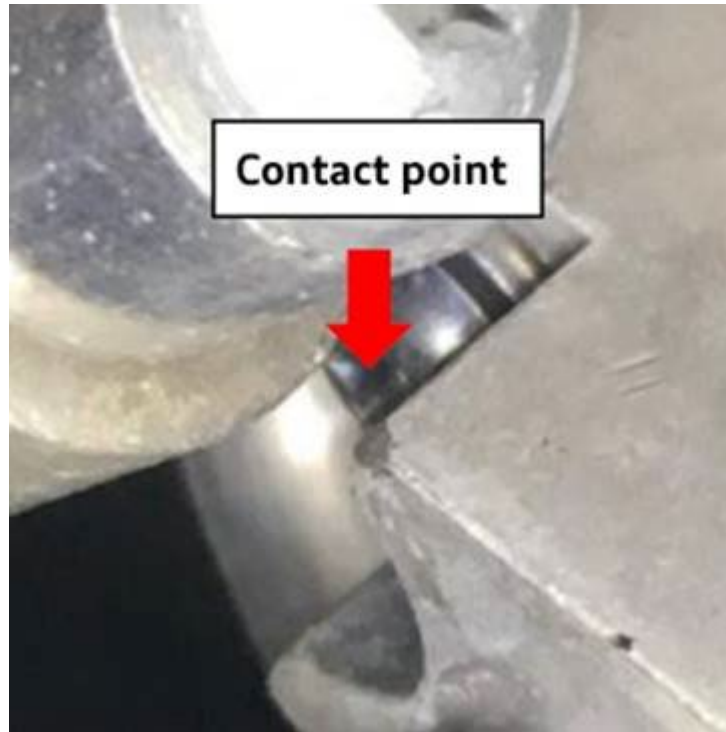
2. Figure 3 shows a close-up view of the point of contact.

*Figure 3. Point of contact.*

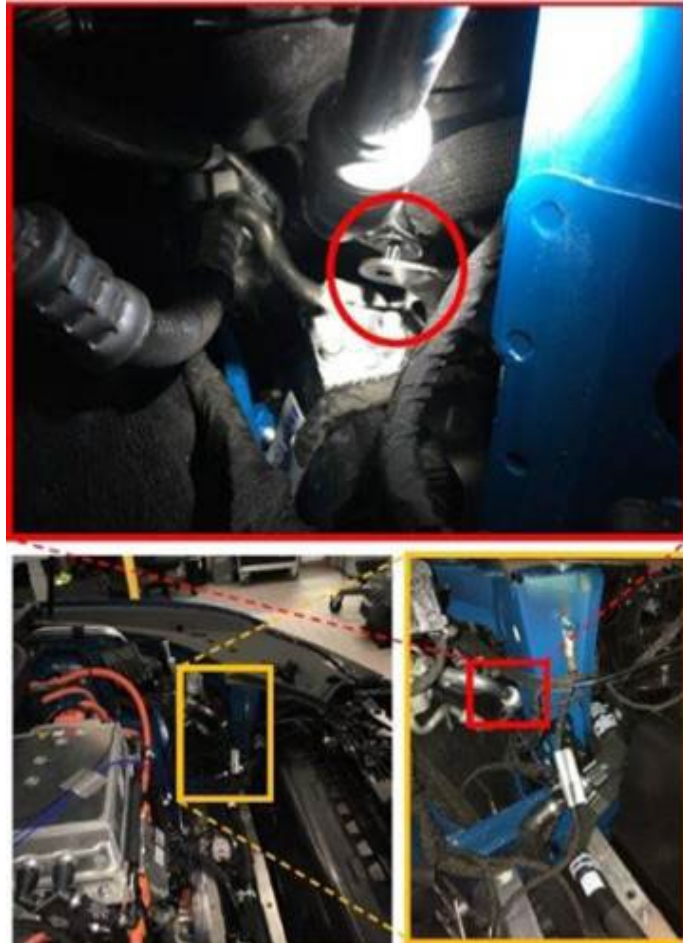
**Figure 4.** The area in the motor bay where contacting lines are located.

3. These refrigerant lines must be separated and, if necessary, retained in a separated state using a hose holder, clip, or tie-wrap (Figure 4).

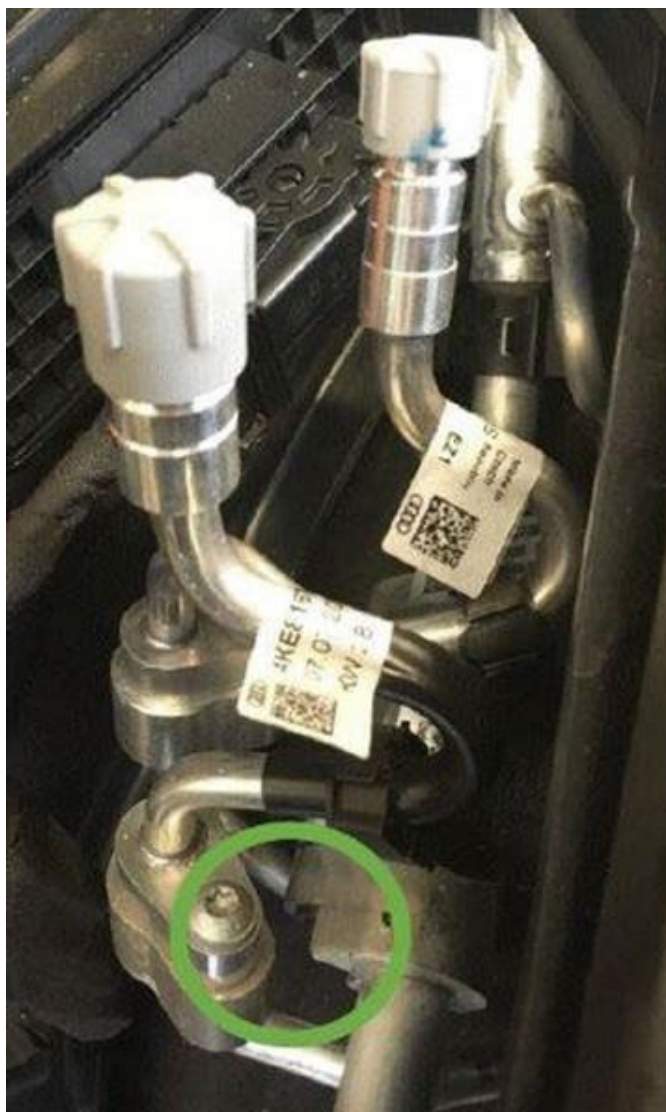
4. Figure 5 shows properly separated refrigerant lines.

*Figure 5. The refrigerant lines have been separated.*
